Tookany Creek Flood Damage Reduction Feasibility Study Section 205 Continuing Authorities Program

Field Inspection Notes 27-29 September 2012

US Army Corps
of Engineers
Philadelphia District

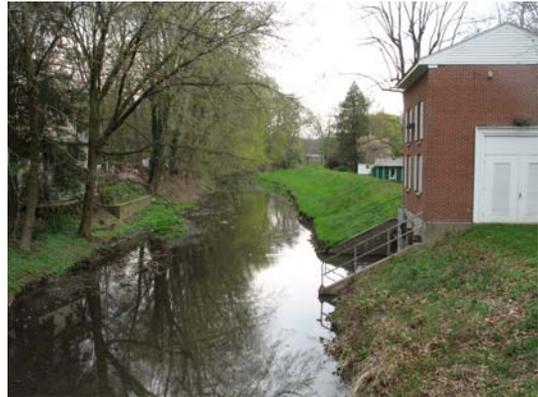
Figure 1: View looking upstream along Tookany Creek at Rice Mill Road. Pump Station is shown on the right.

According to the residents interviewed, flooding occurs in this area predominantly because of interior drainage issues associated with runoff flowing down Keswick Avenue. Although water has reached the top of the berm, residents reported the berm has not overtopped except near the pump station at Rices Mill Road Bridge. Most of the damage reported includes damage to vehicles and contents associated with basement flooding. The PADEP is evaluating a flood control project in this area that includes raising the berm and the construction of several basins.

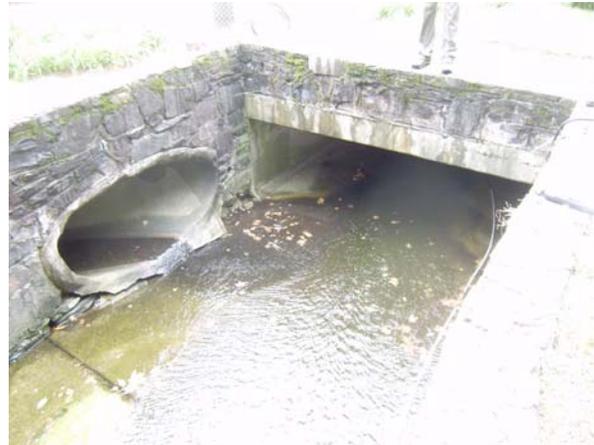
Figure 2: Culvert at upstream limit of underground portion of the unnamed tributary before flowing behind the homes on Brookside Road.

begins to back up behind a wall adjacent to Tookany Creek until a ponding area forms. Evidence, indicated by signs of erosion, suggests sheet flow may occur down Brookside Road (from Church Road) and flow between two homes and potentially contributing to the ponding area. Water enters the homes through basement drains and/or cracks in the foundation walls. Some of the homes had small parapet walls surrounding basement windows that indicate the homes may have experienced basement flooding from overland flow.

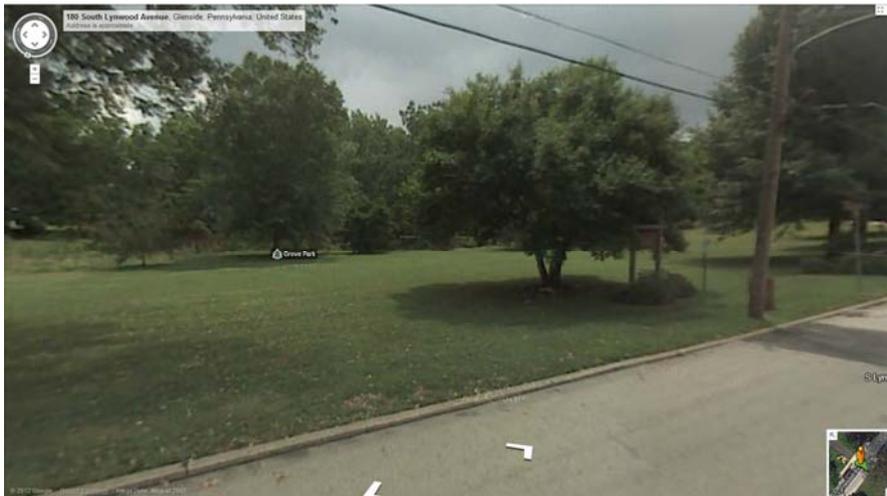
Figure 3: One of the parks upstream of the Harrison Avenue site.

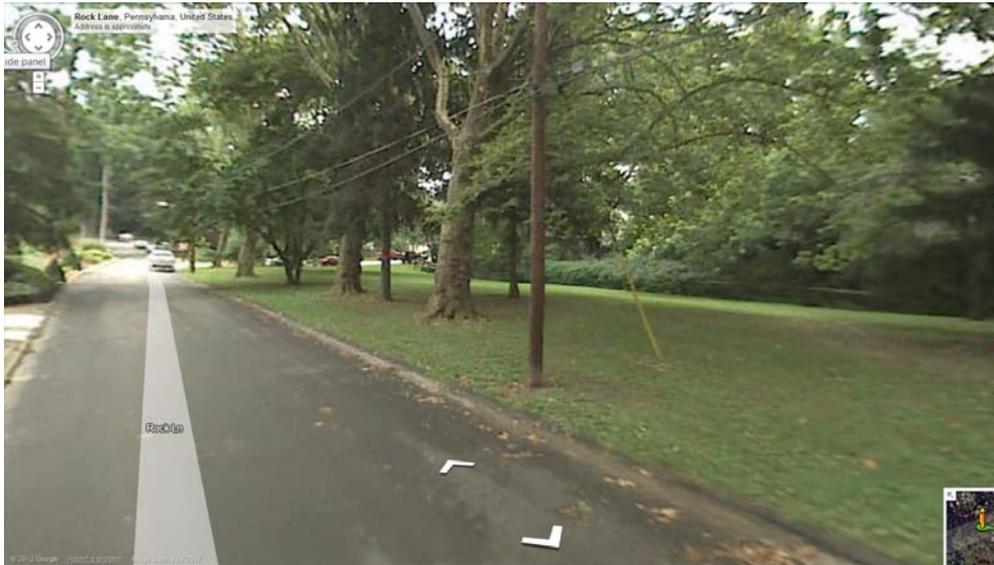
0930 Rock Lane/Widener: Flooding along Rock Lane occurs predominately upstream of Widener Road and downstream of Serpentine Lane. At some point in the 1960's, Cheltenham Township acquired several homes between these two points and adjacent to Rock Creek. Majority of the flooding is contained to basement and vehicular damage along Rock Lane. Although, following the 2011 Tropical systems, one structure along Widener Road sustained significant structural damage. At this location, Rock Creek enters a culvert before traveling an unknown distance and discharging into Tookany Creek.

Figure 4: Area of previous acquisition project by Cheltenham Township in 1960s along Rock Creek.

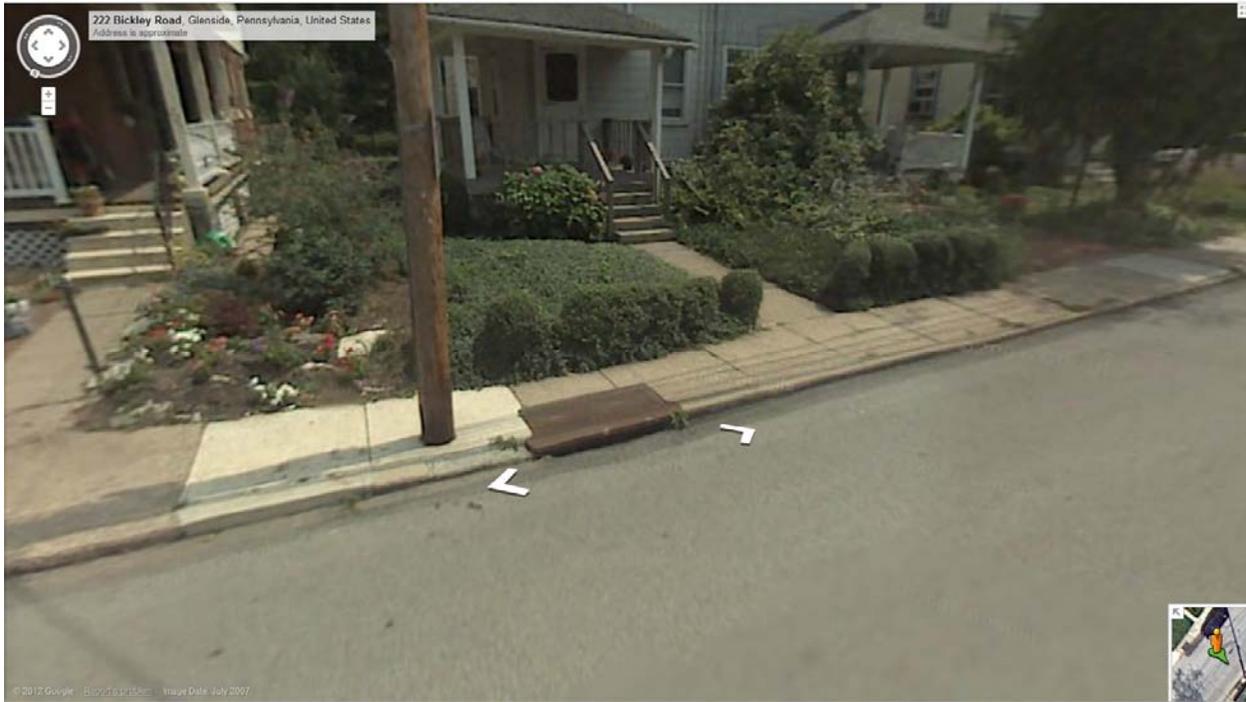
1100 Bickley Road: Eight homes along Bickley Road experience similar circumstances to the residents along Harrison Ave. Approximately 70 feet after Tookany Creek flows under Bickley Road, it enters a culvert and travels approximately 125 feet before daylighting. Within these 125 feet, the creek makes an approximate 90 degree turn. Resident testimony indicates water backs up behind South Keswick Ave. flooding the back yards while stormwater ponds in front of the houses. One inlet along the 200 block of Bickley Road drains the runoff from this area. Residents indicated water as deep as 10 feet behind the homes. Damage in this area consists of basement flooding and vehicular damage. One structure reported receiving structural damage to a front porch footer, however the claim was denied by Flood Insurance.

Figure 5: Single storm inlet along Bickley Road

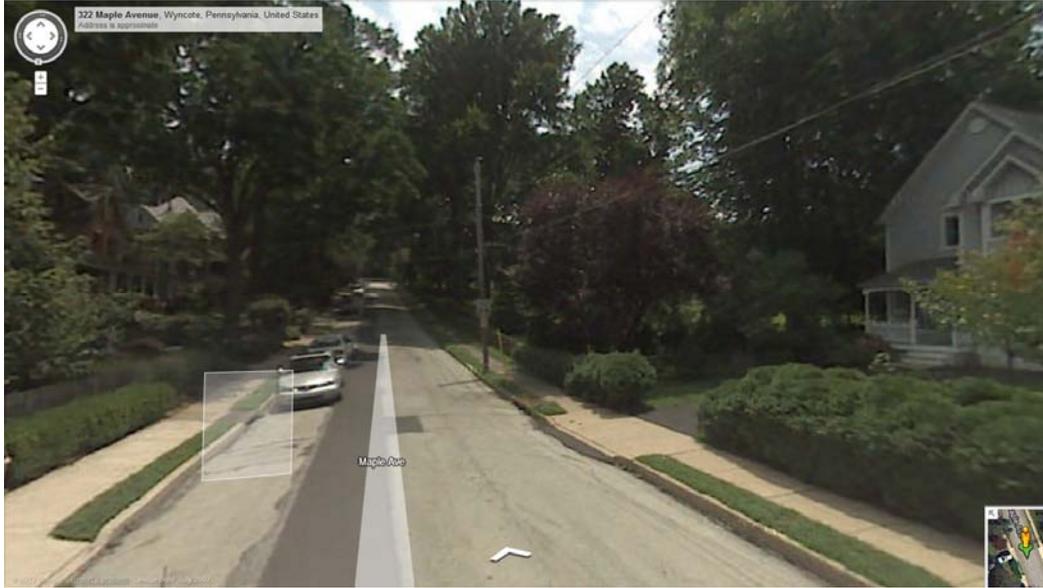
Flooding in this area is predominately limited to vehicular damage, basement flooding and damage to exterior structures (garages/sheds). One resident documented significant damage from a walkout basement. The flooding occurs when surface water reaches the natural drainage channel during high intensity storms, following the terrain contours and flows towards Tookany Creek.

Figure 6: Inlet along Maple Ave. The inlets represent the natural low-point in this area.

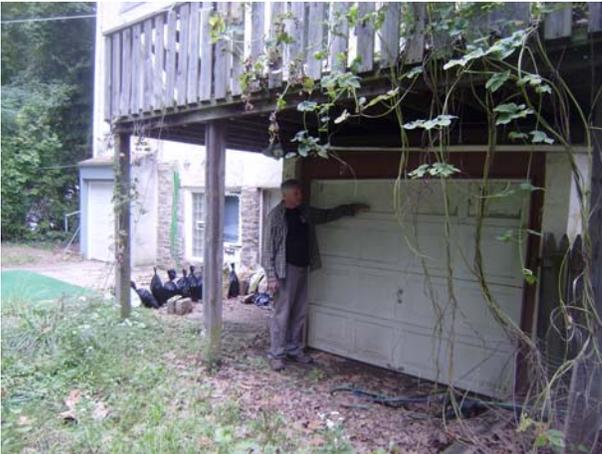
0930 High School Road: At the High School Road location, four structures are potentially subject to flooding with two of those structures significantly more susceptible than the others. The homes are located just downstream of the High School Road bridge. Upstream of this bridge is the Ogontz Field. Flooding in this area begins from backwater associated with the downstream Mill Road Bridge crossing as well as overtopping of the High School Road Bridge. Flooding also occurs from ponding within Ogontz Field as it drains through low points along High School Road between the houses. Residents interviewed indicated that the water behind the homes is relatively still during flood periods, “almost like a swimming pool.”

Figure 7: High water mark from the 2011 Events behind High School Road.

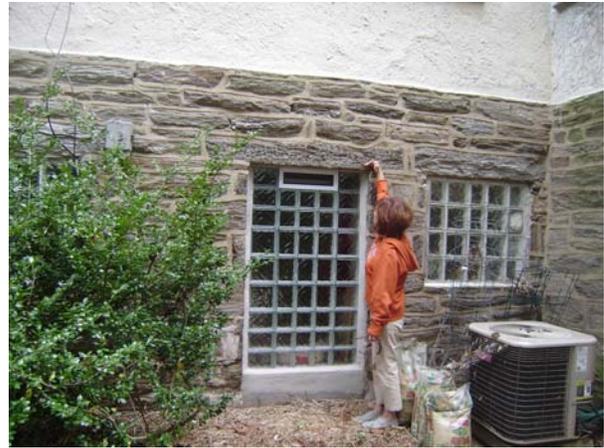
1130 Mill Road: The Mill Road crossing over Tookany Creek causes backwater to affect upstream areas (High School Road). As this backwater increases in elevation, the water eventually overtops the banks near the bridge, causing flood damage to nearby residences and one business. Mill Road slopes down and away from the bridge forcing overflow towards the residences along Mill Road. Backwater effects from the downstream Harrison Ave crossing were not noted. Prior to the Township's installation of the temporary sanitary sewer bypass system, this area experienced significant problems with sewer backups.

Figure 8: A resident points out a high water mark from the 2011 events.

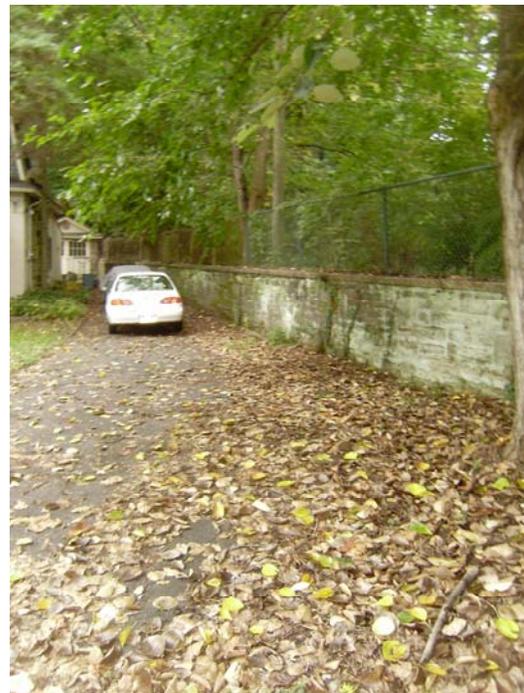
Figure 9: Wall adjacent to Tookany Creek overtopped in 2011.
