Site Visit Report

Date: Tuesday, Nov. 6, 2001

Project: Bushkill Creek Stream Restoration Project

Purpose of Visit: Observe Geophysical Investigation

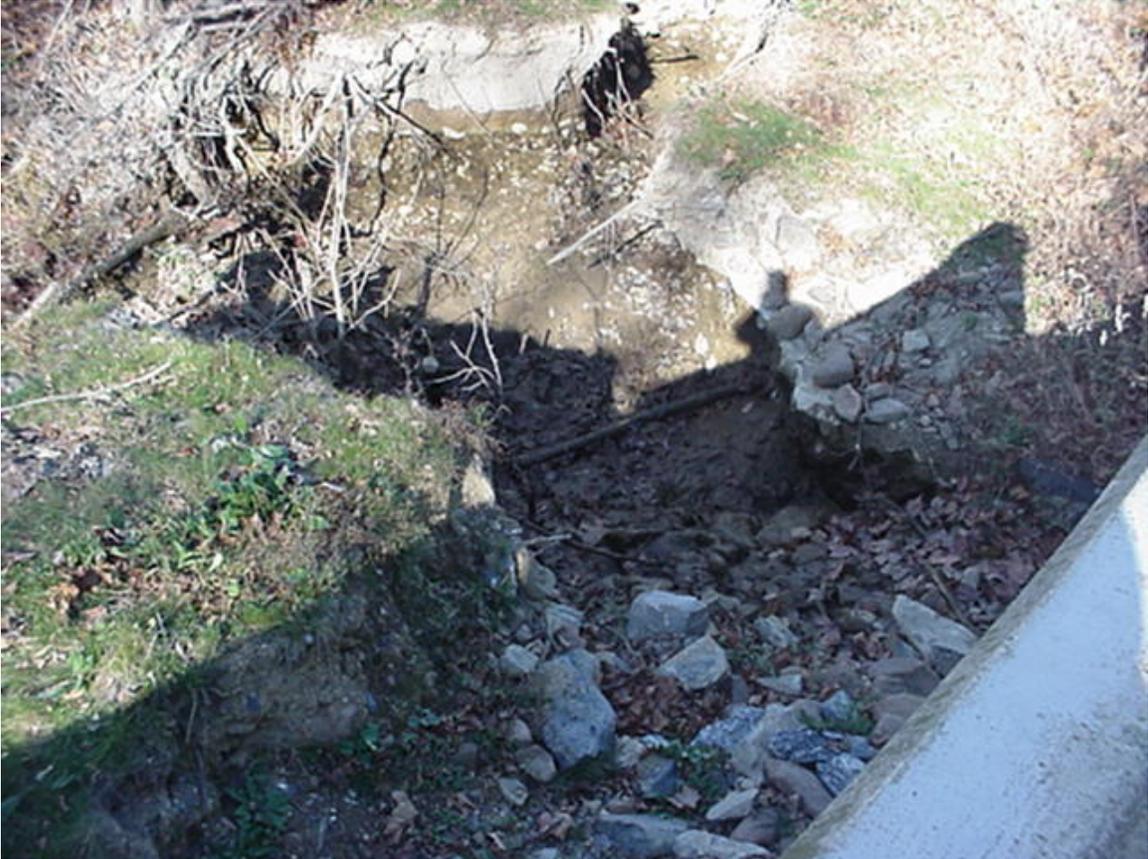
View looking northwest of the sinkhole area immediately west of the northern side of the SR 2017 bridge.

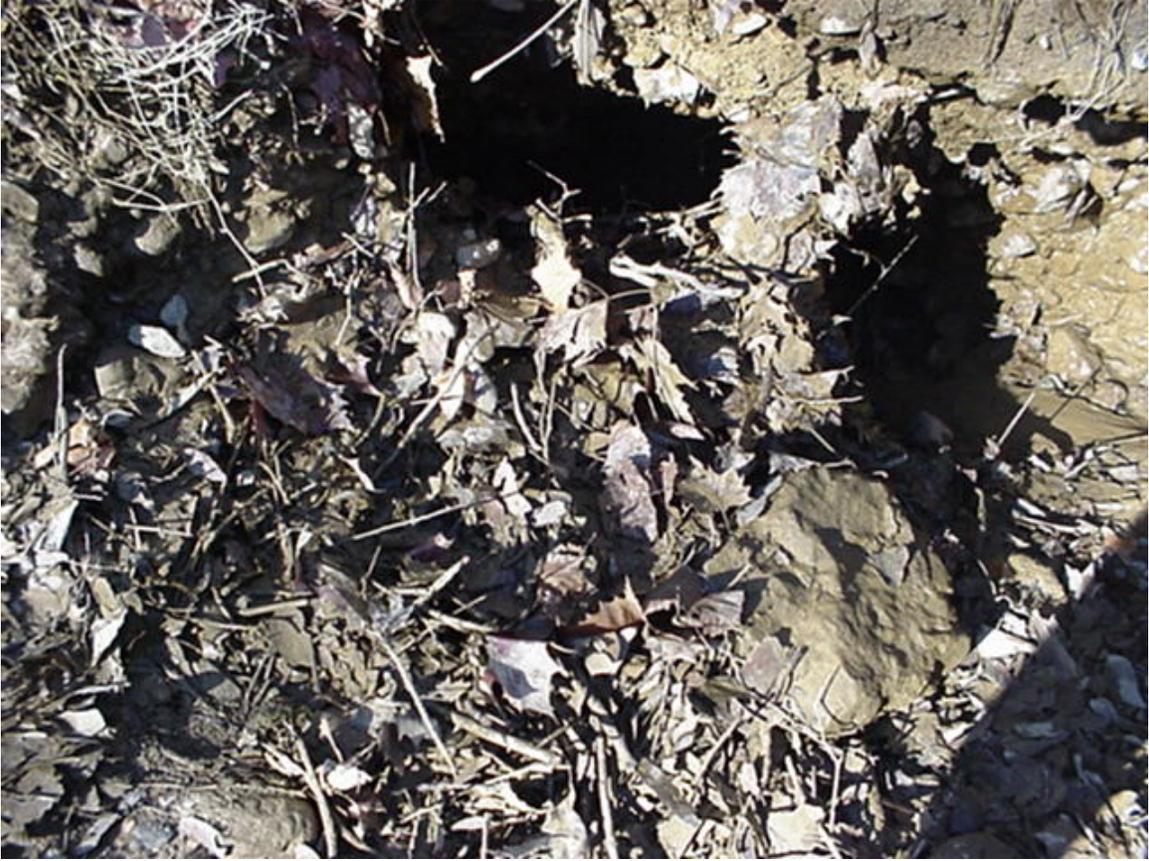
View looking north-northwest of the same area shown in the previous photograph.

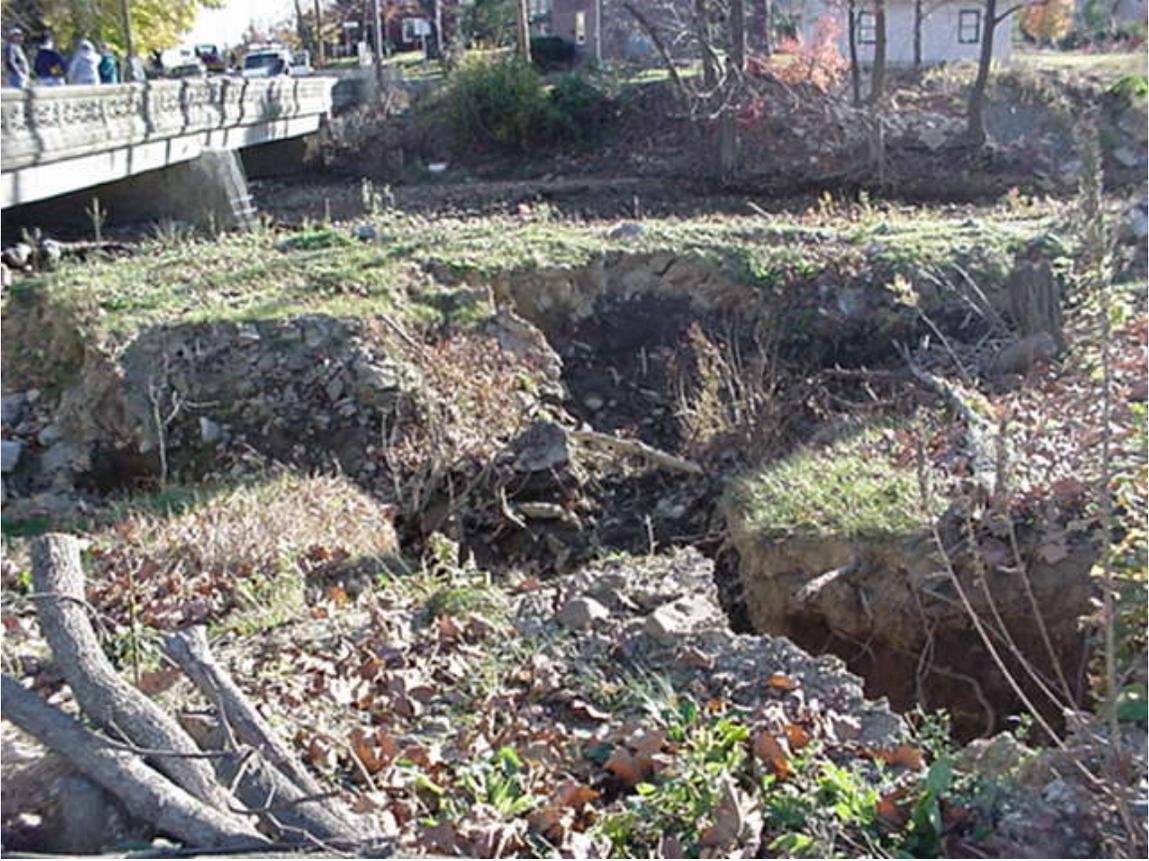
View looking south towards the same area shown in the previous photos.

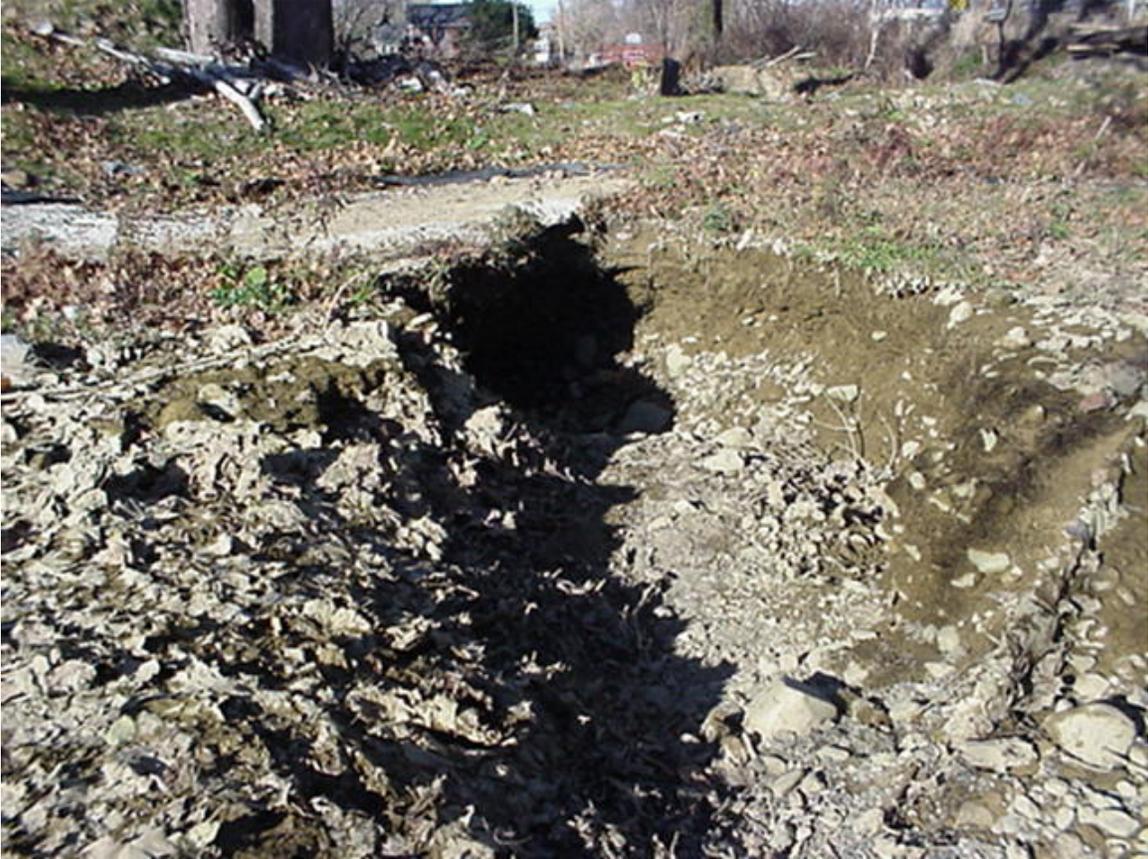
View looking north into the area immediately west of the area shown in the previous photographs. The previously placed concrete patch over the original smaller sinkhole is visible at the surface.

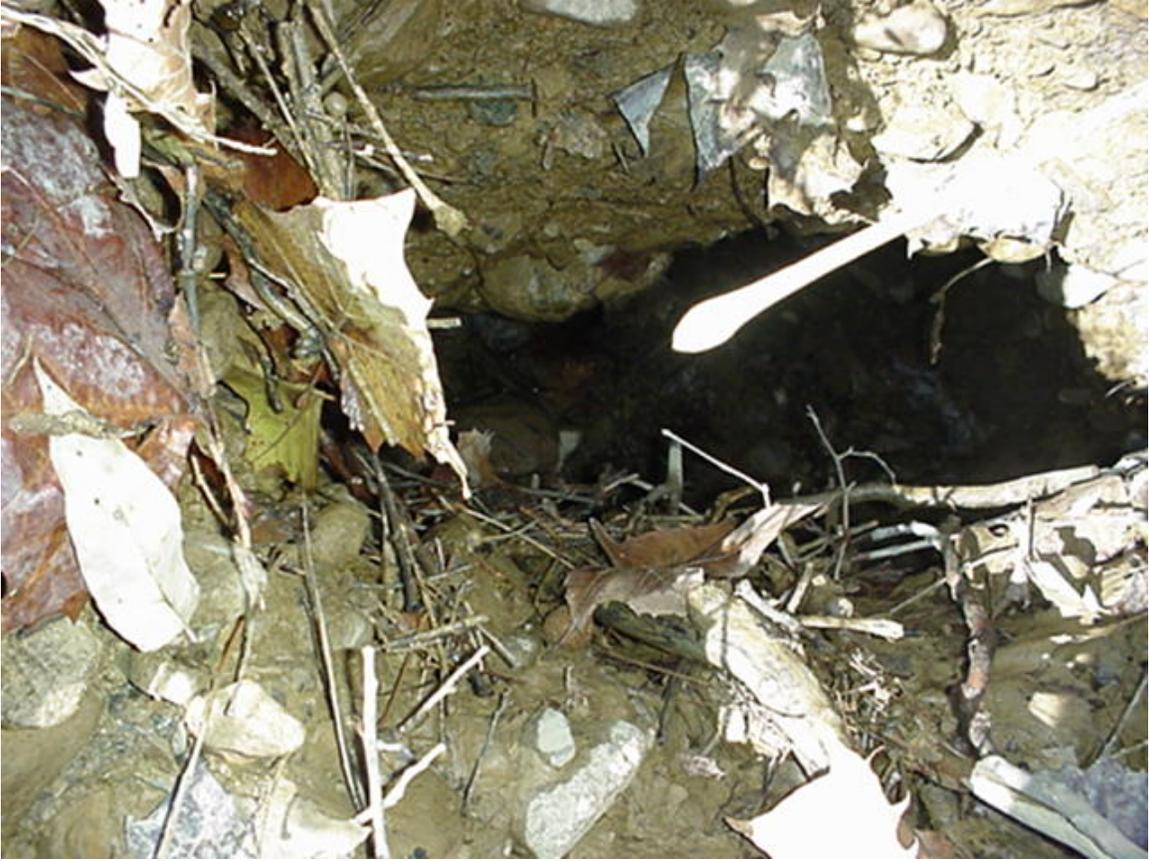
View looking into the sinkhole shown in the previous photograph.

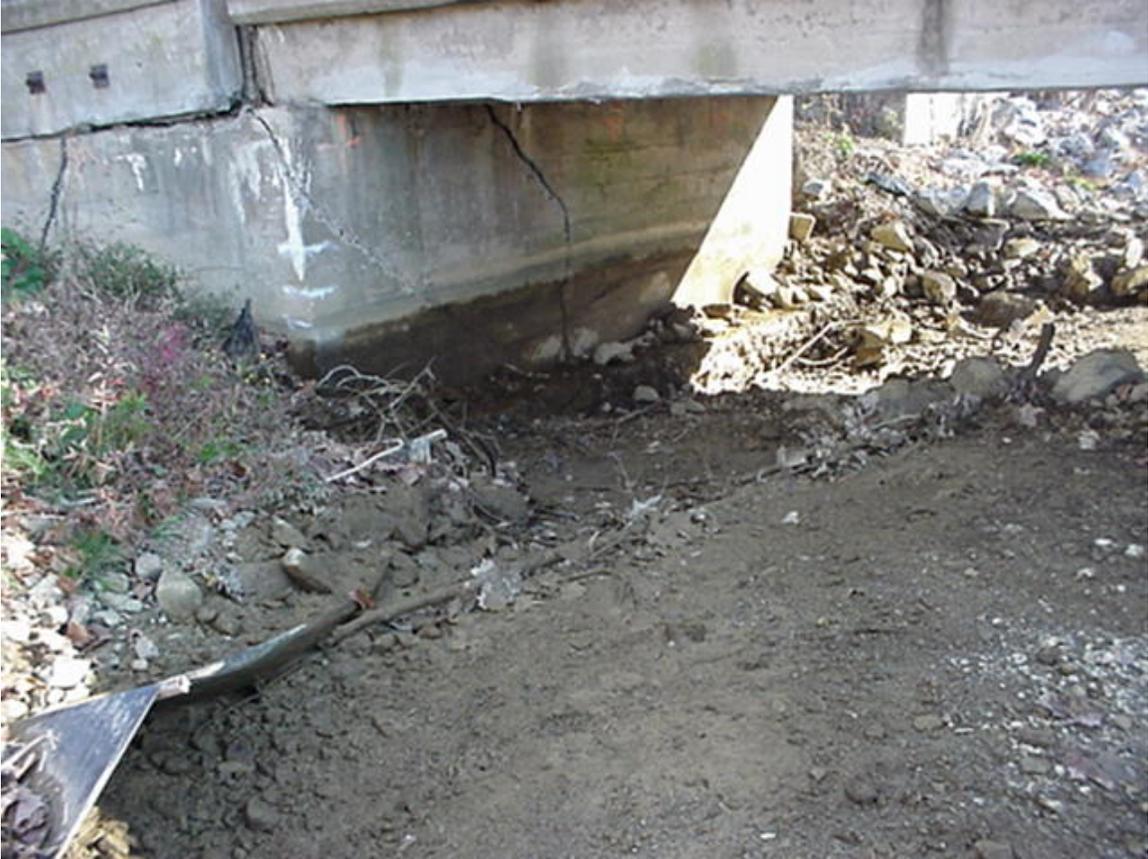
View looking northeast at the northern bridge foundation. This is the failed foundation of the bridge. The footing is completely exposed.....this can be visualized better in the following 2 photographs.

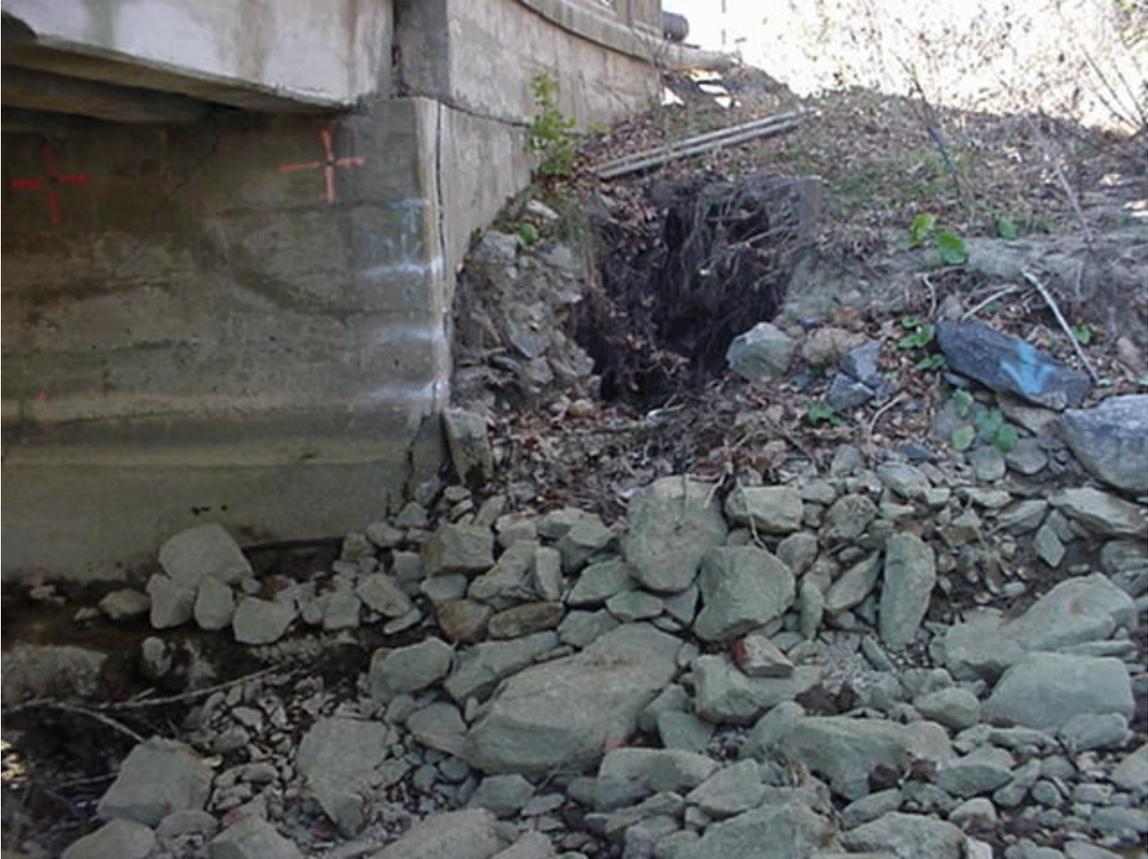
View looking north-northwest towards the eastern end of the northern bridge abutment (that failed). Note the sinkhole to the right of the bridge.

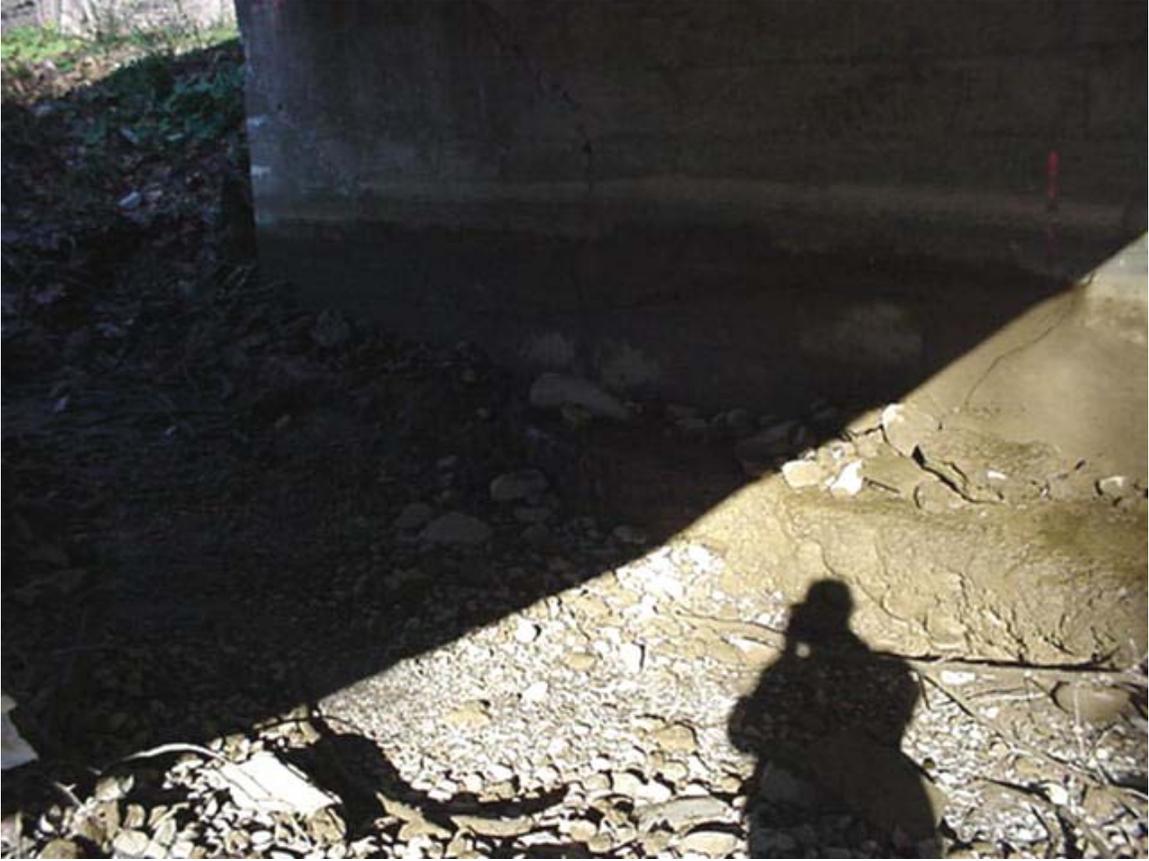
View northwest of the exposed foundation of the north abutment of the bridge. The spread footing is located just above the shadow of the photographer's head.

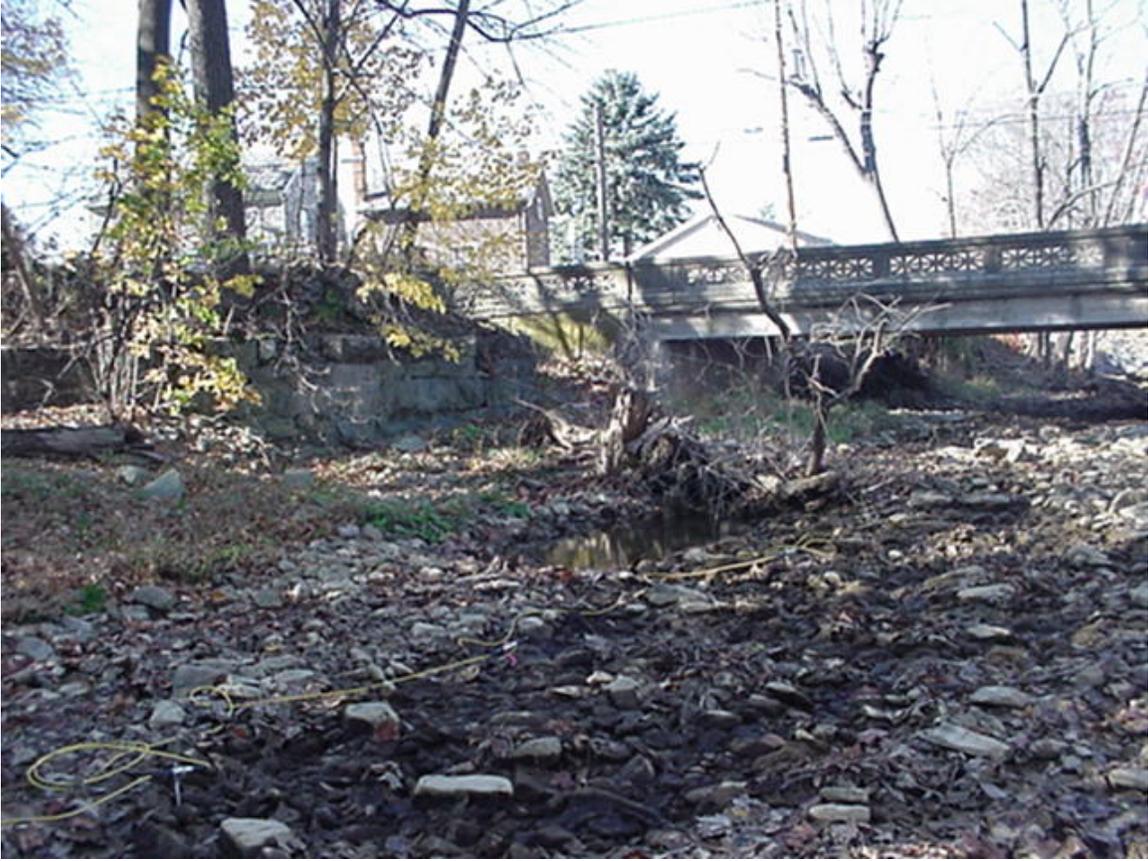
View looking southwest of the south end of the eastern side of the bridge from the streambed area. The area that was indicated in yesterday's photo as being a potential sinkhole development area is in the center of the photo, below the log sticking up from the streambed.

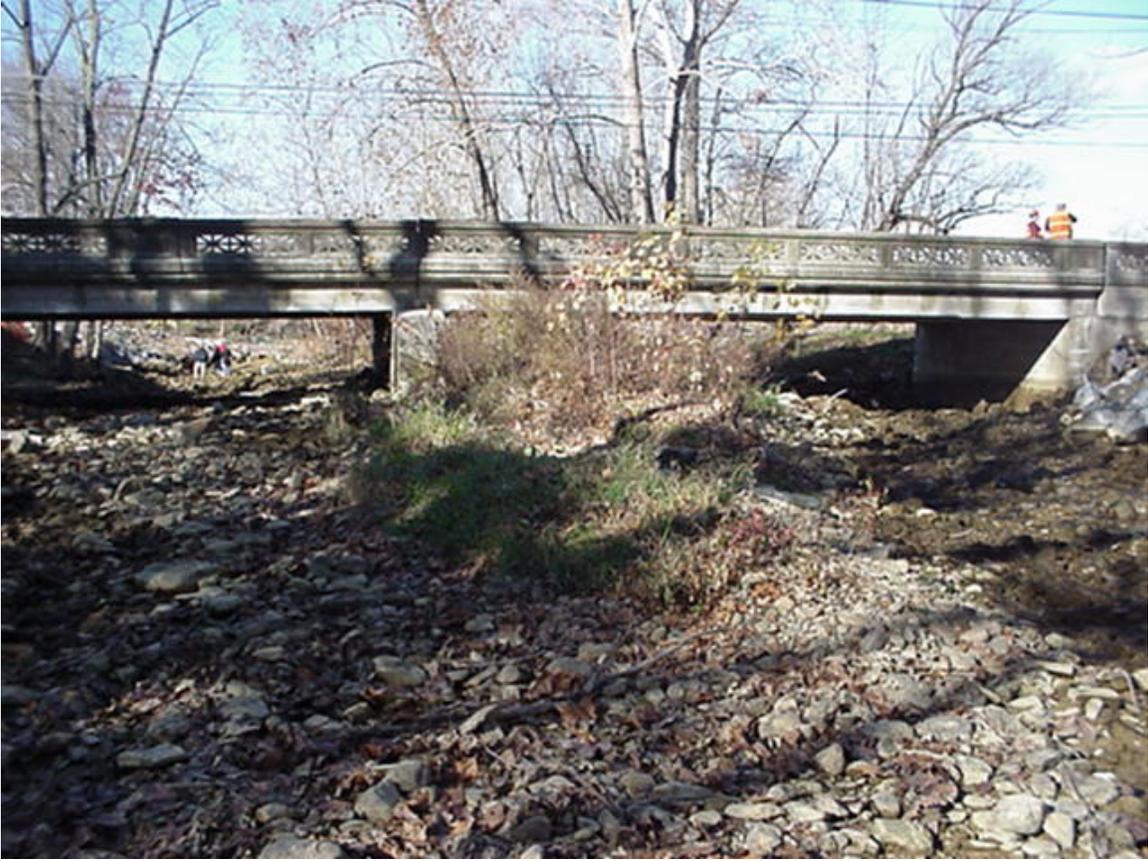
View looking west towards the northern end of the eastern side of the bridge. This photo shows the area immediately to the right of the previous photograph.

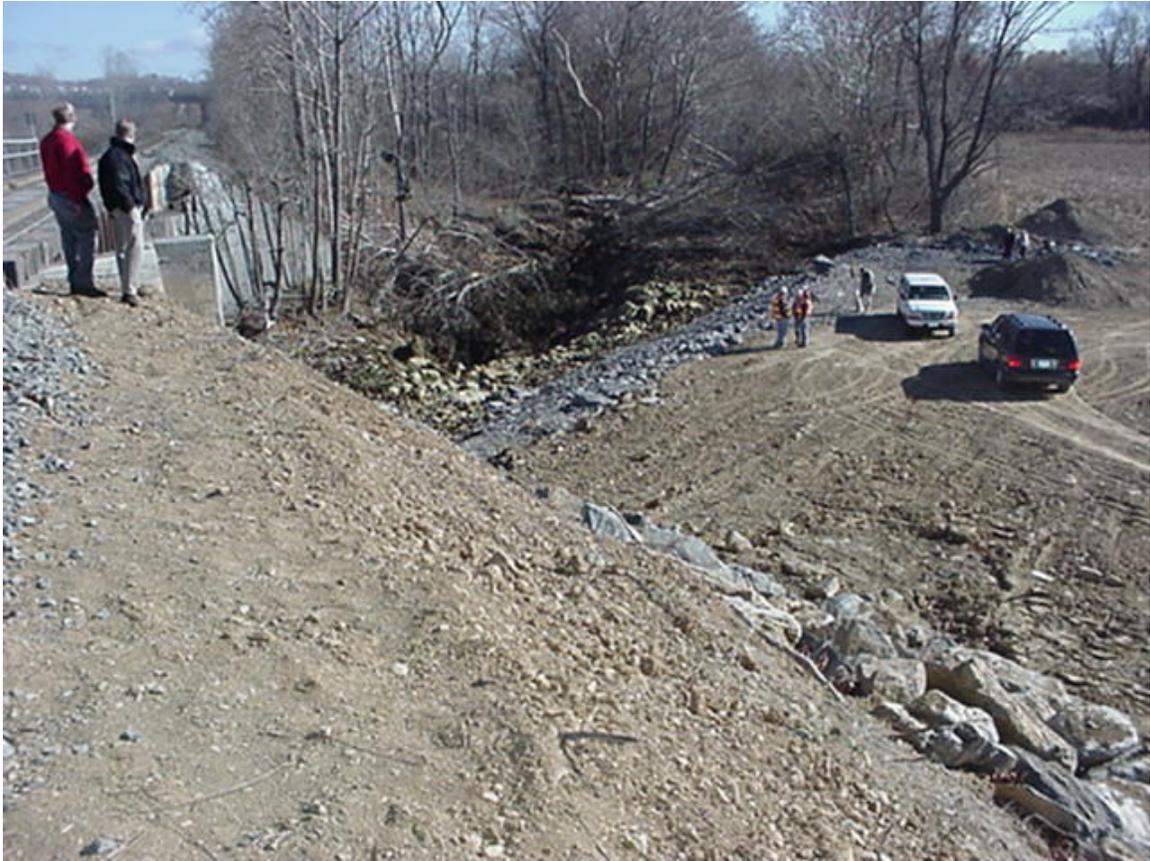
This is a view of the sinkhole problem area at the railroad bridge west of Route 33. The photograph was taken looking towards the east from the embankment west of the railroad bridge. The bridge wing wall that moved out and failed was located to the right of the gentlemen in the upper-left of the photograph. The wall was partially removed and buried in the new fill and rock placed in this area to restore the surface. The surveyors work for Hercules and are checking benchmarks in the area. The dewatered streambed is not easy to see in the photo, but runs diagonally from the middle to upper-right corner of the photograph. The large elongate dark zone in the streambed is a very large sinkhole that has opened up in this area. This area is blown up in the following photograph.

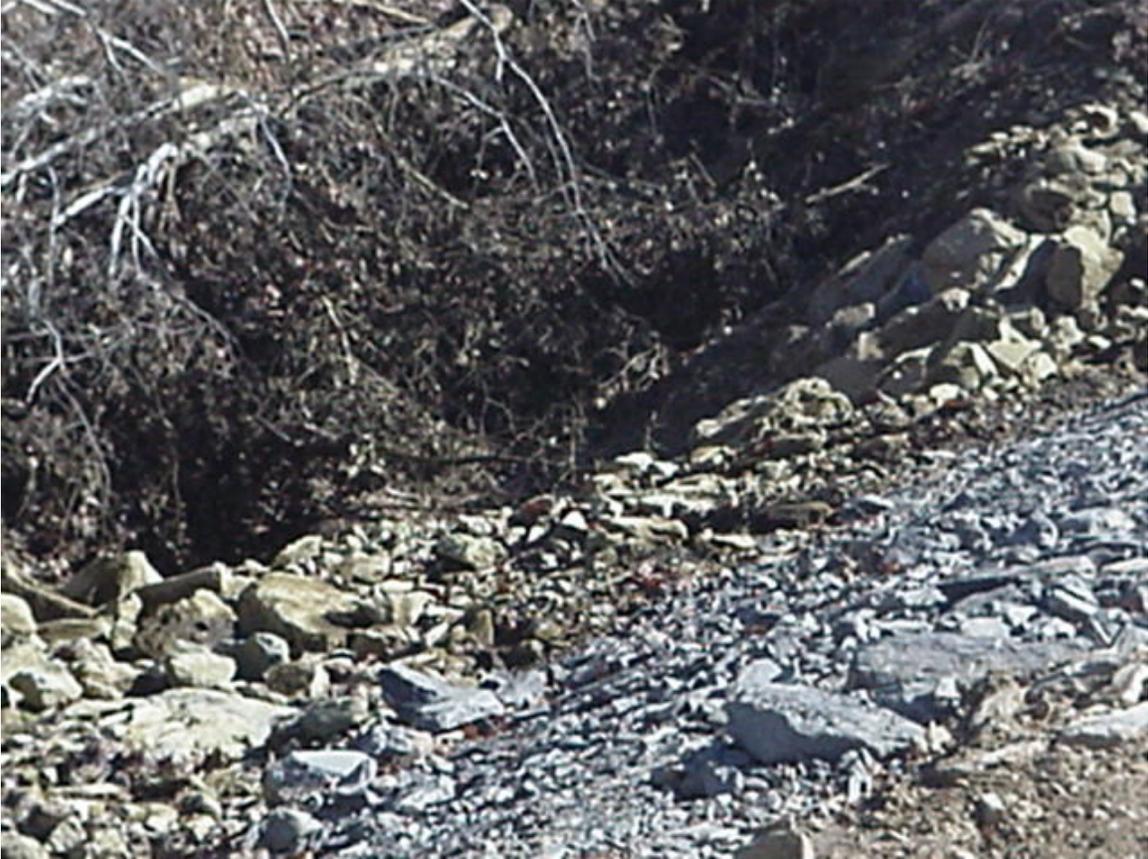
Enlargement of the sinkhole in the streambed that is shown in the previous photograph southeast of the train bridge. A local resident Tony Marinelli told C. Sutphen that there are also a line of smaller sinkholes, lined up and further east of this sinkhole in a wooded area.
