Appendix C

Building Exterior Assessment

MAP GUIDE: FELTONVILLE EXTERIOR BUILDING ASSESSMENT

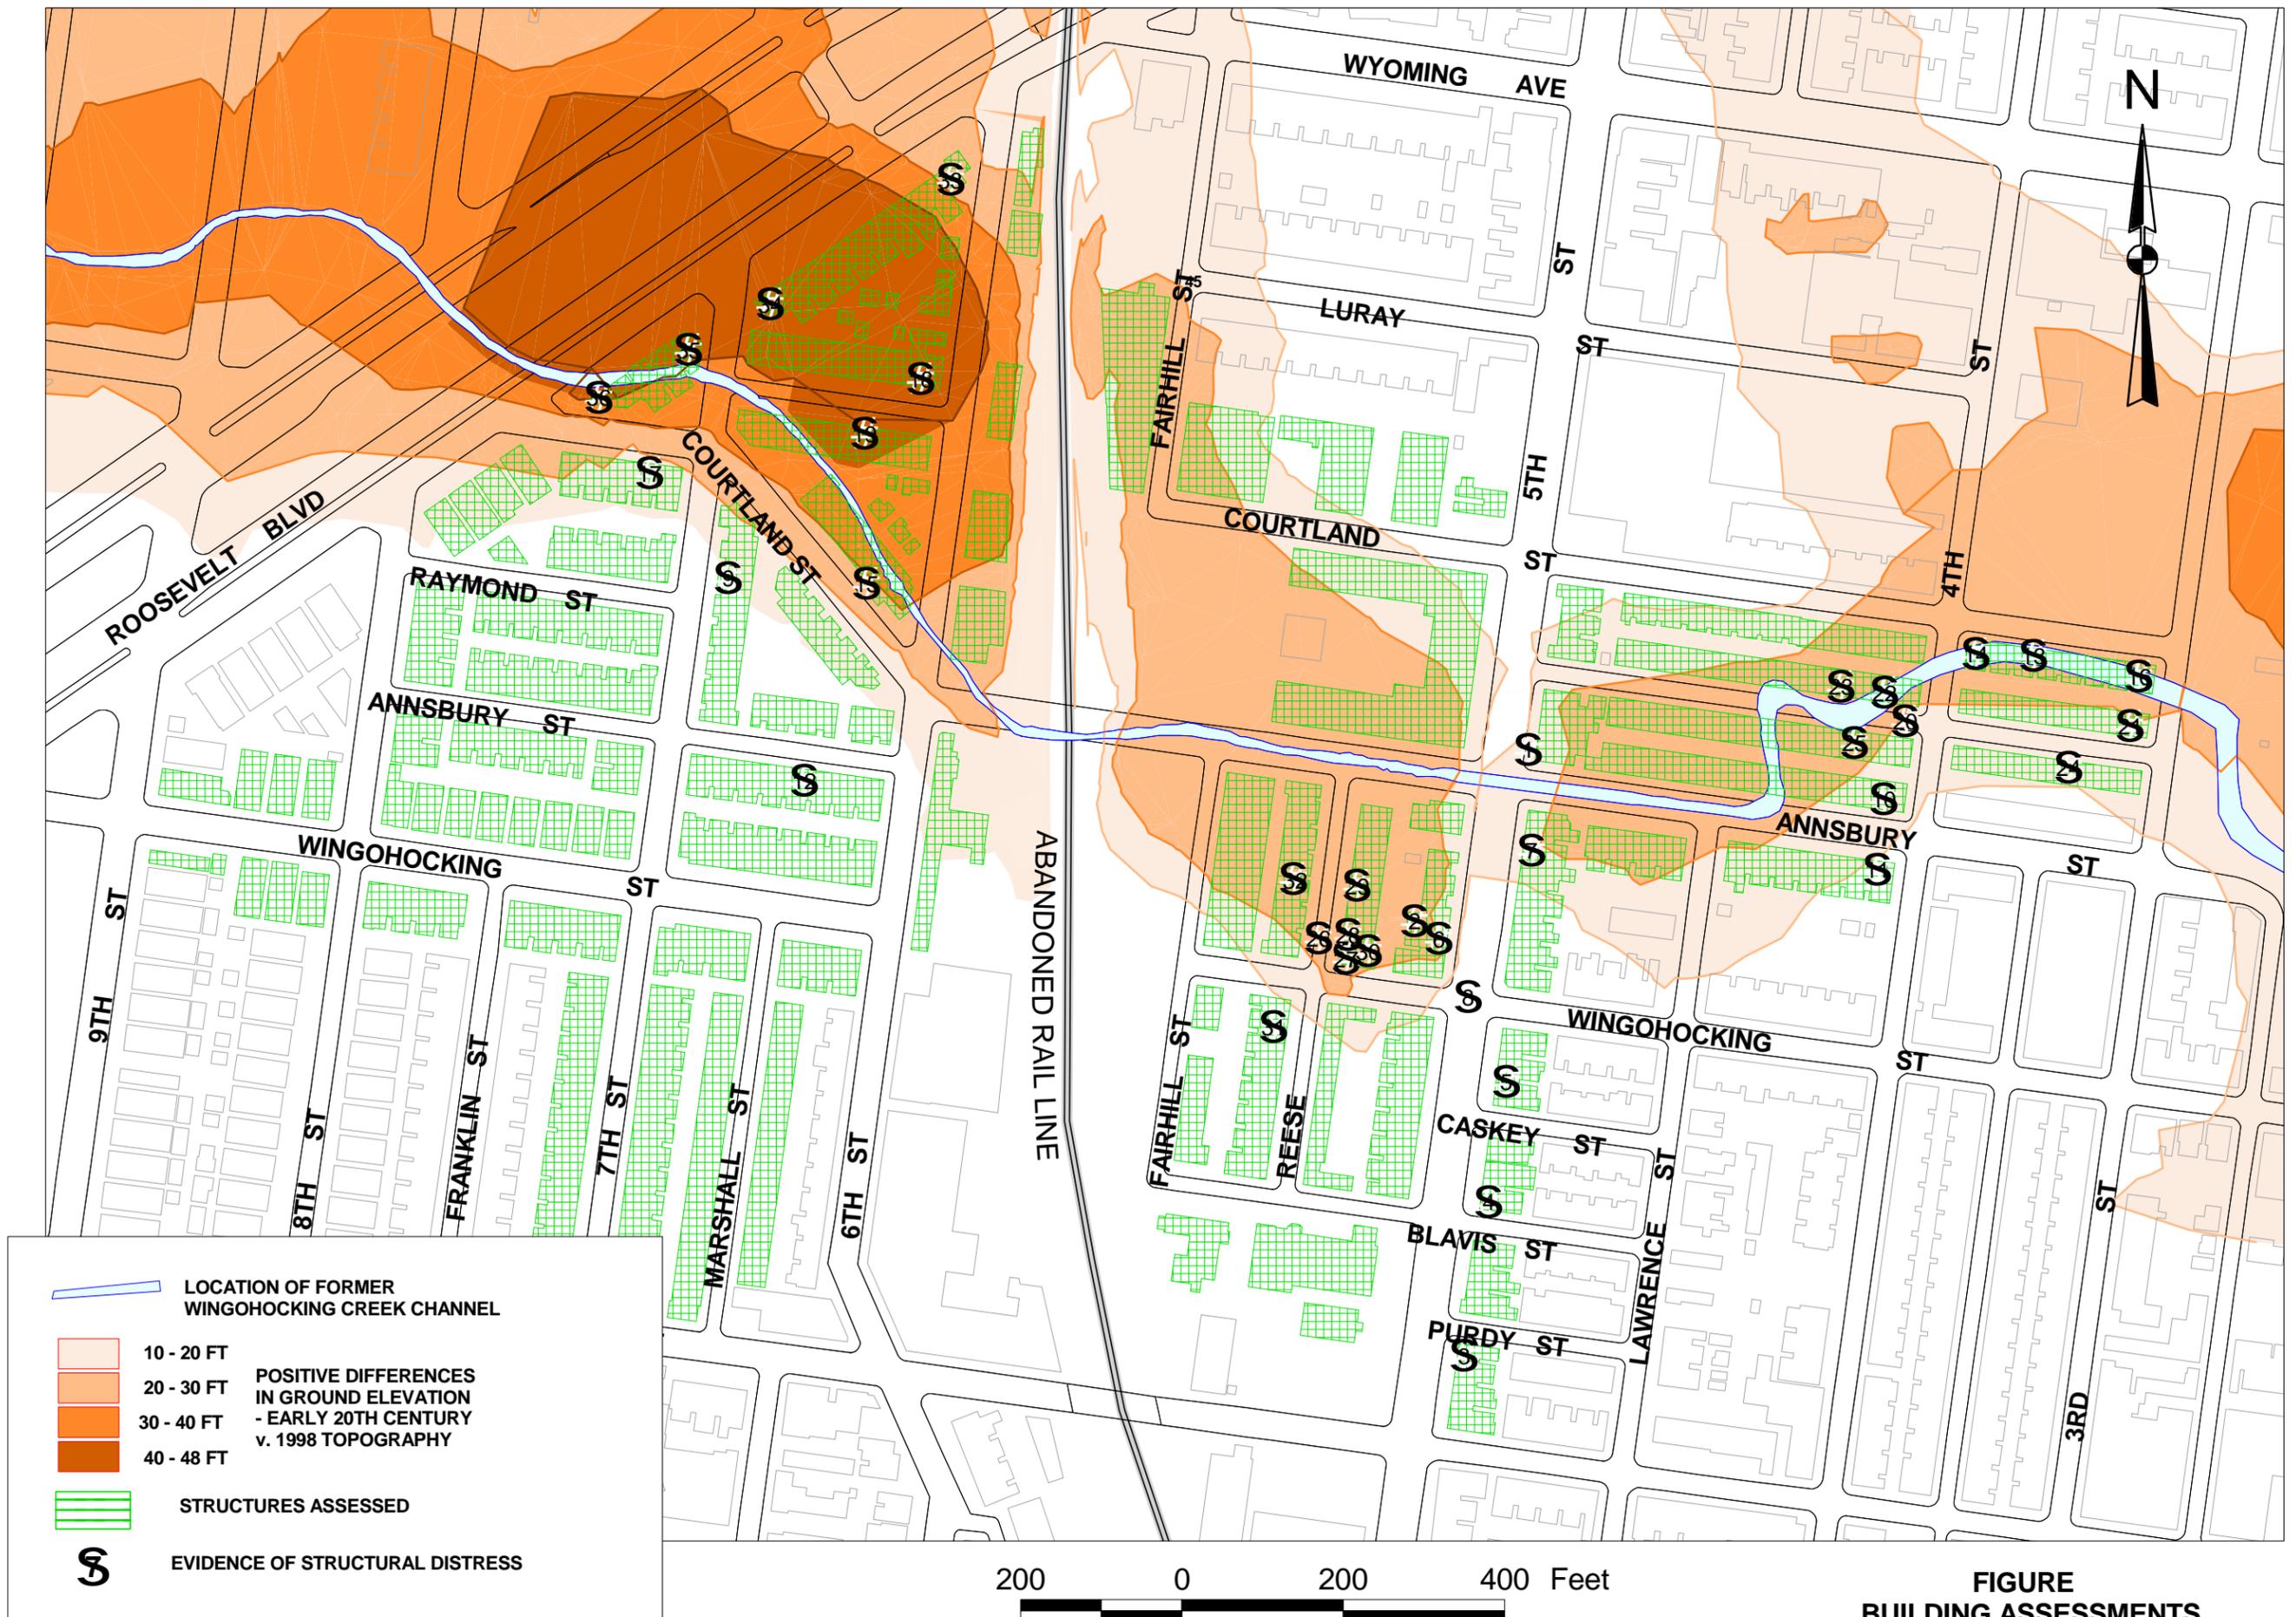
FIGURE BUILDING ASSESSMENTS

map_id	Address	Notes - For a detailed description see pages D-11 to D-21
1	5th & Annsbury	End unit – Corner 5th St and Annsbury St. (north Side)- Repaired step crack from 2nd floor window to 1st floor large plate glass window.
2	5th & Wingohocking	Rear of fifth home from Wingohocking St. – Repaired step cracks from 2nd floor window to 1st floor window to foundation wall. Step cracks in chimney.
3	4411 5th St	Porch column foundation tilted.
4	4429 5th St	4429 to 4435 – Abandoned one- story, burned out, masonry building. Sidewalk settled and broken at curb (4-2). Step cracks from 1st floor window to foundation wall. No roof, but wide flange beams extend to the walls on each
5	4445 5th St	4447- 4445 -Porch column and masonry porch wall settled. Step cracks on each.
5	4447 5th St	End unit on Wingohocking St. Repaired step cracks from second floor window to 1st floor window.
6	4507 5th St	2nd floor dormer settled down to the right.

7	4523 5th St	Step crack from 2nd floor window to 1st floor window at common (party) wall. 2nd floor dormer settled down to right.
8	4500 5th St	Corner of Wingohocking St. and Fifth St. – Street settled on Wingohocking St.
8	4508 5th St	Brick porch column bowed out.
8	4512 5th St	Crack in concrete floor slab for porch. Step crack from 2nd floor window to 1st floor window.
8	4516 5th St	4516 – 4514- Repaired step cracks from 2nd floor window to 1st floor window to foundation wall.
9	4543 7th St	4545 to 4543 – Windows not level, and porches and columns on foundations are not level and plumb.2-4
10	401 Annsbury St	Door lintel and window lintels are not level.
10	405 Annsbury St	Step crack from door to lintel, and windowsill and lintel not level.
10	413 Annsbury St	Windowsill and lintel not level
11	400 Annsbury St	End unit – south side- Repaired step crack from 2nd floor window to 1st floor window.
11	408 Annsbury St	Windowsill and lintel not level

11	422 Annsbury St	Windowsill and lintel not level, but no cracks.
12	622 Annsbury St	622-624 - Masonry walls for front porch have differential settlement. Difficult to see main structure wall due to porches and frame cantilever dormers. No visible distress cracks.
13	4th & Courtland	5th and 6th unit from 4th St. – Walls bowed out.
14	4th & Courtland	End unit – 4th St and Courtland St. – End wall – repaired step cracks.
15	611 Courtland St	Step crack from first floor window (double hung)
15	615 Courtland St	615 – 617 Courtland St.- Front windows out of plumb.
15	619 Courtland St	619-621 Courtland St. – Step cracks and front windows not level1-16

16	300 Courtland St	End unit- Repaired step cracks from 2nd floor window to 1st floor window.
17	700 Courtland St	Abandoned structure - End of row – Wall out of plumb.
17	700 Courtland St	700 –702 Courtland St.- Crack along party wall and step cracks on front of
17	704 Courtland St	704-706 Courtland St. – Settled porch wall tilted toward street. Sidewalk not settled around trees. South side of pavement on street settled more than north side of street.
17	710 Courtland St	710-712 Courtland Street - South side of pavement settled 2' to 3' from the centerline of road.
18	601 Luray St	Corner of 6th St. and Luray St.- Basement wall bulging.
18	613 Luray St	photographed
18	629 Luray St	Corner with 7th St.- step cracks; basement wall in poor condition
19	626 Luray St	626-628 Luray St. - settled porch; step cracks at rear
19	628 Luray St	
20	4th & Raymond St	Repaired pavement was in the street and it was reported by a homeowner that there was a sinkhole and water had run under ground along the street.

21	301 Raymond St	Rear at 3rd St- End unit- repaired step cracks from 1st floor window to foundation wall and 2nd floor window to 2nd floor window.
21	301 Raymond St	301 –303- Repaired step cracks 2nd floor window to foundation wall and 1st floor door openings. Evidence of much settlement and condition should be verified by interior inspection.
21	305 Raymond St	305,307,317,319,323, 325, 328 and 330- repaired step cracks from 2nd floor windows to 1st floor windows.
21	319 Raymond St	319-321 – Settlement at party wall. Repaired step crack from 1st floor window to foundation wall.
21	325 Raymond St	325-327- Corner of 4th and Raymond (North Side)- Front- Step cracks from 2nd floor window to 1st floor window to foundation wall. Porch masonry wall settled. 4-5,4-6
22	405 Raymond St	405-407 – 2nd floor window sills and lintels settled down to left, but no cracks
23	413 Raymond St	413- Step cracks from 2nd floor window to party wall, but partially hidden.

24	320 Raymond St	320- same as above
25	408 Raymond St	408, 410, 412, 420- 2nd floor windowsills and lintels are settled, but no visible cracks.
26	4506-07 Reese St	Curb has settled at 4506 and 4507 Reese St. Homes have settled towards the hole on both sides of the street.
27	4501 Reese St	End unit – Abandoned and currently being demolished. Step cracks on rear wall from second floor windows to first floor. Structure sloped settled toward Wingohocking St.
28	4505 Reese St	Masonry foundation wall for porch and lintel for front door settled1-5 Settlement appears to be old. Doors are squared in opening that is not square.
29	4517 Reese St	Door lintel of home and masonry foundation wall for front porch settled. Step cracks from first floor window down to foundation wall. .1-6
29	4519 Reese St	Step cracks in porch foundation wall at basement windows.
29	4521 Reese St	Door lintel not level and repaired cracks at door.

29	4523 Reese St	End unit on east side at Annsbury St.-Open vertical above window. Door lintel not level. Open step cracks from first floor window. Front wall and side wall is bowed/tilted out. (1-9). Foundation wall on Wingohocking St.
30	4501 Reese St	4501 –4503- Rear- Step crack in party wall from first floor window to foundation wall.
30	4501 Reese St	Rear- End unit- Abandoned-Step crack from second floor window to foundation wall. End of building has settled down towards Wingohocking St. Structure is being demolished by hand and top floor is gone.
30	4509 Reese St	Rear- Windowsills not level.
30	4519 Reese St	Rear – Step cracks from first floor window to top of basement door.
30	4521 Reese St	4523-4521 – Rear from alley – Repaired step cracks from first floor window that have reopened. (1-8) Alley in rear for garages under homes. Grade is too steep to access garages; may have been caused by settlement.

31	4458 Reese St	West side- 4458 – End Unit-repaired step crack on end wall facing Wingohocking St..
32	4500 Reese St	Step crack from first floor to door.
32	4506 Reese St	4506-4508- Door lintel not level and repaired step crack from first floor window. Masonry porch foundation wall settled in opposite direction from the house wall.
32	4510 Reese St	Inspected interior of home by owner's request and permission. Top of front door facing front of house sloped down to the left. Living room floor sloped down to the front (1-2) and dining room floor sloped down to the
32	4514 Reese St	Front door lintel slopes to left.
32	4516 Reese St	Front door lintel slopes down to left.
32	4518 Reese St	Front door lintel slopes down to left looking from front.
32	4520 Reese St	Front door lintel not level and vertical cracks above lintel. Repaired step crack under window. 1-11
32	4524 Reese St	End unit- Step crack from first floor window to ground floor1-10

33	600 Roosevelt Blvd	Back walls tilted, no distress 1-13,1-14, 1-15
34	638 Roosevelt Blvd	Building collapse Spring 2000
35	710 Roosevelt Blvd	End of unit at Courtland St.- Step crack from roof to foundation wall 2-3
36	734 Roosevelt Blvd	End unit at corner of 8th St. – Step crack from first floor window to basement wall. Windowsill not level.
