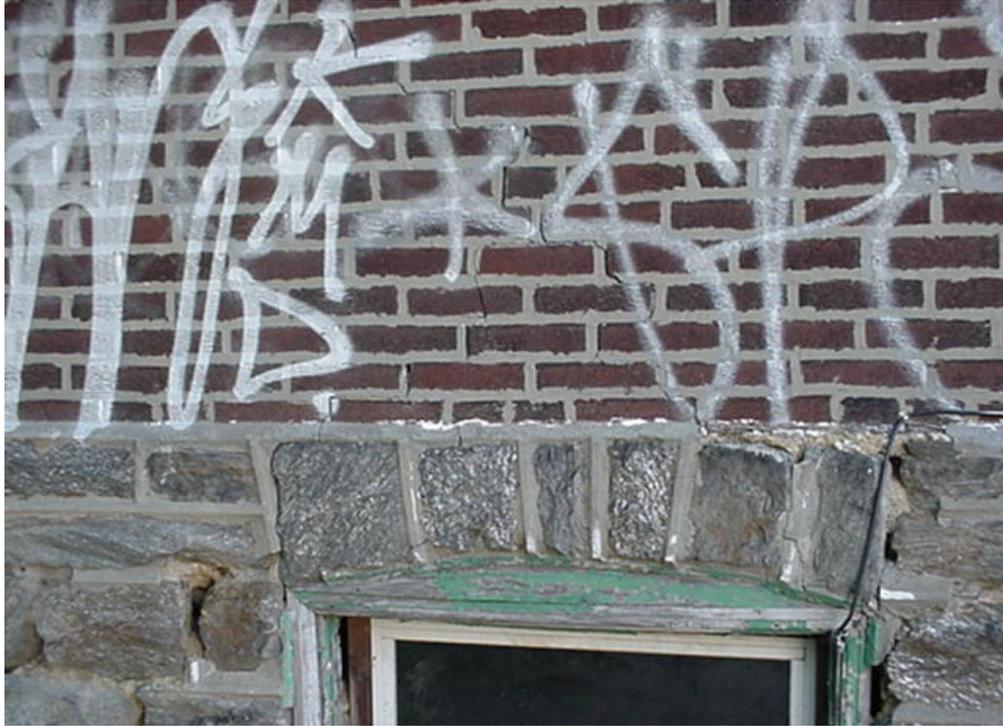
Photo #1: 629 Luray Street—Step cracks in foundation wall. Cracks extend down along wall from 2nd floor window.

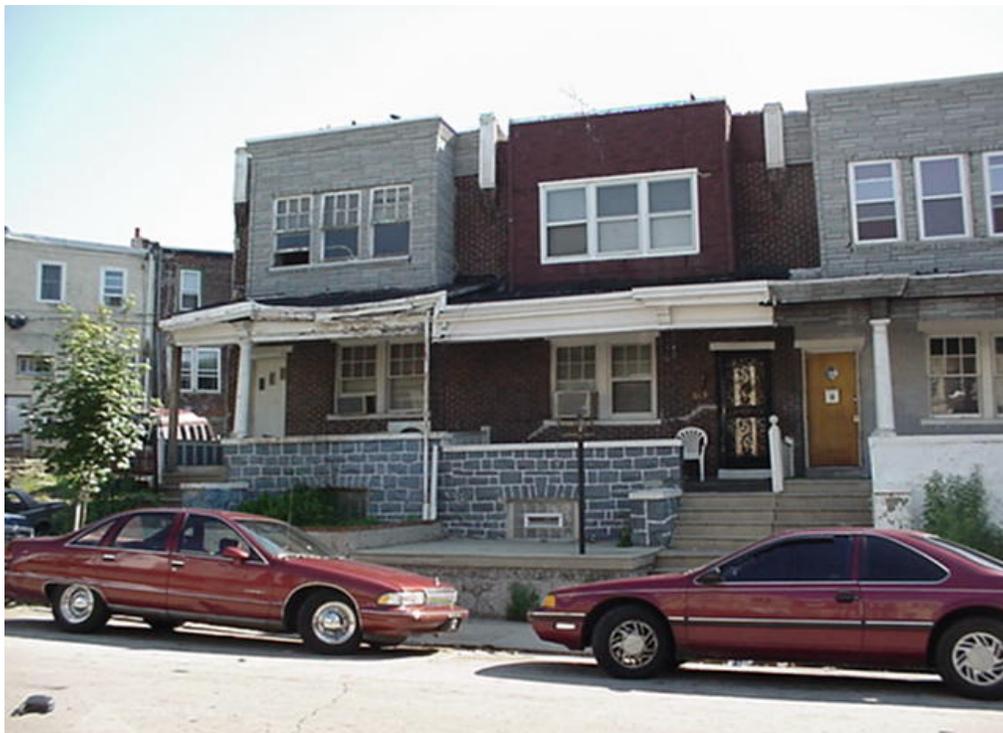
Photo #2: 619-621 Courtland Street—Step cracks from 1st floor window, and windowsills and door lintel not level.

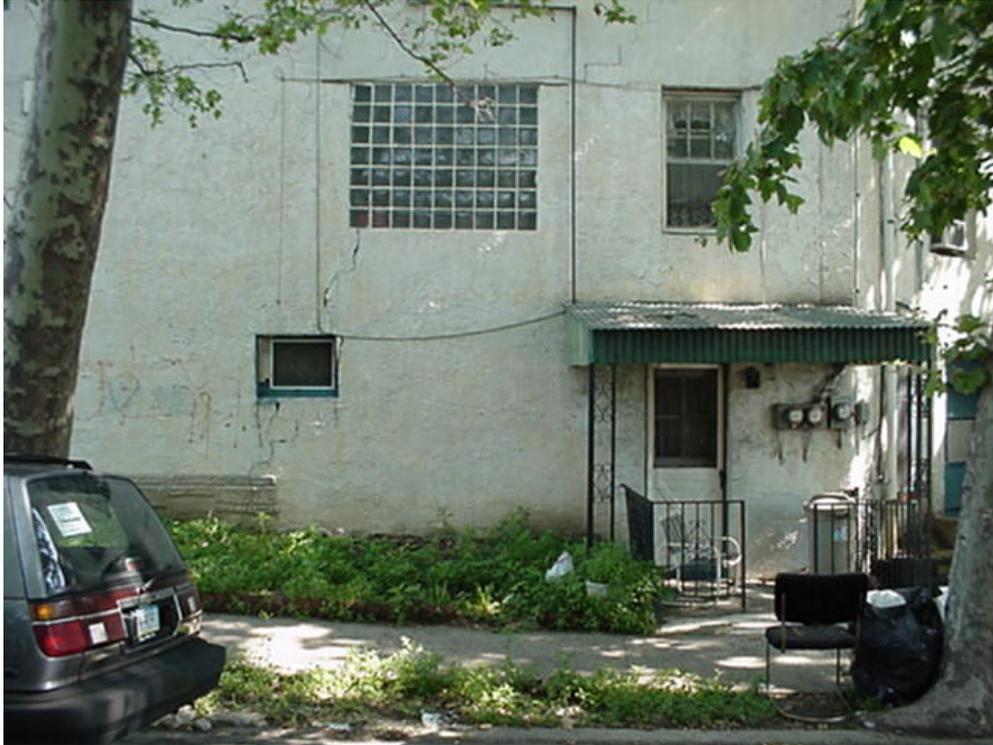
Photo #3: 710 Roosevelt Boulevard—End of row—Step crack from roof to foundation wall.

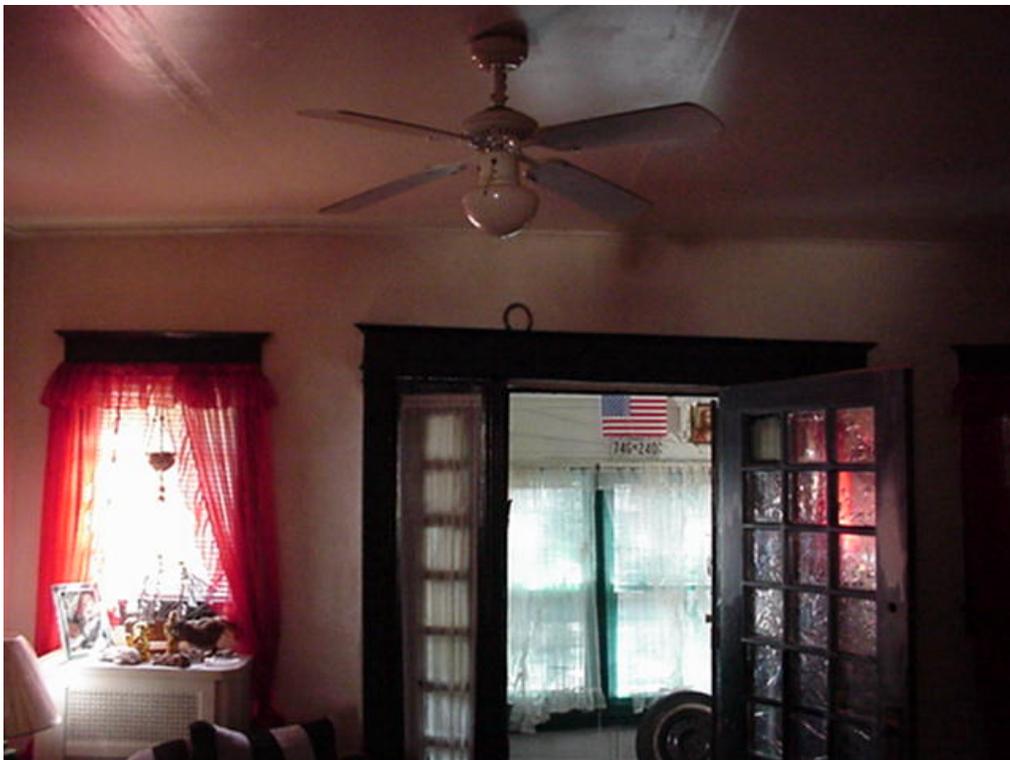
Photo #4: 4510 Reese Street—Interior Top of front door, in living room, not level.
C-6

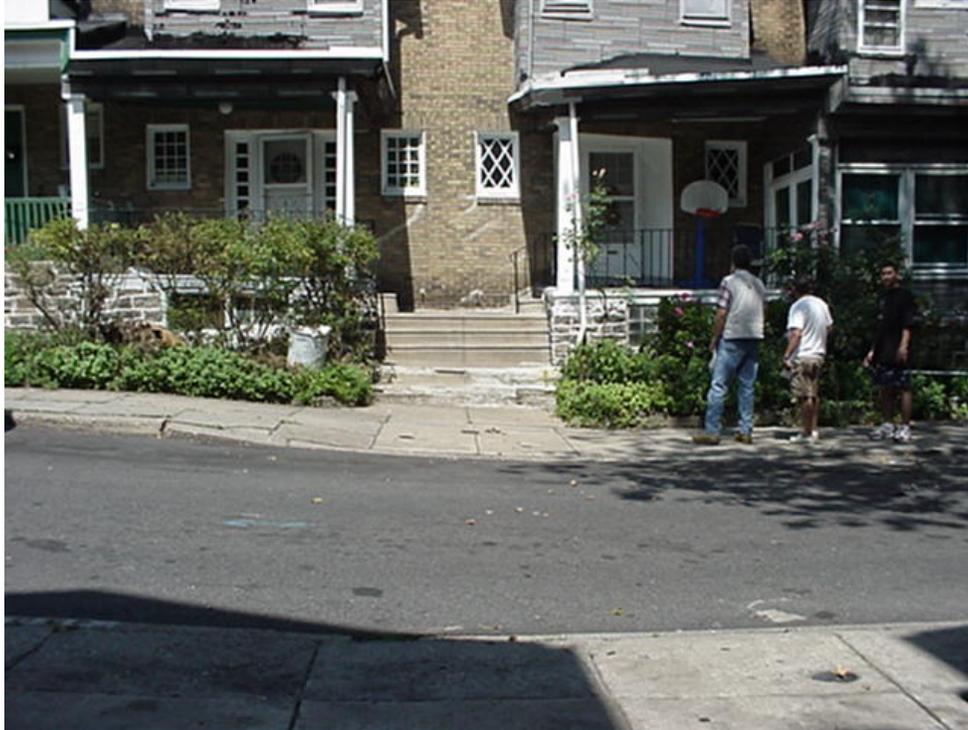
Photo #5: 4506-4508 Reese Street—Door lintels and front porch not level, repaired step cracks, and low point in street.

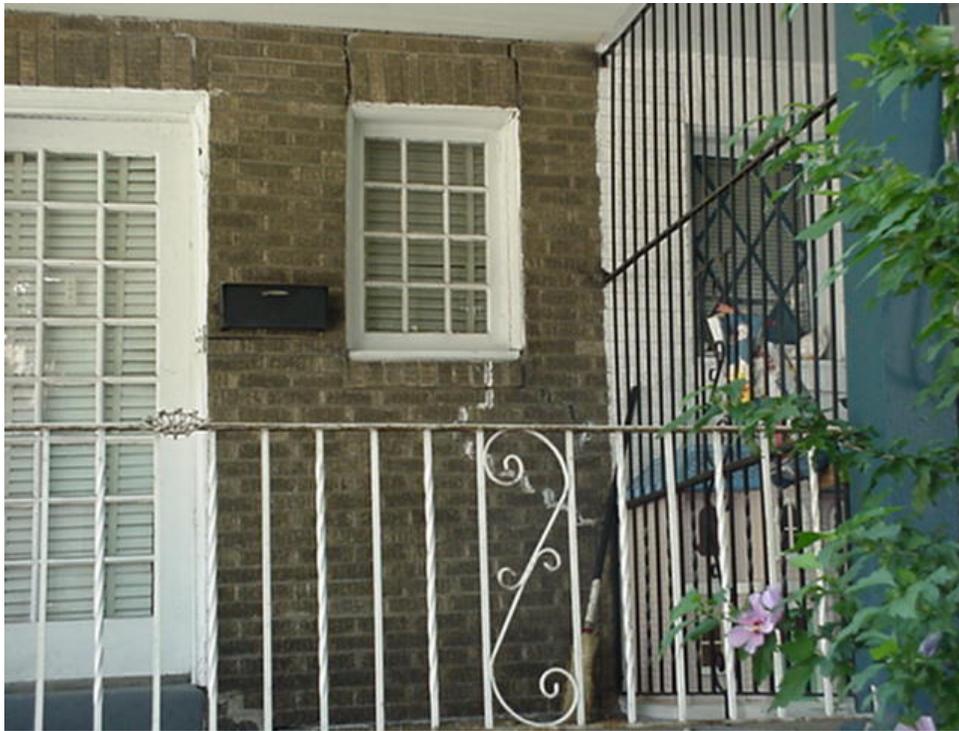
Photo #6: 4523 Reese Street—Door lintel not level, and step cracks from 1st floor window to 2nd floor.

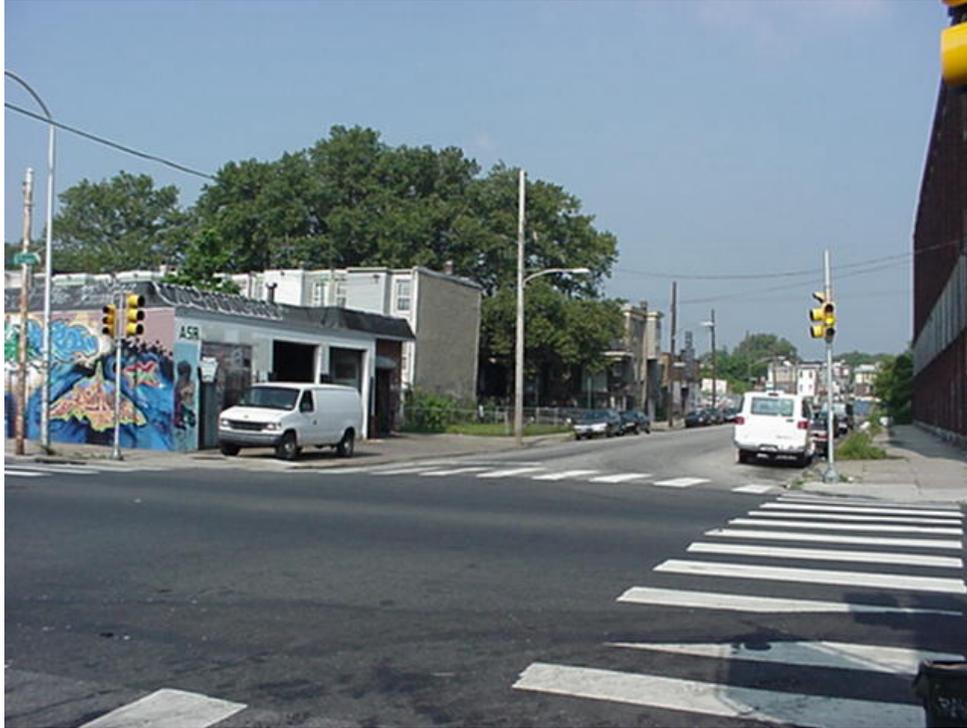
Photo #7: 4523 Reese Street (from Fifth and Annsbury) End of row—Front and rear corner of north wall not plumb.

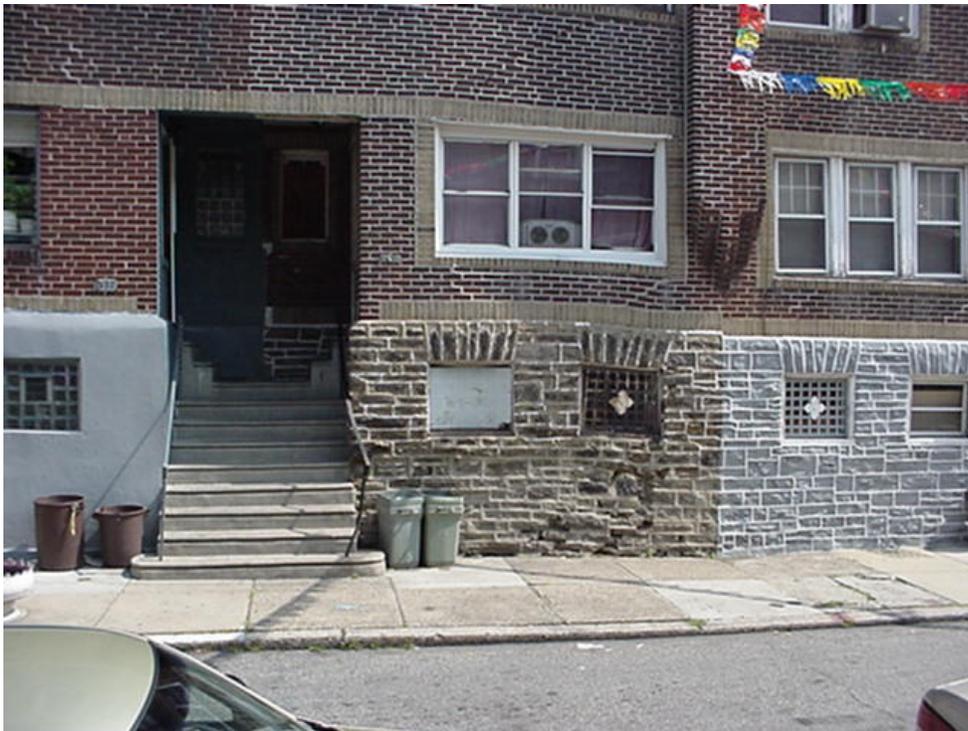
Photo #8: 325-327 Raymond Street at corner of Fourth Street—Party wall settlement and step cracks from 1st floor window down to foundation wall.

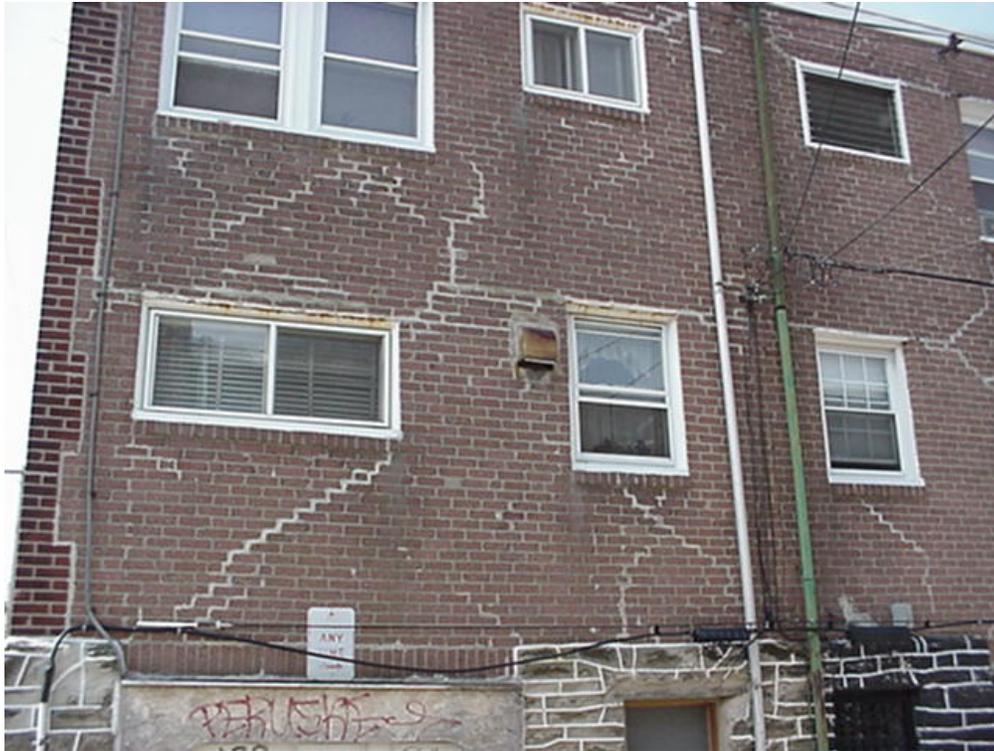
Photo #9: 301-327Raymond Street (rear in alley) Repaired step cracks.

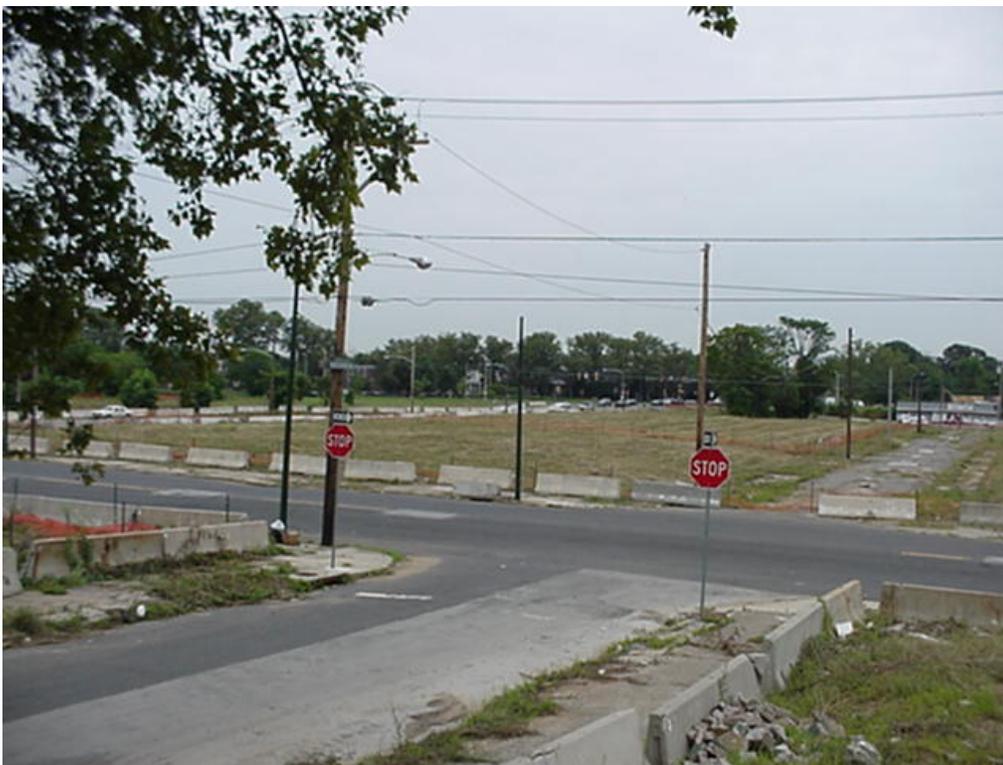
Photo #10: Site of former Logan Sinking Homes that have been demolished.

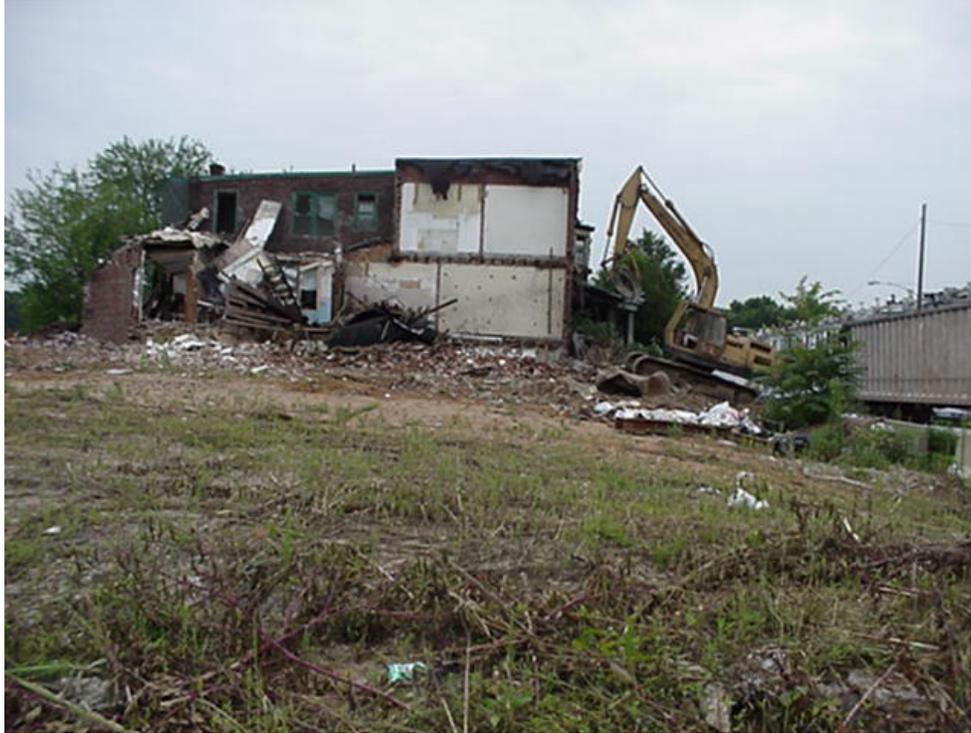
Photo #11: Continuing demolition of sinking homes in Logan area.
