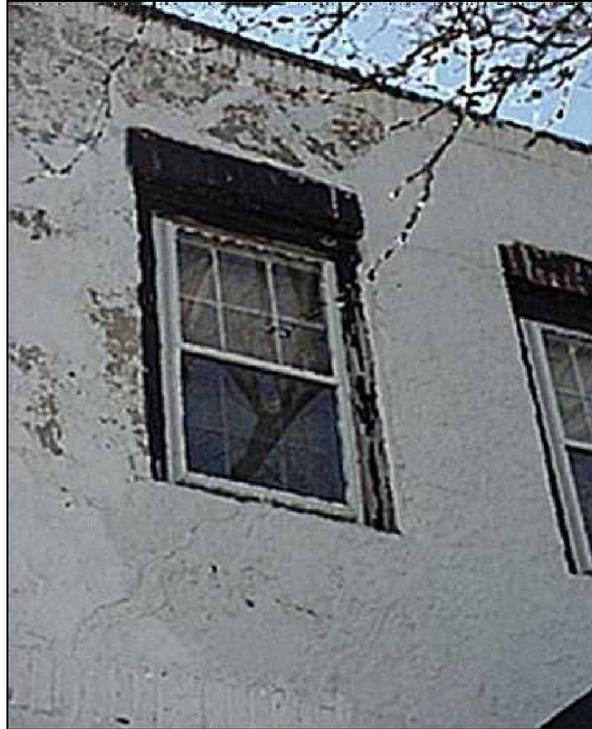
PHOTO #1. 6163 Vandike St.-Front of row home - Repaired step cracks from 2nd floor window.

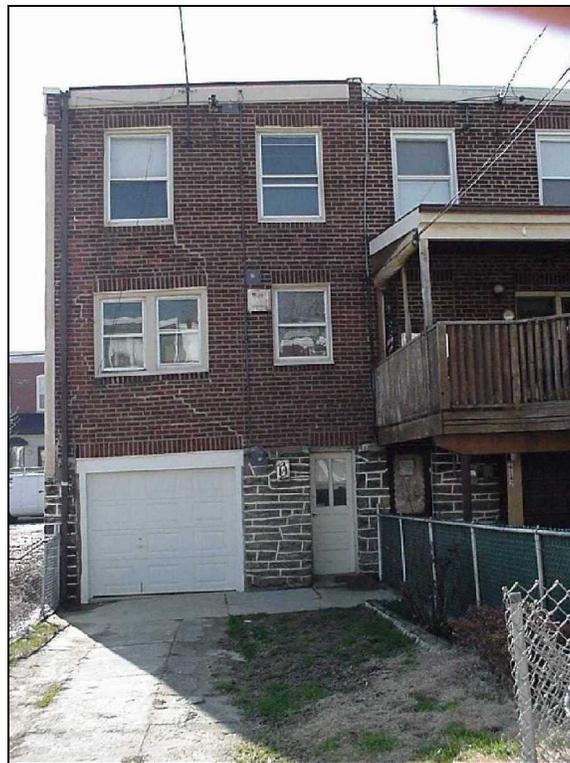
PHOTO #2. 6144 Hegerman St.-Rear of row home-Repaired step cracks from 1st floor and 2nd floor windows.
