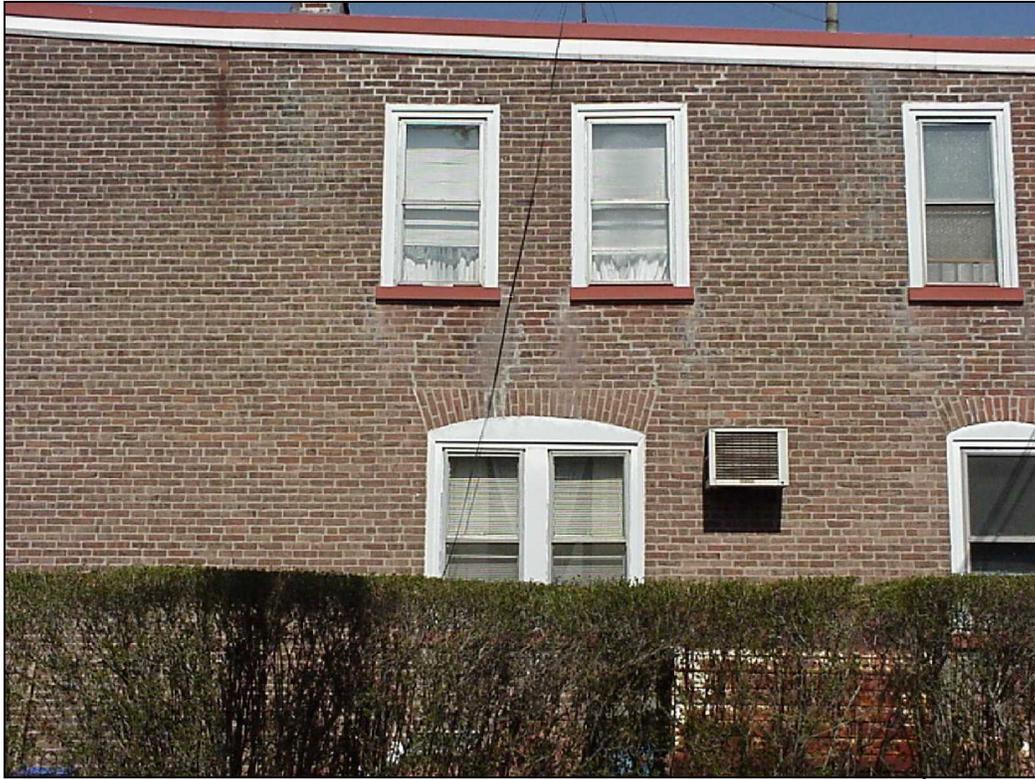
**PHOTO #3.** 4719 Benner St.-Side of row home-Repaired step cracks from 2<sup>nd</sup> floor windows.

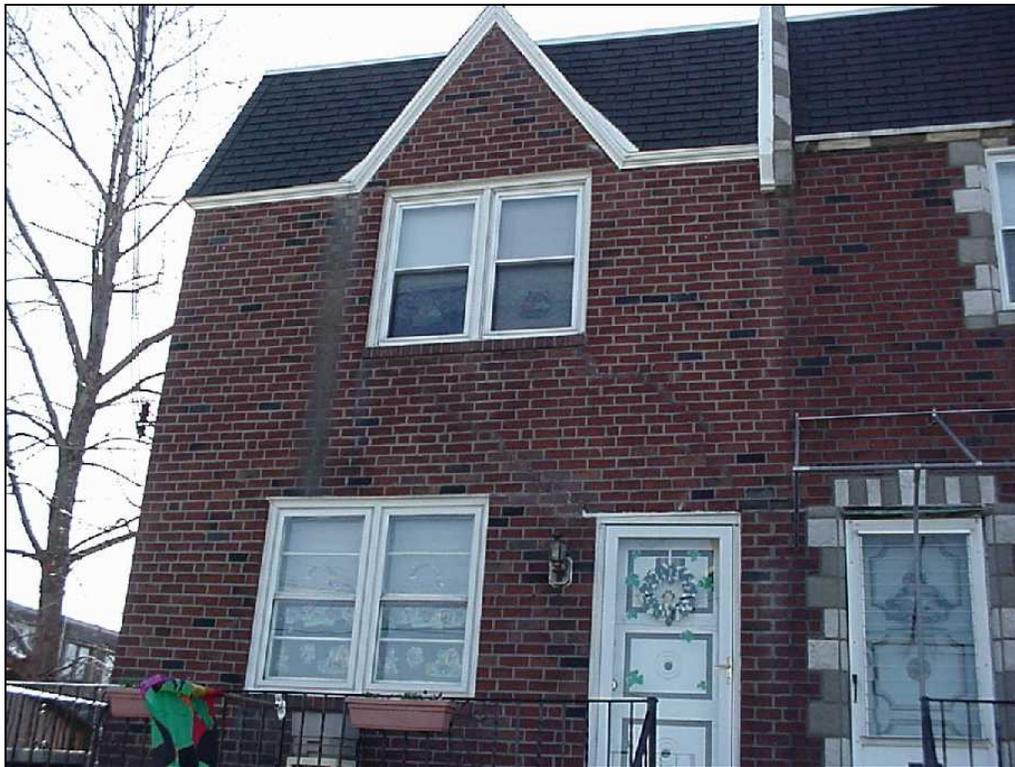
**PHOTO #4.** 6355 Vandike St.-Front of row home-Repaired step cracks from 2<sup>nd</sup> floor windows.
