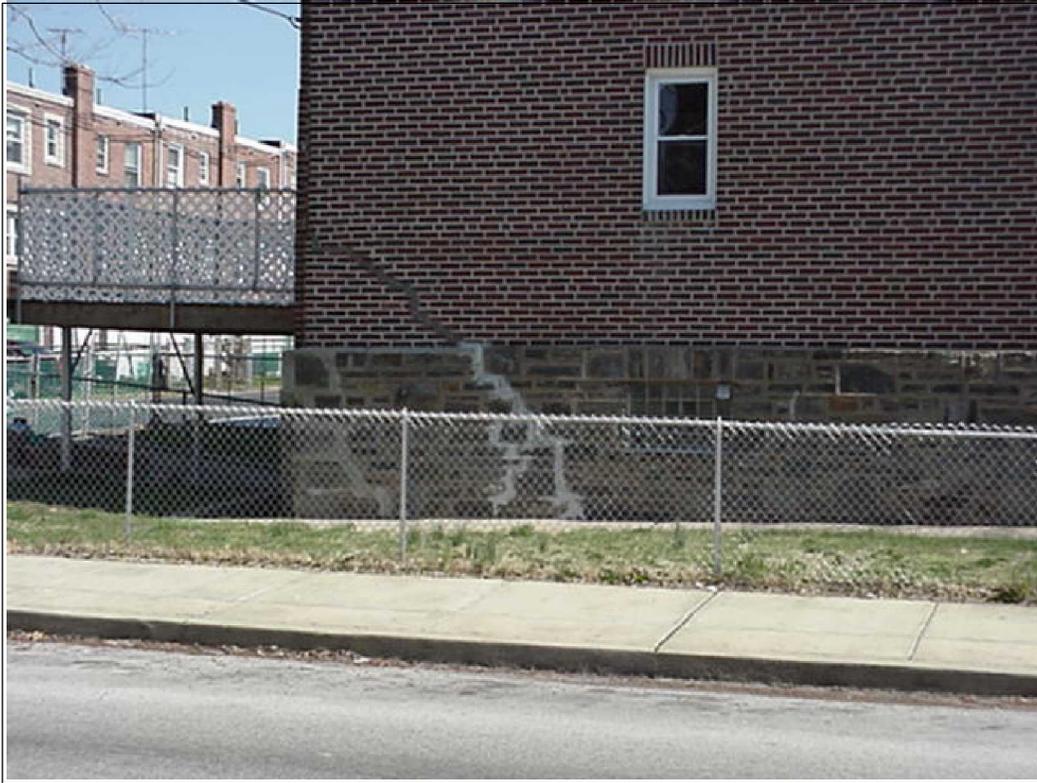
**PHOTO #5.** 4500 Robbins Ave.-Side of row home-Repaired step cracks from corner of wall down through foundation wall.

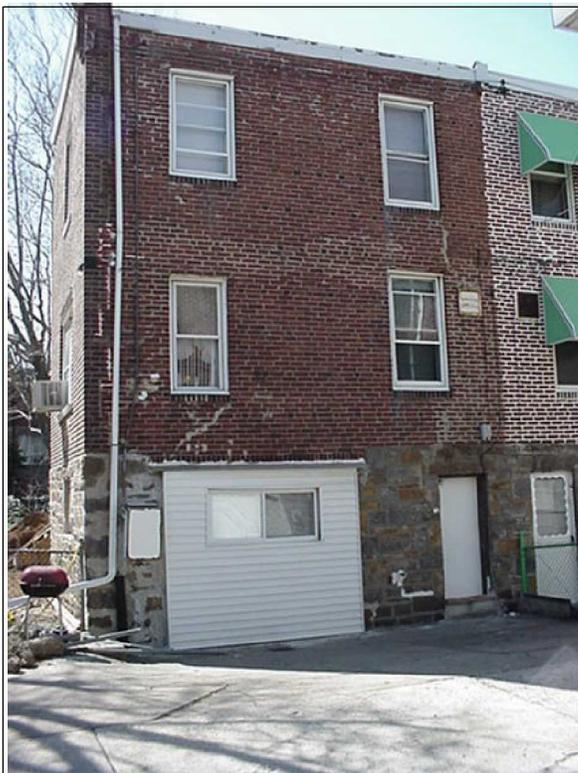
**PHOTO #6.** 4123 Tackawanna St.-Rear of row home-Repaired step cracks from 2<sup>nd</sup> floor window and 1<sup>st</sup> floor window.
