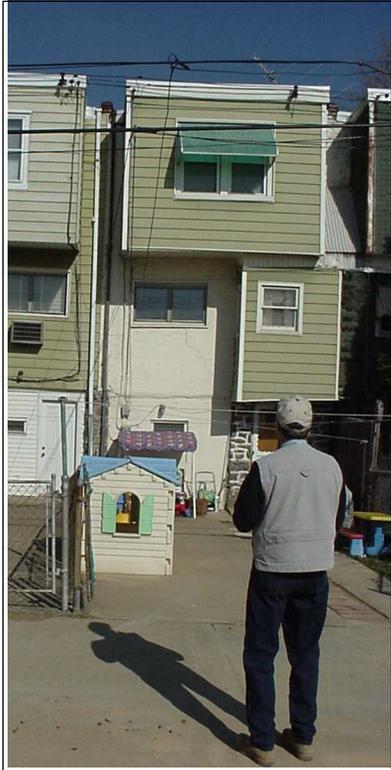
PHOTO #8. 6153 Vandike St.-Rear of row home—Hairline stepped settlement crack. Common wall appears to have settled.

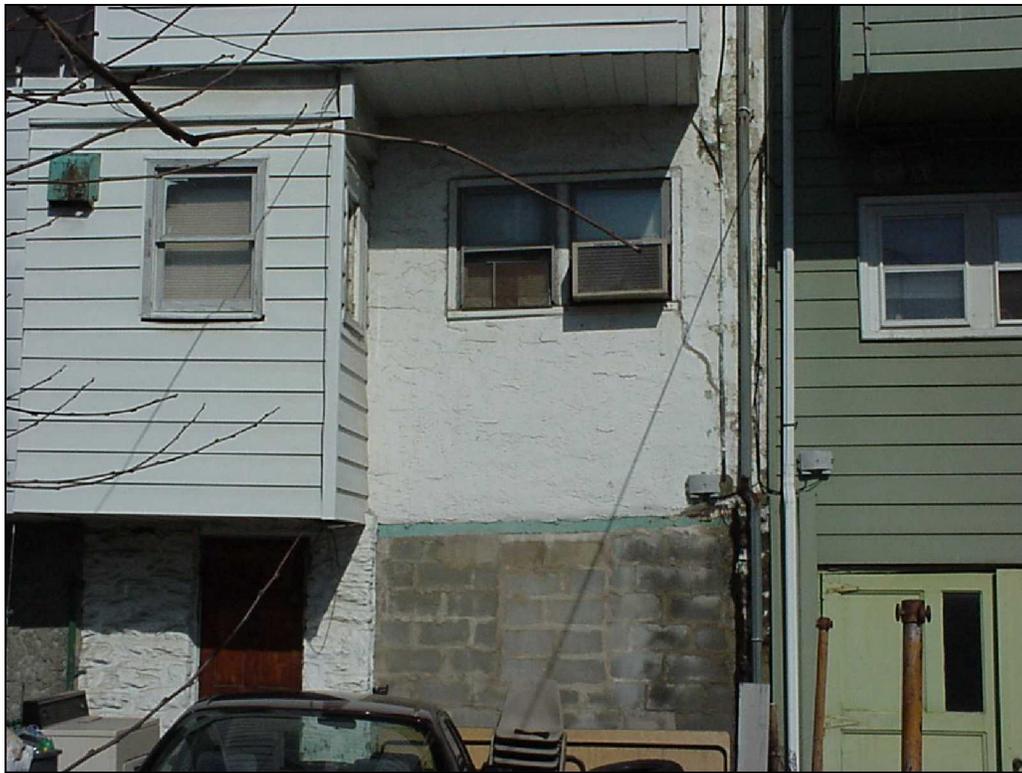
PHOTO #9. 6131 Vandike St.-Rear of row home-Repaired step crack from 1st floor window.
