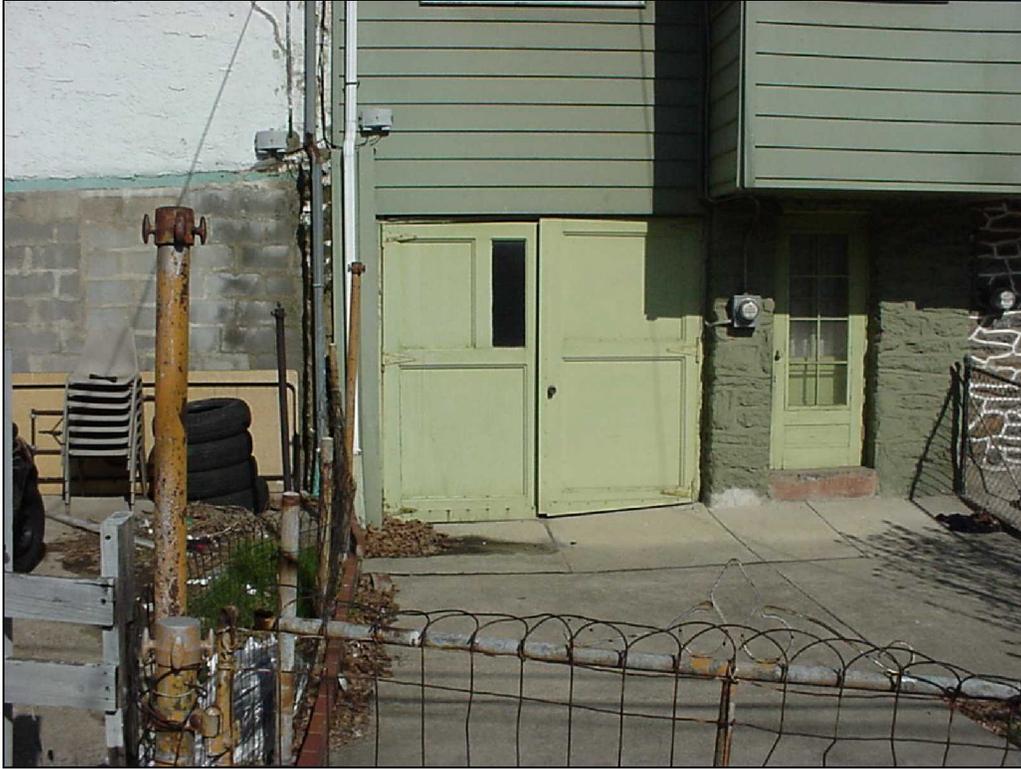
**PHOTO #10.** 6133 Vandike St.-Rear of row home-Floor slab settled. Garage door cut crooked.

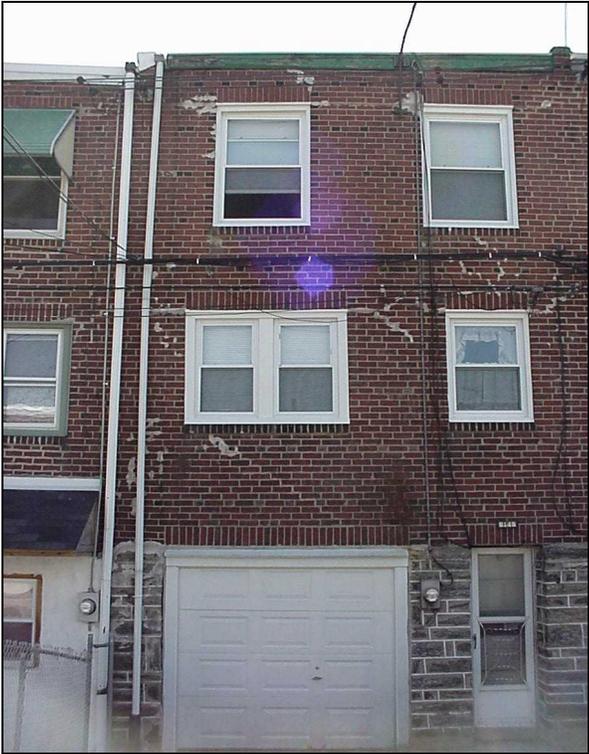
**PHOTO #11.** 6148 Vandike St-Rear of row home-Repaired step cracks from 1<sup>st</sup> floor and 2<sup>nd</sup> floor windows.
