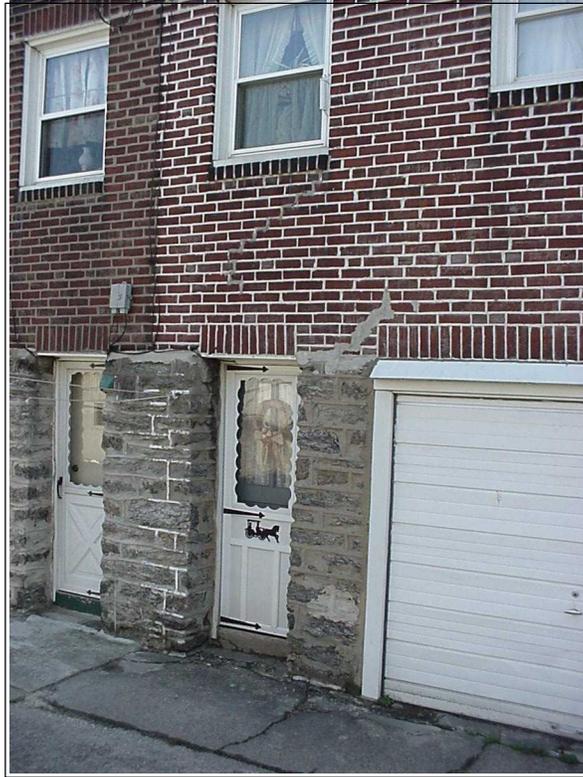
**PHOTO #12.** 6122 Vandike St.-Rear of row home-Repaired step crack from 1<sup>st</sup> floor window to top of rear door and foundation wall.

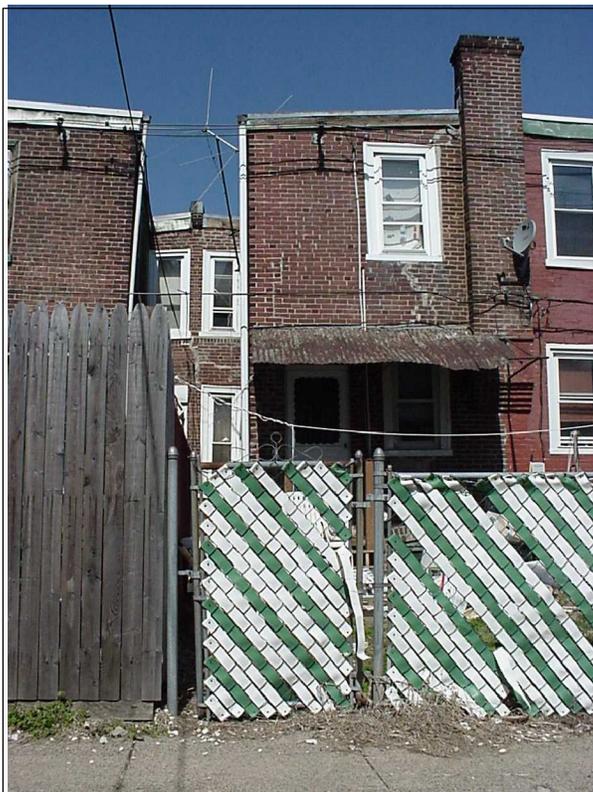
**PHOTO #13.** 6131 and 6133 Torresdale Ave.-Rear of row homes-Repaired step crack from 2<sup>nd</sup> floor windows to porch and 1<sup>st</sup> floor windows.
