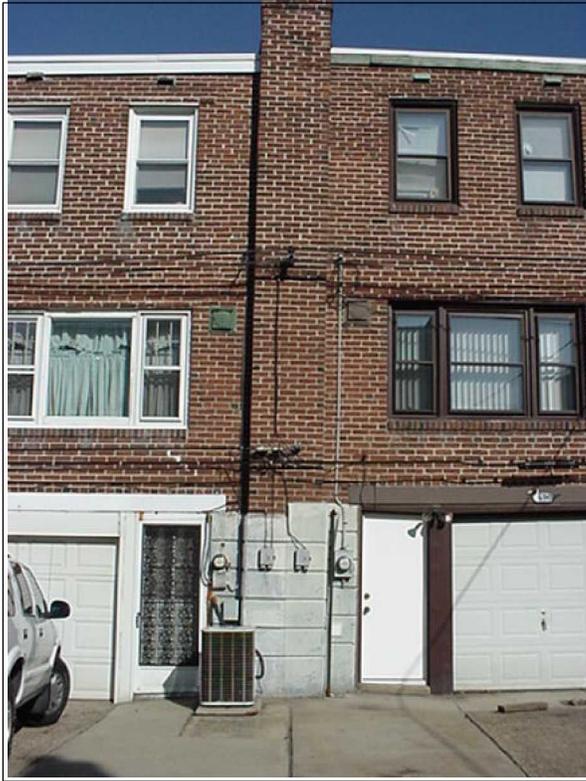
PHOTO #14. 6341 Vandike St.-Rear of row homes-Repaired step crack from 1st floor window. Doors out of plumb and common wall appears to have settled.

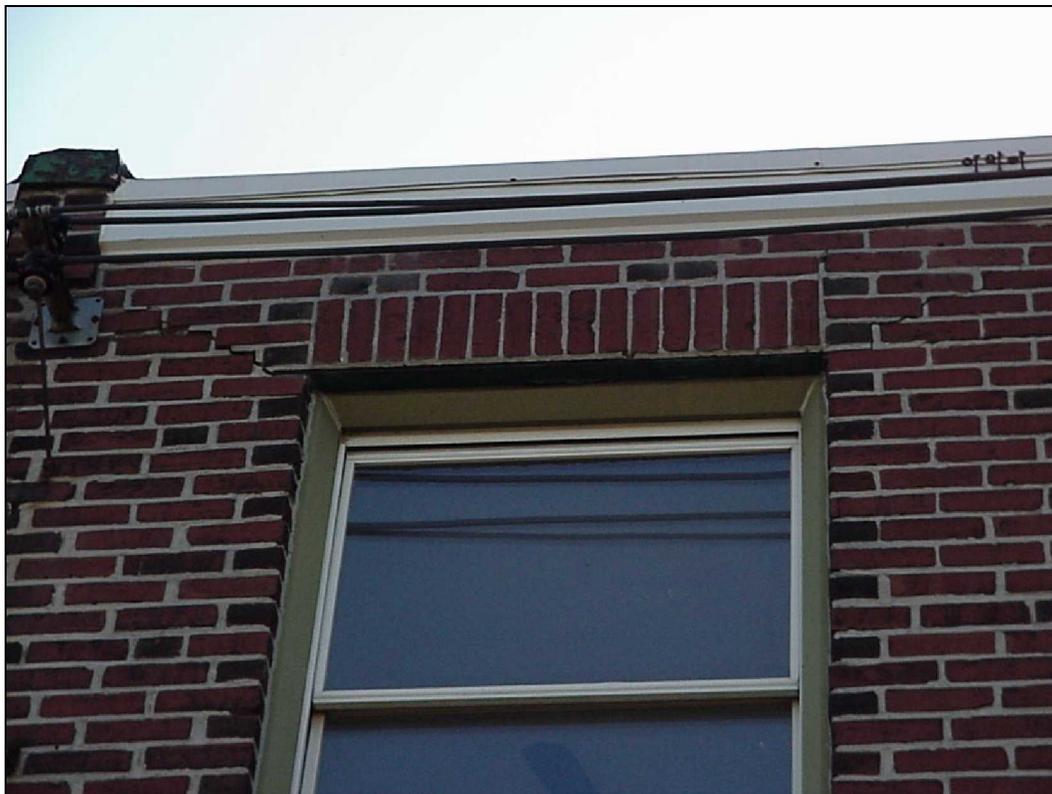
PHOTO #15. 6100 Vandike St.-Rear of row home- Step crack from 2nd floor window to top of parapet wall. Window is not level.
