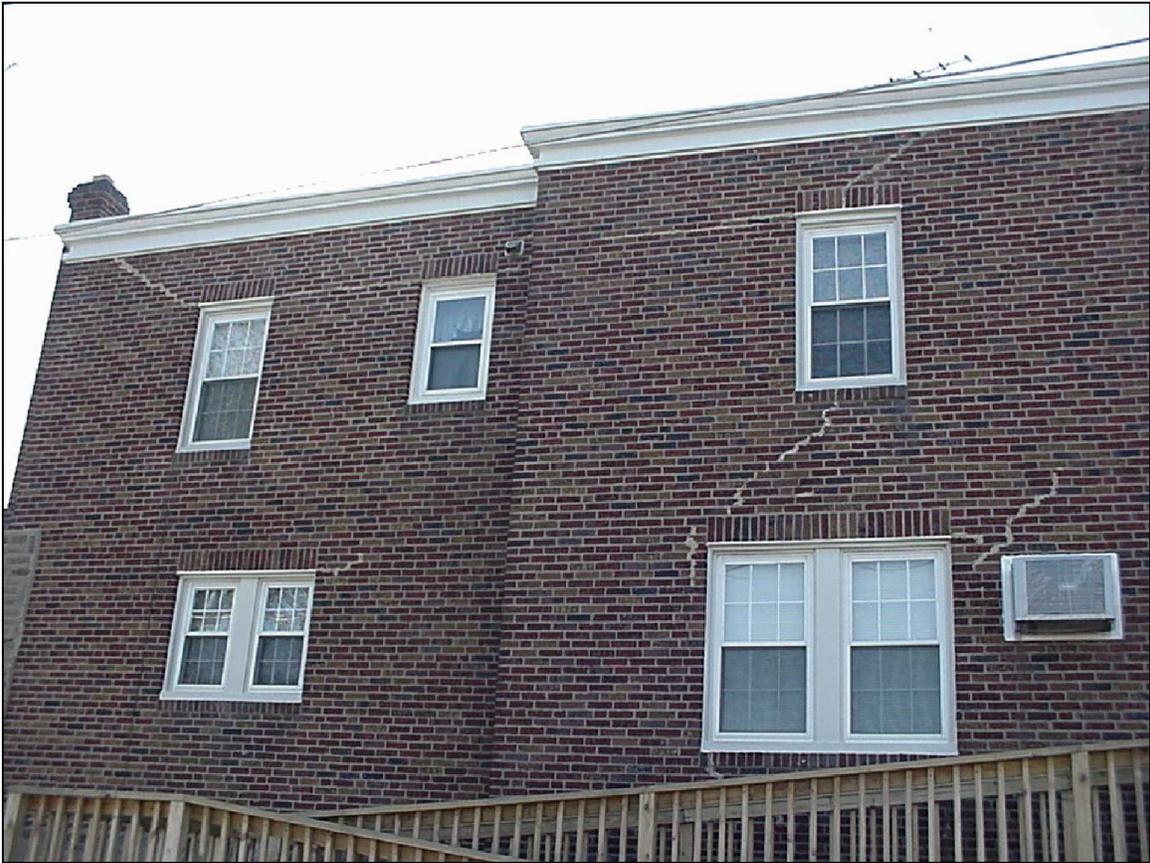
**PHOTO #16.** 4728 Levick St.—side of row home—repaired step cracks in masonry from 2<sup>nd</sup> floor windows to 1<sup>st</sup> floor windows and 2<sup>nd</sup> floor windows to top of parapet wall.
