SUBJECT: Environmental Restoration Report and Environmental Assessment Lower Assunpink Creek Ecosystem Restoration Project - Broad Street Culvert

**Environmental Restoration  
Report and Environmental  
Assessment  
Lower Assunpink Creek  
Ecosystem Restoration Project  
- Broad Street Culvert**

November 2007

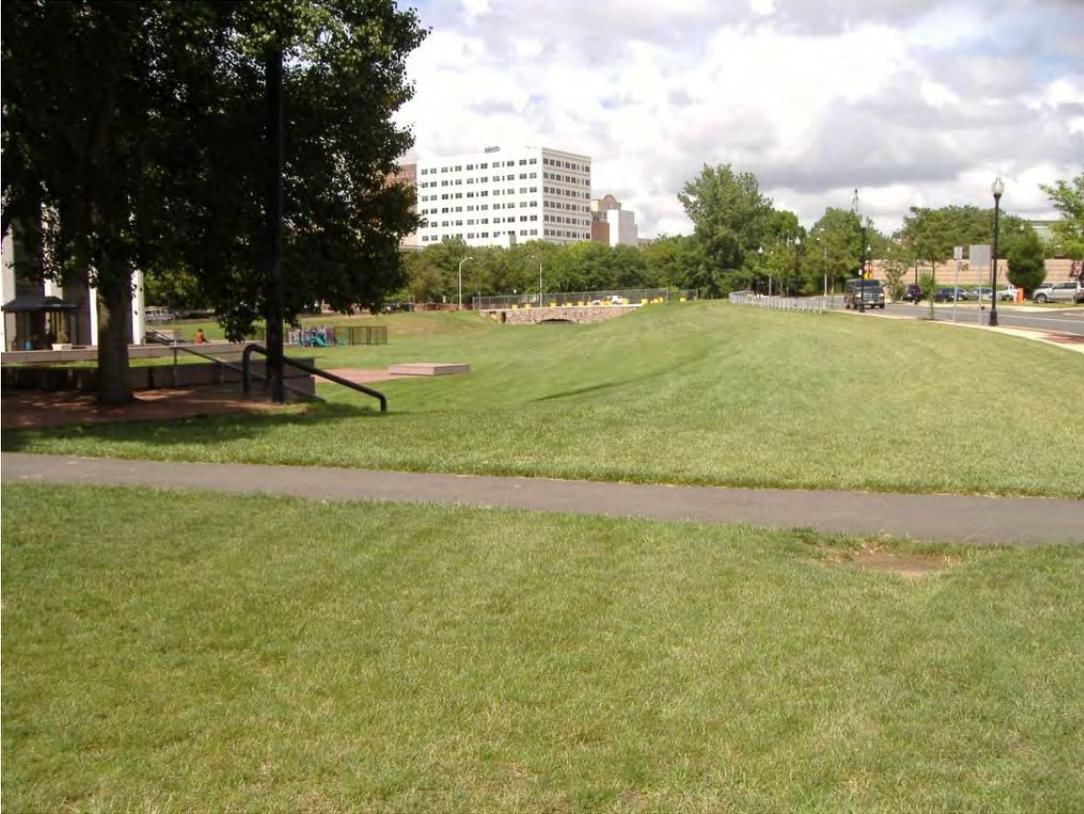
**Plate 1.** View upstream of turf and fill covering the Broad Street culvert.

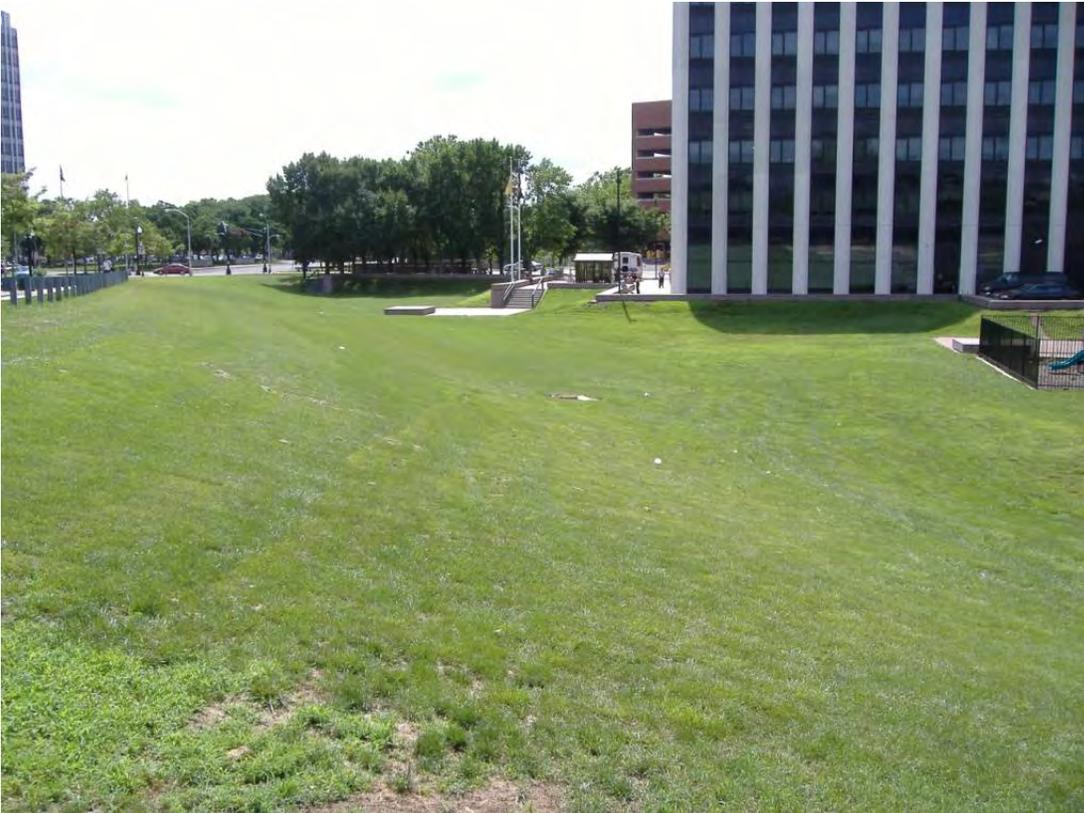
**Plate 2.** View downstream of turf and fill covering the Broad Street culvert.

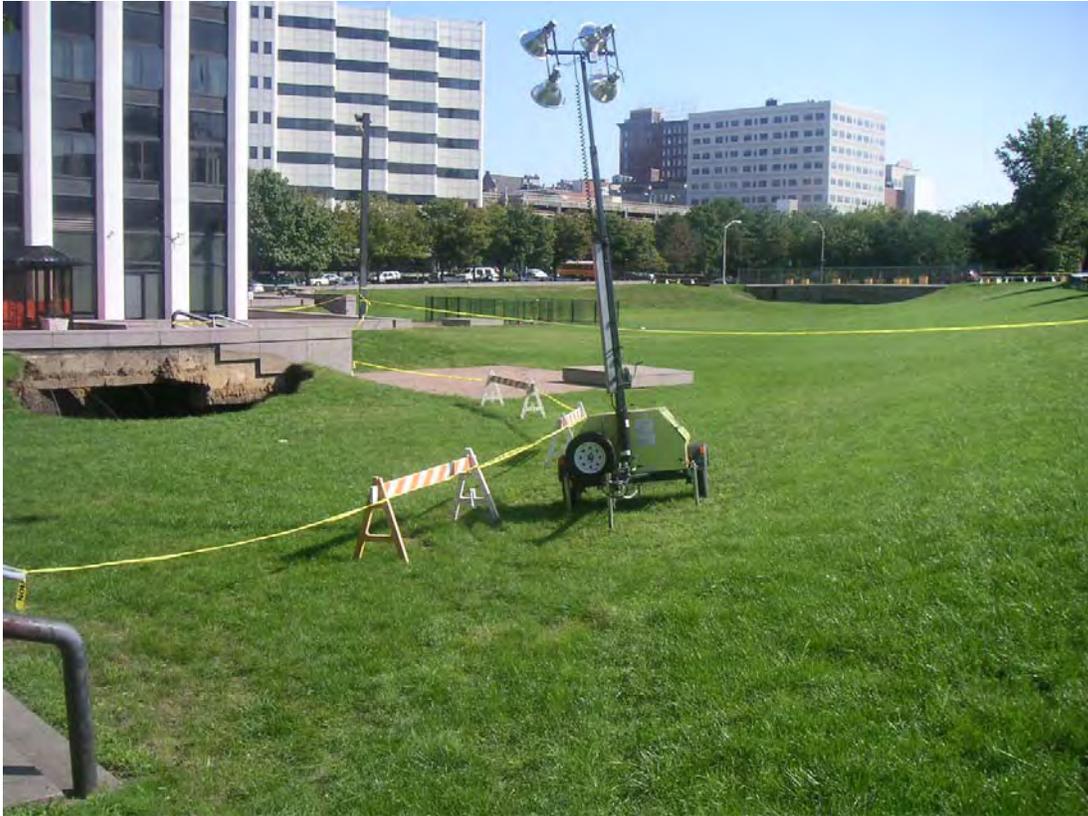
**Plate 3.** View upstream showing the collapsed culvert roof section.

The Broad Street culvert in particular poses a significant barrier for anadromous fish migration from the Delaware River to the headwaters of Assunpink Creek. The September 3, 2006 partial collapse of a 24- by 35-foot section of culvert adjacent to the State of New Jersey Department of Human Services (DHS) building has increased the urgency to address the Broad Street culvert component of the Assunpink Creek restoration plan. An initial assessment of the failure, performed by Birdsall Engineering (Appendix A), attributed the collapse to the failure of the culvert roof deck slabs. Citing the potential for future sudden collapse of remaining roof slabs, the Birdsall report recommended that the entire culvert perimeter be cordoned off to any access. The City of Trenton has taken action to limit access; however, the collapsed deck slabs still remain within the creek, creating an obstruction and potential flooding hazard.

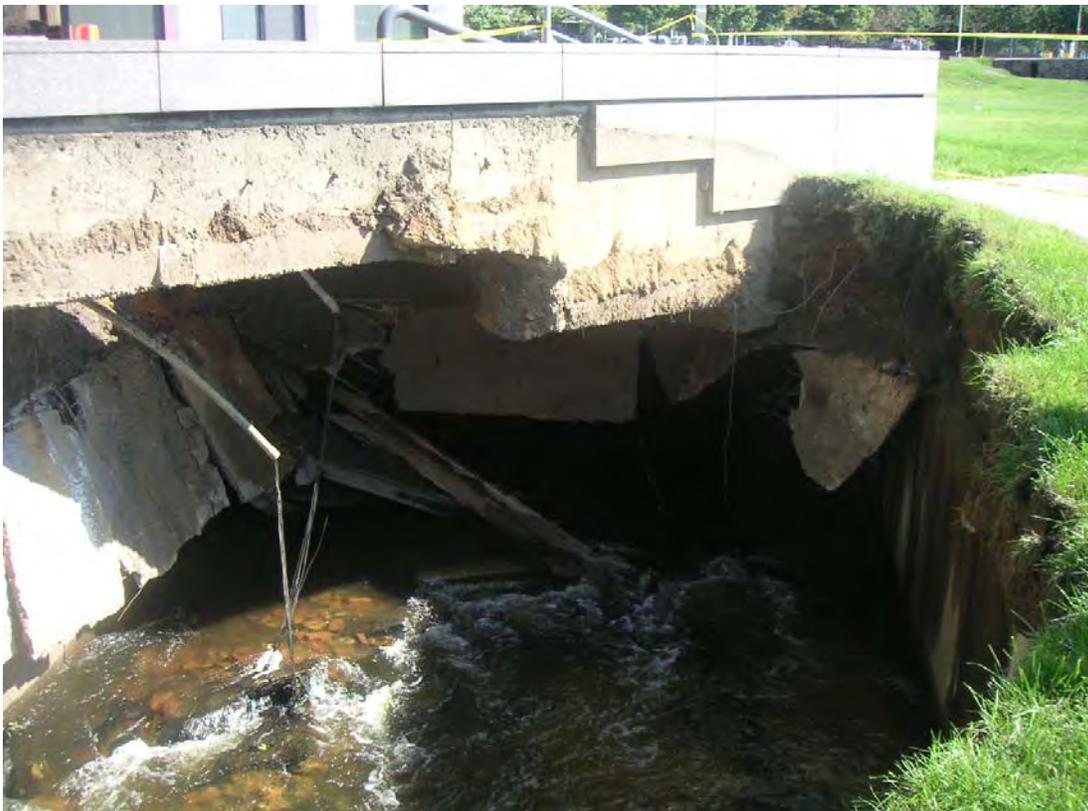
**Plate 4.** Location of the collapsed culvert roof section.
