Site 6: Livezey Dam

Site Information

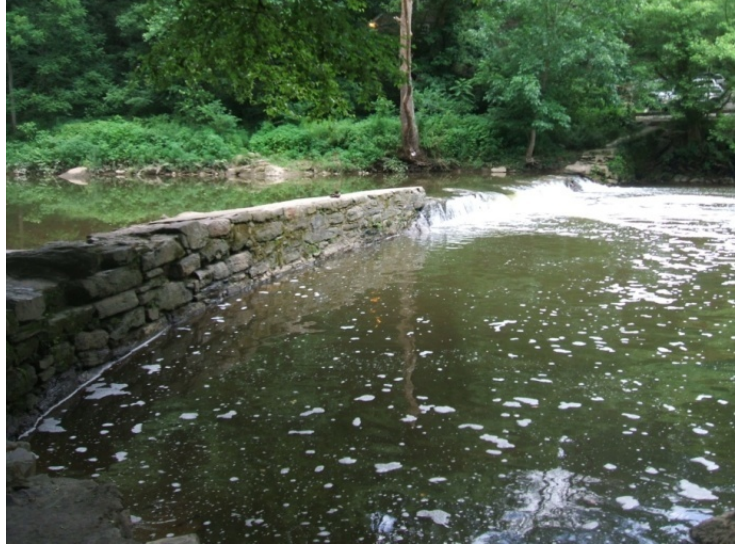
Livezey Dam is located approximately 3.6 miles above the confluence of Wissahickon Creek with the Schuylkill River, and on the creek's mainstem.

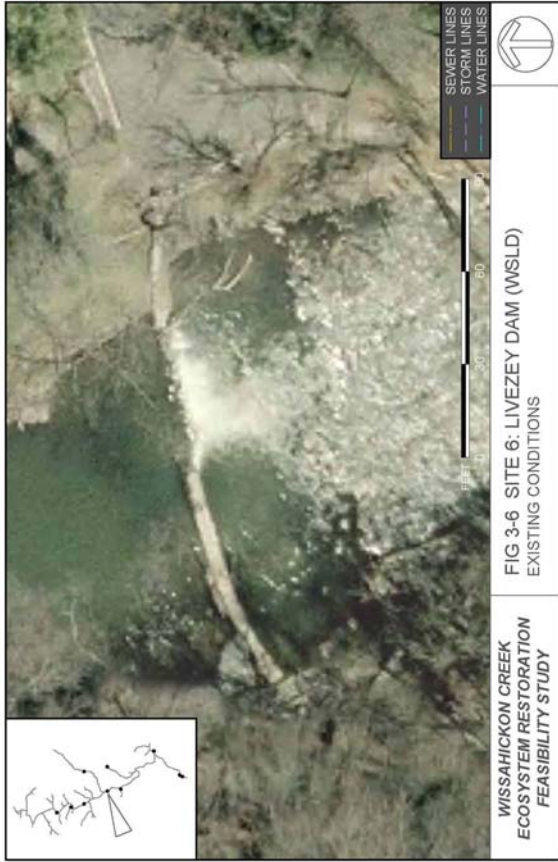
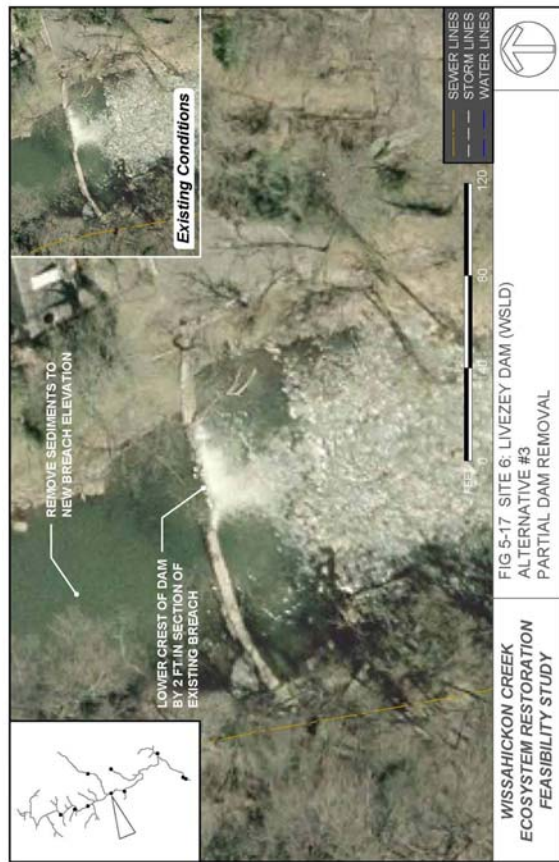
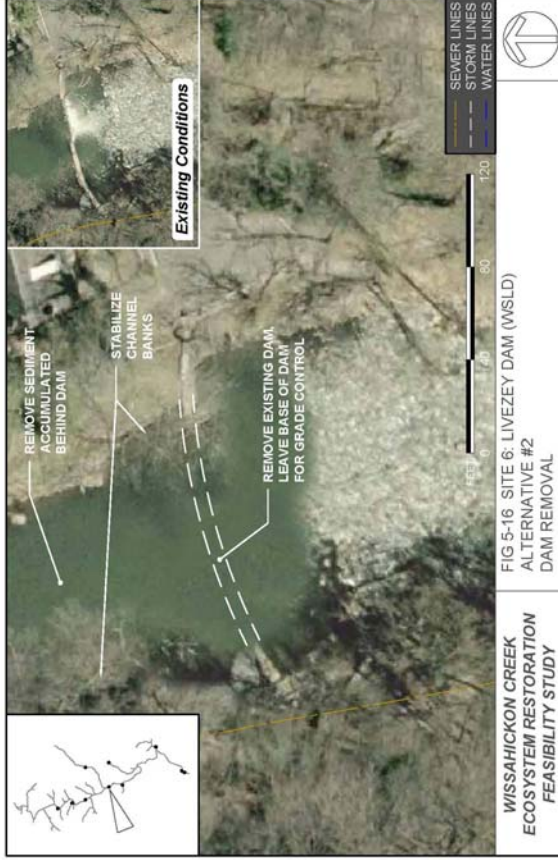
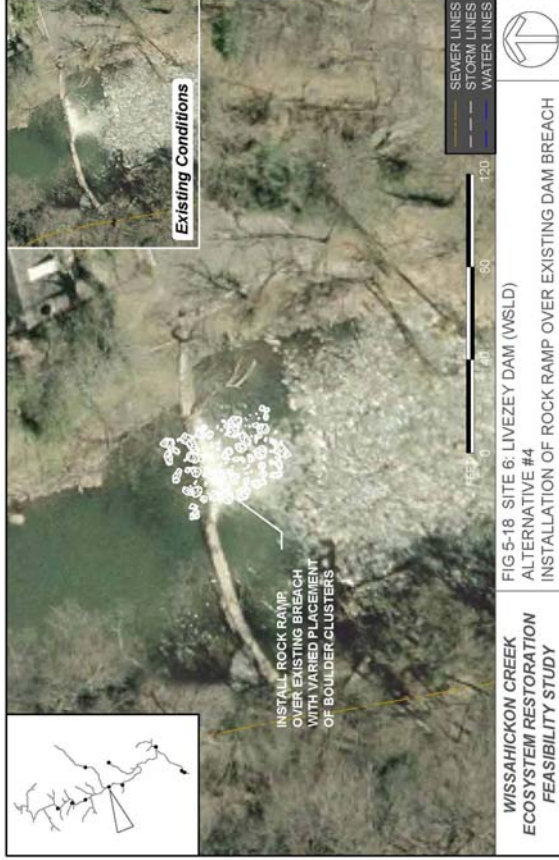
Alternative	Overview
1: No action	The dam would remain an impassable barrier to fish movement and continue to trap sediment, and poor habitat conditions would persist. The structure will likely exceed its design life within 50 years and require extensive renovation or replacement.
2: Dam removal	Alternative #2 consists of the removal of the existing dam and accumulated sediment upstream, thereby improving fish passage and promoting the most significant improvements to aquatic habitat.
3: Partial dam removal	Alternative #3 would lower part of the existing dam to allow fish passage, locally improve aquatic habitat, and maintain some sensitivity to historic/cultural resources.
4: Installation of rock ramp over existing dam breach	Alternative #4 would construct a rock ramp over the existing dam breach to allow fish passage and maintain some sensitivity to historic/cultural resources.
