Site 8: Magarge Dam

Site Information

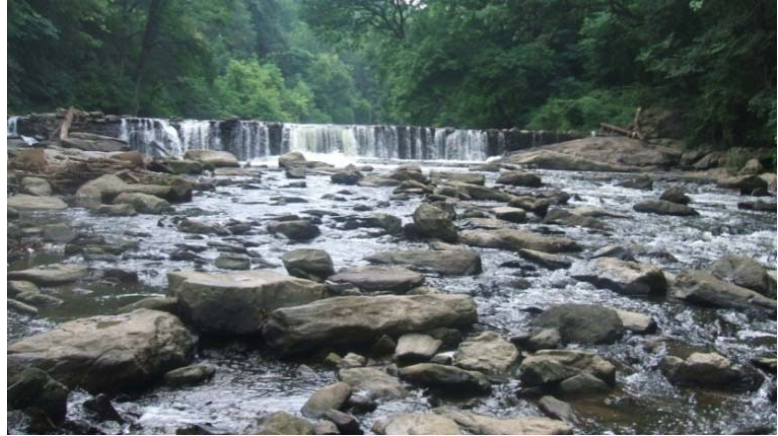
Magarge Dam is located approximately 4.5 miles above the confluence of Wissahickon Creek with the Schuylkill River, and on the creek's mainstem.

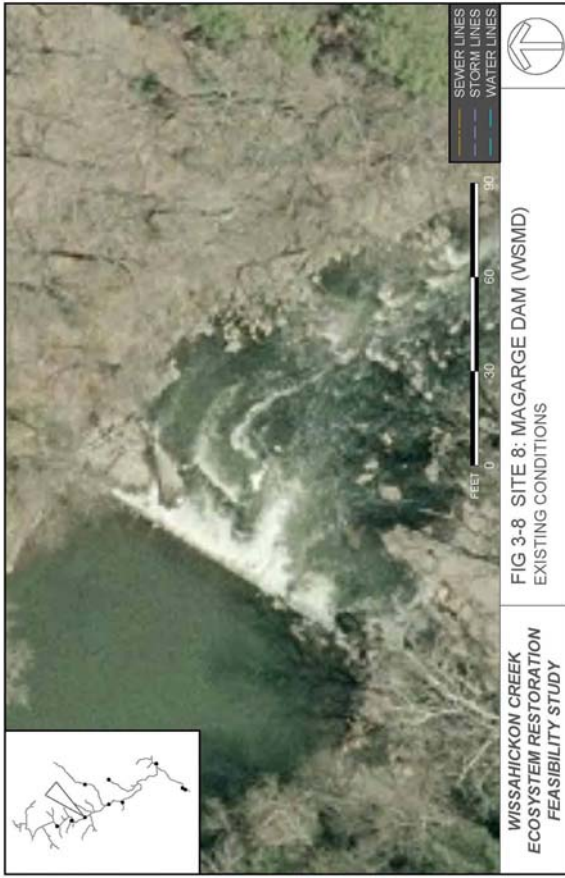
Alternative	Overview
1: No action	The dam would remain an impassable barrier to fish movement and continue to trap sediment and poor habitat conditions would persist. The structure will likely exceed its design life within 50 years and require structural repair or replacement

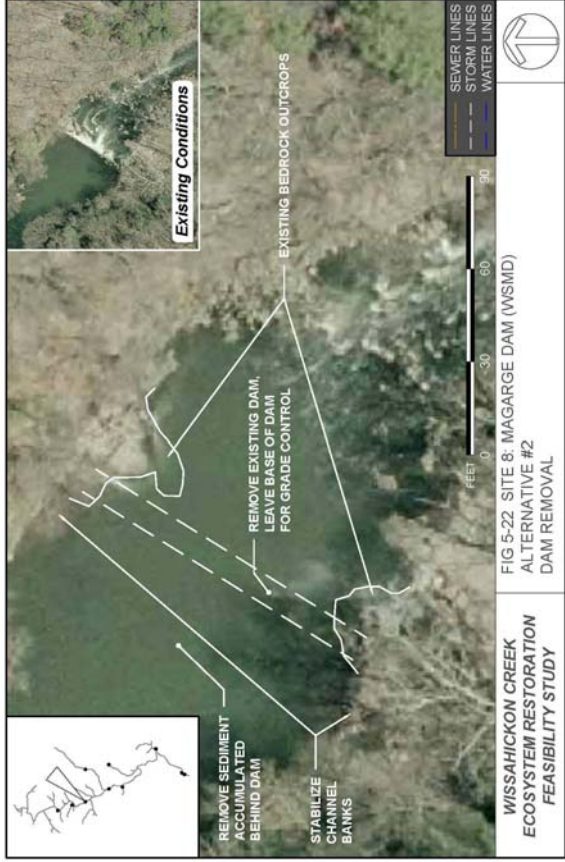
2: Dam removal	Alternative #2 consists of removal of the existing dam and accumulated sediment upstream, thereby improving fish passage and promoting the most significant improvements to aquatic habitat.

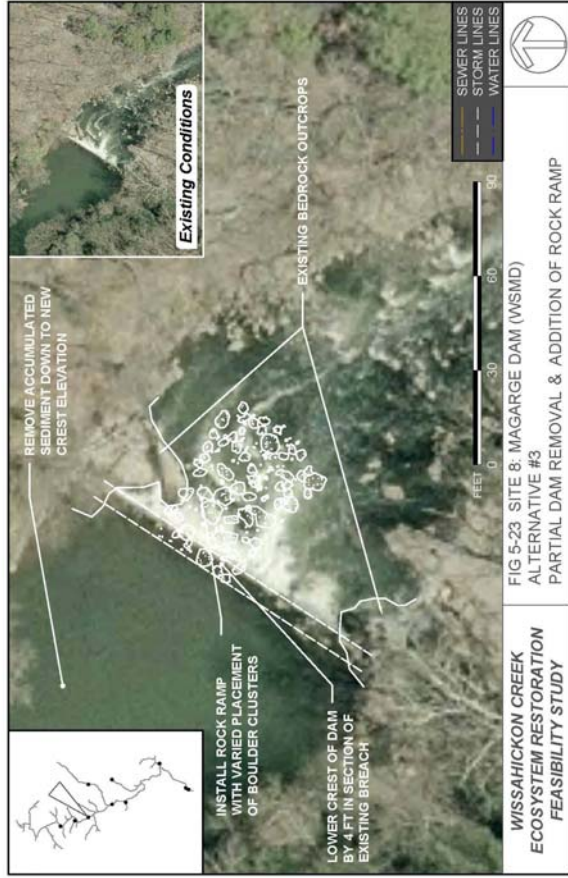
3: Partial dam removal & addition of rock ramp	Alternative #3 would lower the crest of the existing dam, and install a rough-channel, pool pass fish ramp to allow fish passage, locally improve aquatic habitat, and maintain some sensitivity to historic/cultural resources.

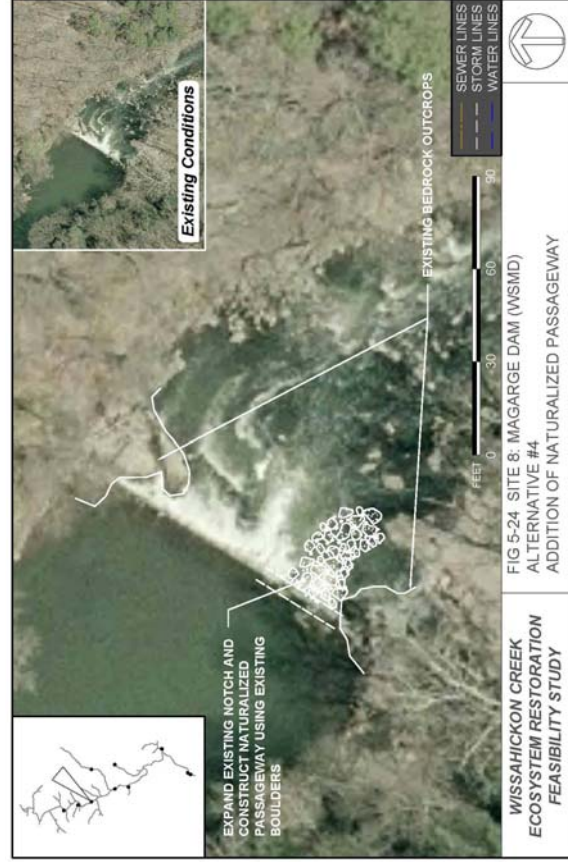
4: Addition of naturalized passageway	Alternative #4 would expand the existing breach to create a naturalized fish passageway. The installation of the fish passageway would achieve the goal of allowing fish migration over the dam and allow for sensitivity to historic/cultural resources, but would not improve the upstream backwater and poor habitat conditions. Alternative #4 is the simplest of the action alternatives since it modifies an already-existing feature.
