## **APPENDIX B**

### **Gamma Surveys**

B-1: Gamma Walkover Surveys

***DuPont Chambers Works FUSRAP – RI/FS Operable Unit 1******Gamma Walkover Survey******Area of Concern 2 – F Parking Corral Area*****1.0 INTRODUCTION**

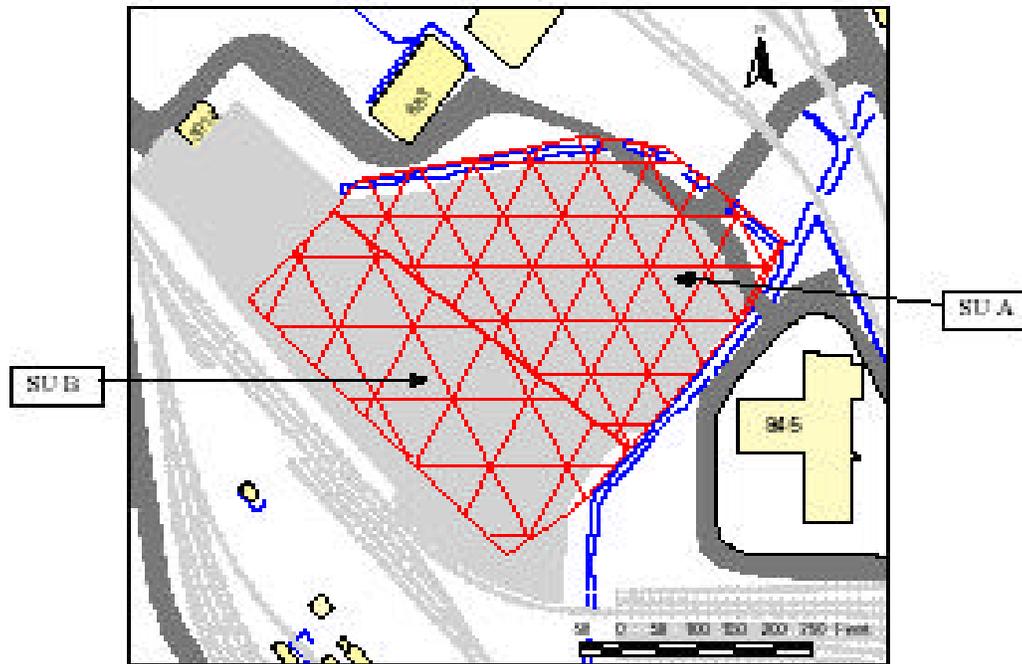
SITE MAP

Area of Concern (AOC) 2 is the site of the F Parking Corral, which is located in the northwest quadrant of the manufacturing complex, directly west of Former Building 845 (AOC 1). The F Parking Corral (Attachment I) includes the location of former Building 708, which was used

for the production of uranium metal. This area is now covered with asphalt, and had been used until recently for open storage and temporary office setup.

F Corral AOC 2

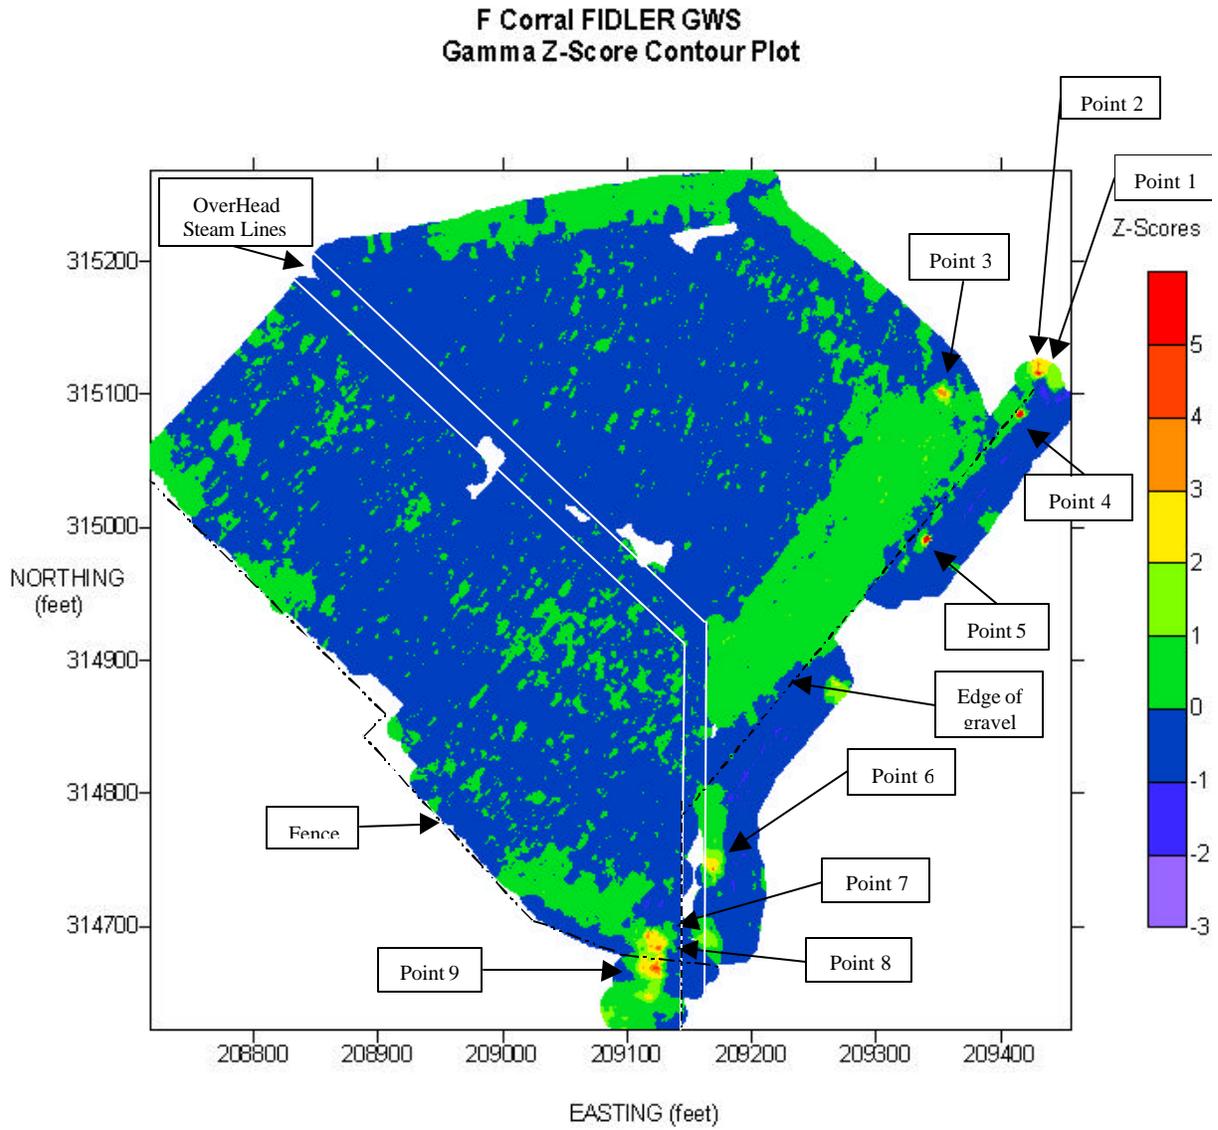
Coordinate System  
US State Plane 1983  
New Jersey 2900  
in feet

The only areas within the AOC 2 boundary not completely covered by the GWS were under the raised steam lines in the central portion of the site, where satellite reception was not possible, and isolated areas within the F Corral were inaccessible due to equipment stored on the ground. These areas show as white patches on the data plot in Attachment I.

Upon fieldwork completion, collated data were imported into a three-dimensional contouring software package (Surfer, Version 8.0). Project data included spatial coordinates (plotted on the X and Y-axes) and gamma readings (plotted on the Z-axis). The software generated a spatially interpolated contour map depicting the gamma count rate Z-scores. The Z-score is the count from each instrument minus the mean of the count population divided by the standard deviation of the population. Z-scores were determined for each instrument and then combined to create the plot seen in Attachment 1, Gamma Z-Score Contour Plot.

As indicated in the Z-score plot (Attachment I), the majority of AOC 2 is within two Z-scores. This suggests that there is little variability of radiological constituents over the surface of the survey unit. Detector # 176941 collected 27,829 data points, which showed an average of 4,855 cpm and a standard deviation of 2,391.25. Detector #176947 collected 25,404 data points, which showed an average of 4,919 cpm and a standard deviation of 1,797.83. The Z scores ranged from -1.6 to 27.

Of primary interest are the areas exhibiting greater than three Z-scores and are shown in orange and red. A number of such areas were identified during this survey. They are located at:

Point	Easting	Northing	Description
1	209,430.34	315,115.03	NE Corner of survey area, by drainage ditch, in gravel
2	209,427.63	315,126.00	Immediately North of above point, in gravel
3	209,352.45	315,101.48	Approximate location of former Building 708
4	209,415.31	315,085.08	South of points 1 & 2, at the edge of gravel and asphalt
5	209,340.12	314,990.79	South west of point 4, at edge of gravel and asphalt
6	209,169.42	314,743.43	South east portion of survey, in gravel
7	209,125.66	314,683.28	South portion of survey, asphalt, leading to RR crossing
8	209,122.95	314,668.24	Immediately south of point 7
9	209,116.05	314,645.07	On top of RR crossing outside fenced area

Points 1, 2, 4 & 5 are located in the gravel area at the northeastern section of the survey area bordering the Building 845 area. Point 4 & 5 are at the edge of the gravel and asphalt. Point 3 is located in the asphalt area in the approximate location of former Building 708. Point 6 is in the southern portion of the survey area, in the gravel at the edge of the steam lines. Points 7 and 8 are on the asphalt leading up to the fence and the railroad crossing. Point 9 is outside of the fence at the top of the RR crossing.

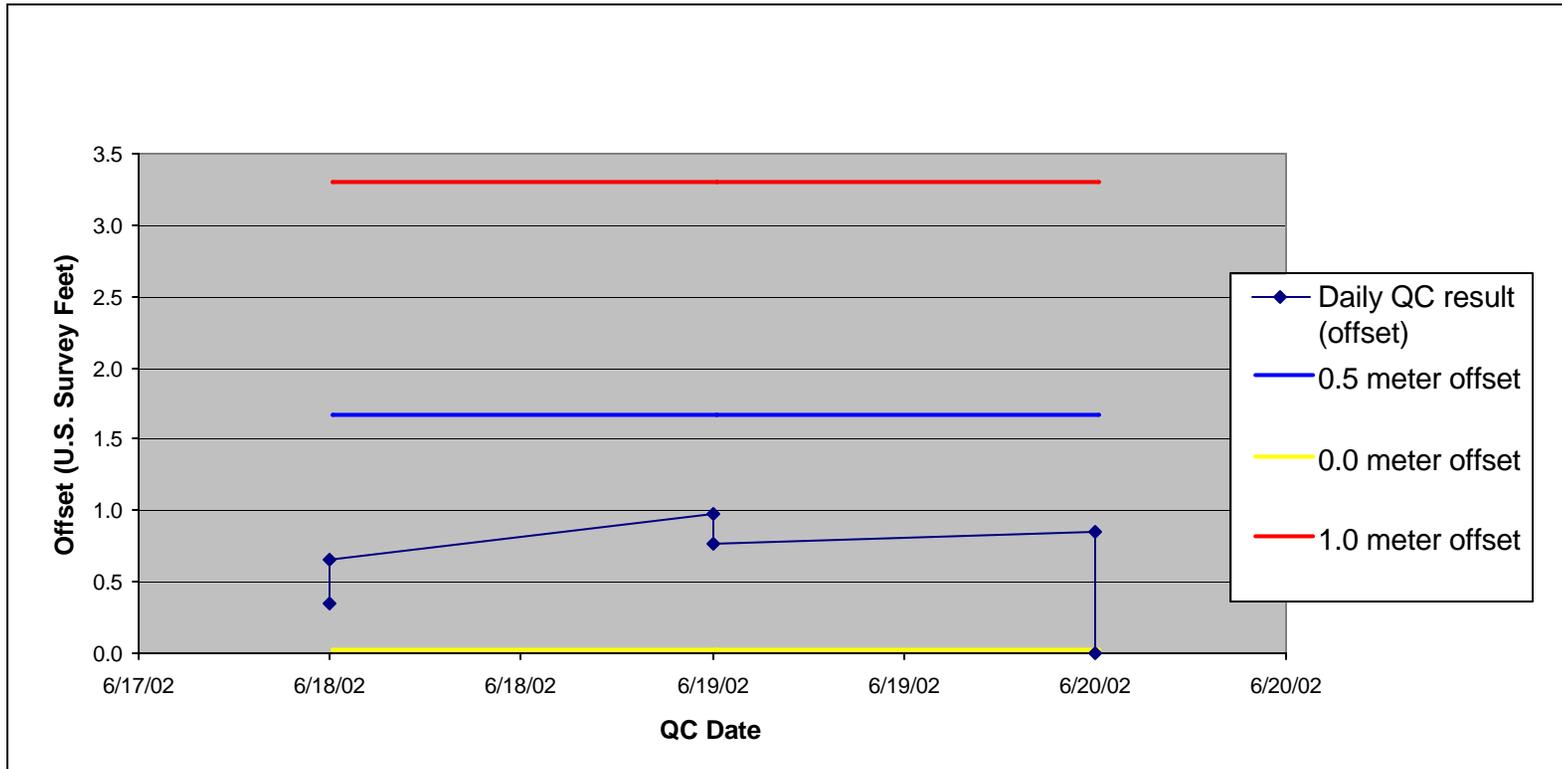
### GPS # 1 CONTROL CHART

The GPS system used the North American Datum 1983 (NAD83), New Jersey East 2900 for the horizontal coordinate system in feet. The GPS systems were also referenced to a set location (a baseline reading) and compared to this location on each day of the GWS. Ten

separate readings were collected at this location and control charts generated for each GPS unit (#1 and #2). On each day of the survey, each GPS unit collected a location reading from this established position prior to and after the GWS. These location readings were compared to the baseline location reading and an offset calculated. If the offset was one meter or greater, the GPS unit would have been removed from use. Calculated offsets for both units were less than one meter each day of the GWS. The control charts are included in Attachment II.
