APPENDIX L

Water Quality Data Figures & Isopleths (Quarters1-6)

Quarterly Monitoring Event, May 2007 [Q7]
 DuPont Chambers Works, Deepwater, NJ

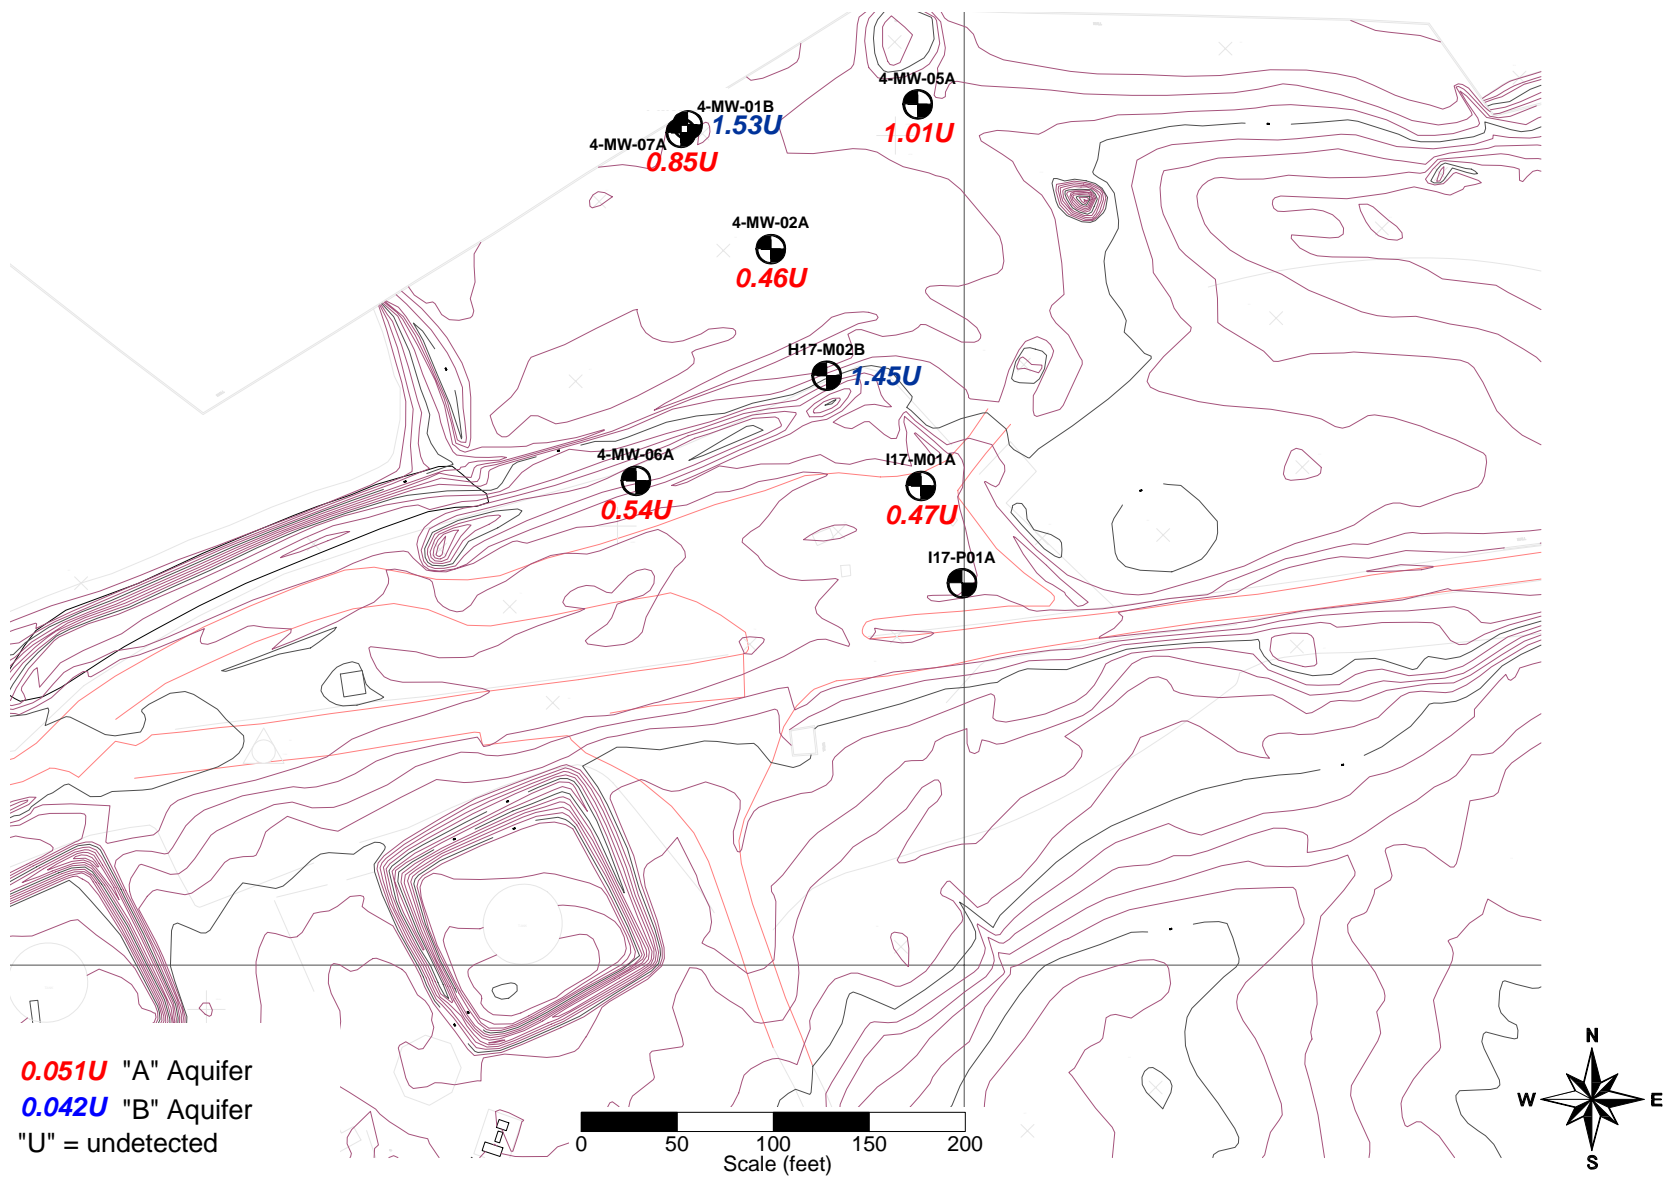
Figure H-3
 Ra-226 + Ra-228 Contour Map - "A" and "B" Aquifers
 AOC 4

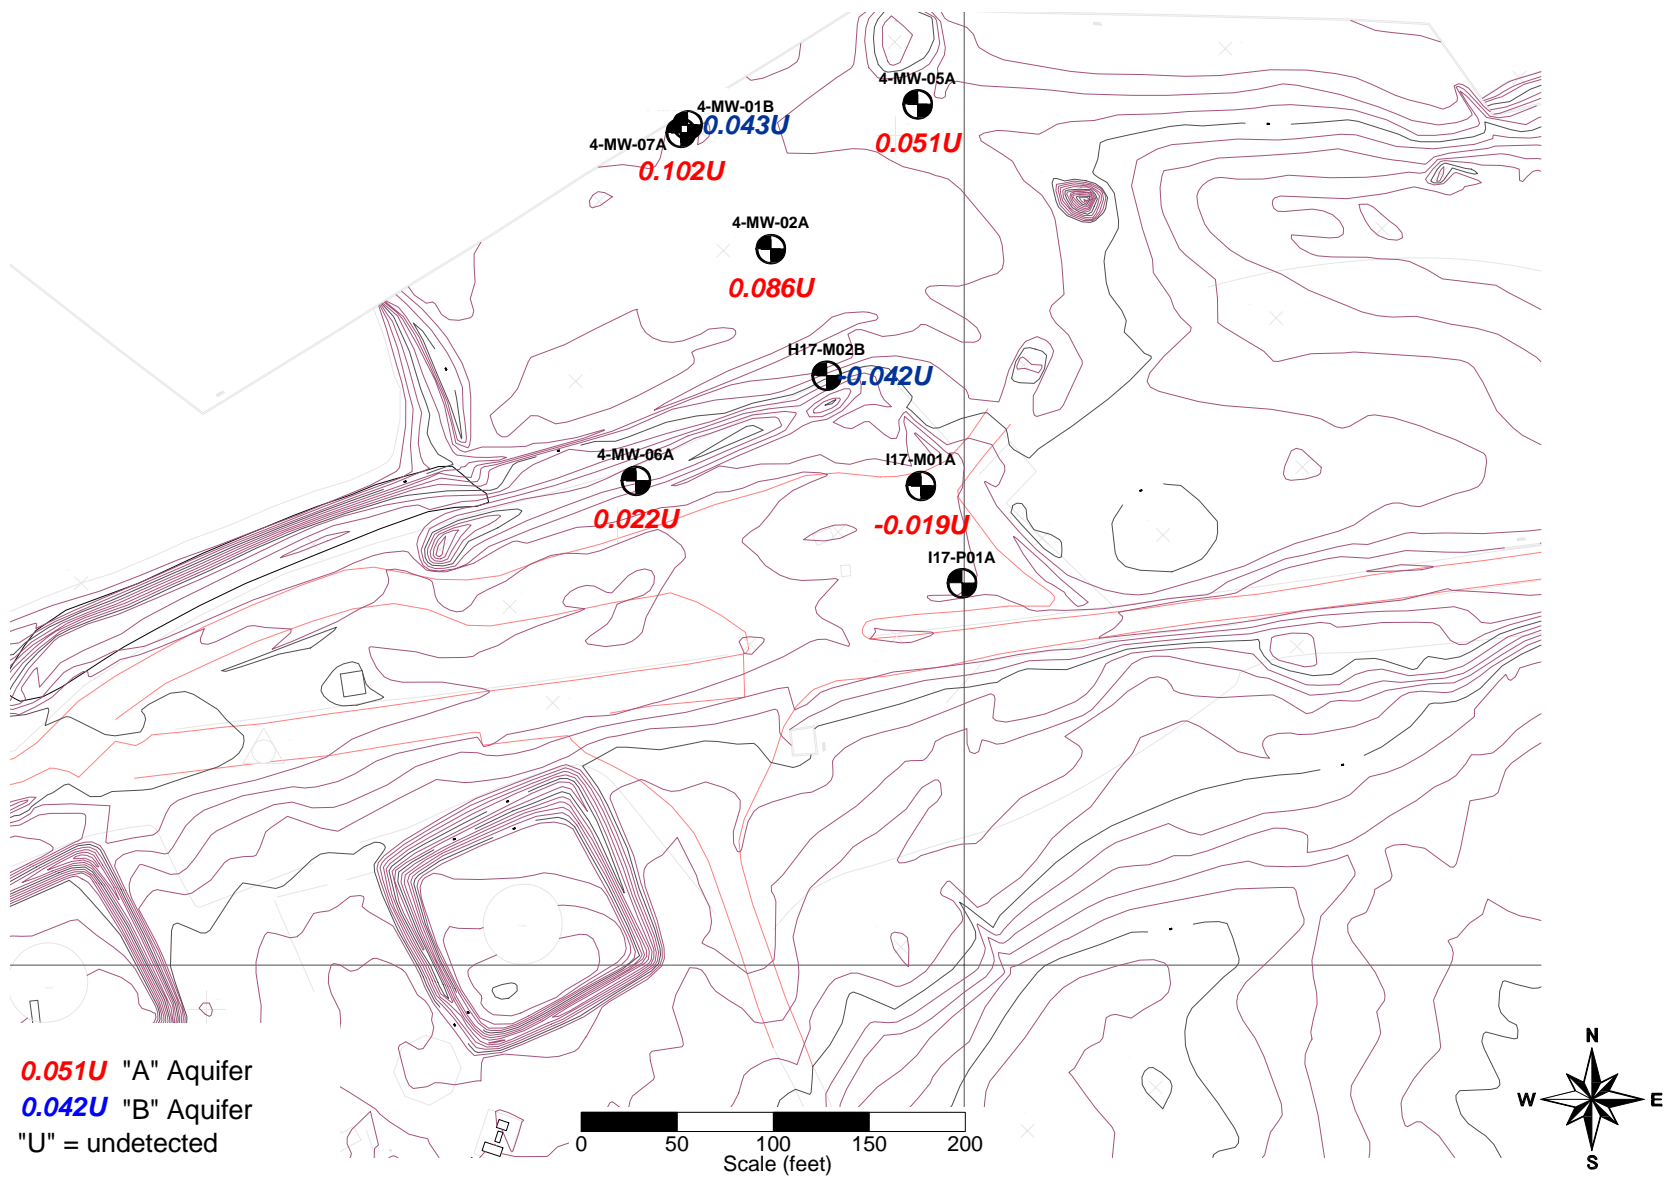
Figure H-4
 Thorium-230 Contour Map - "A" and "B" Aquifers
 AOC 4

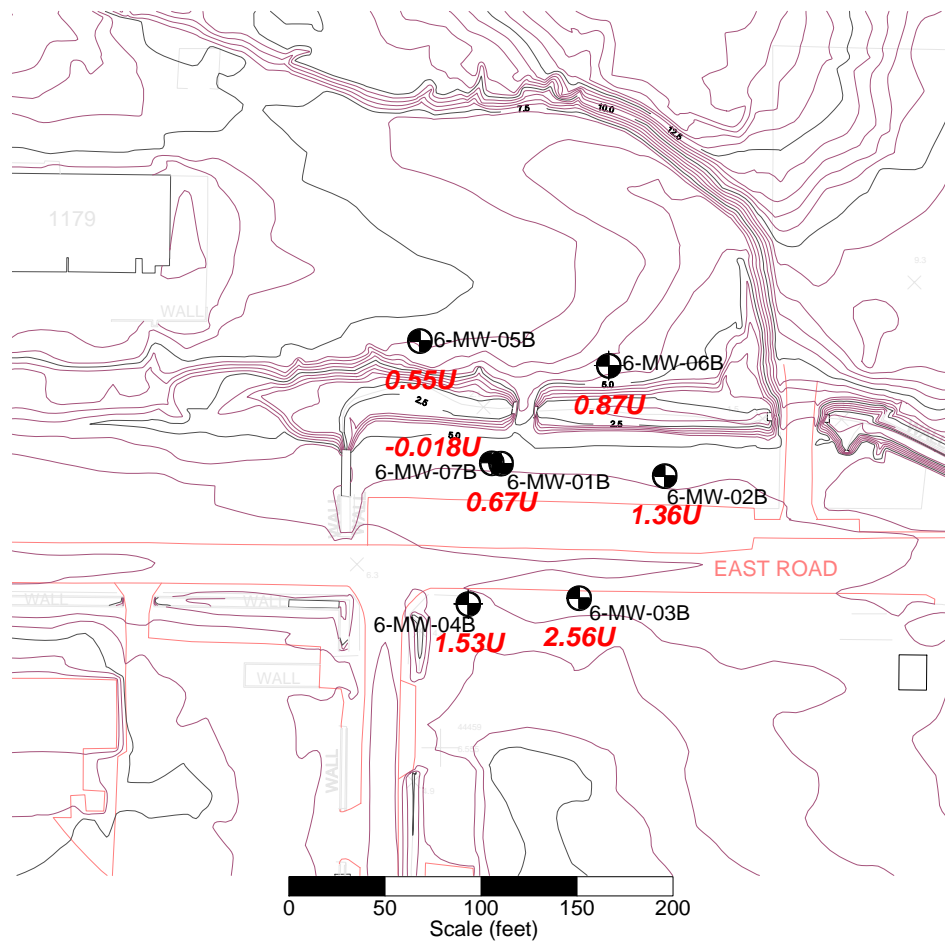
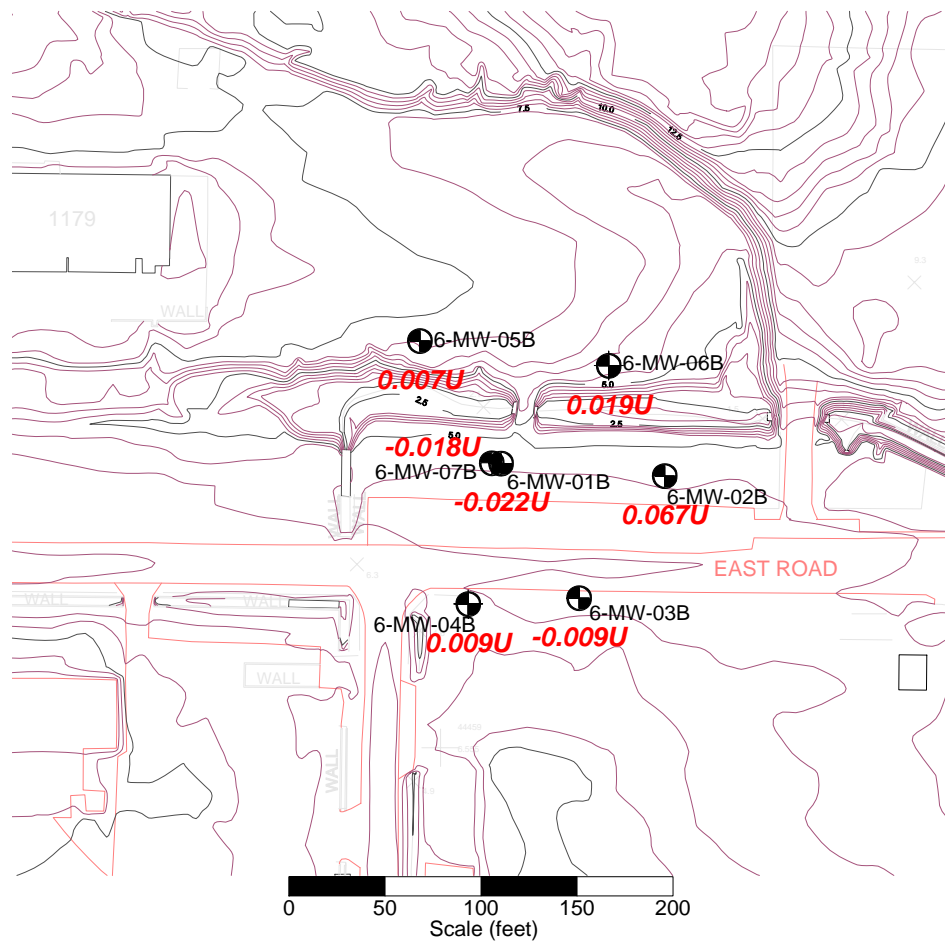
0.019U "B" Aquifer
 "U" = undetected

Figure H-7
 Thorium-230 Concentrations - "B" Aquifer
 AOC 6
