**FINDING OF NO SIGNIFICANT IMPACT  
 ABINGTON ENVIRONMENTAL INFRASTRUCTURE IMPROVEMENT PROJECT  
 ABINGTON TOWNSHIP  
 MONTGOMERY COUNTY, PENNSYLVANIA  
 SECTION 566, WATER RESOURCE DEVELOPMENT ACT of 1996**

The Abington Environmental Infrastructure Improvement Project (project or proposed action) is a stream and habitat improvement project in Abington Township, Pennsylvania adjacent to and along Sandy Run Creek (Figure 1). The project is authorized under Section 566 of the Water Resources Development Act (WRDA) of 1996 (Public Law 104-303), which was amended by Section 552 of WRDA 1999 (Public Law 106-53) to include environmental restoration as an authorized project purpose.

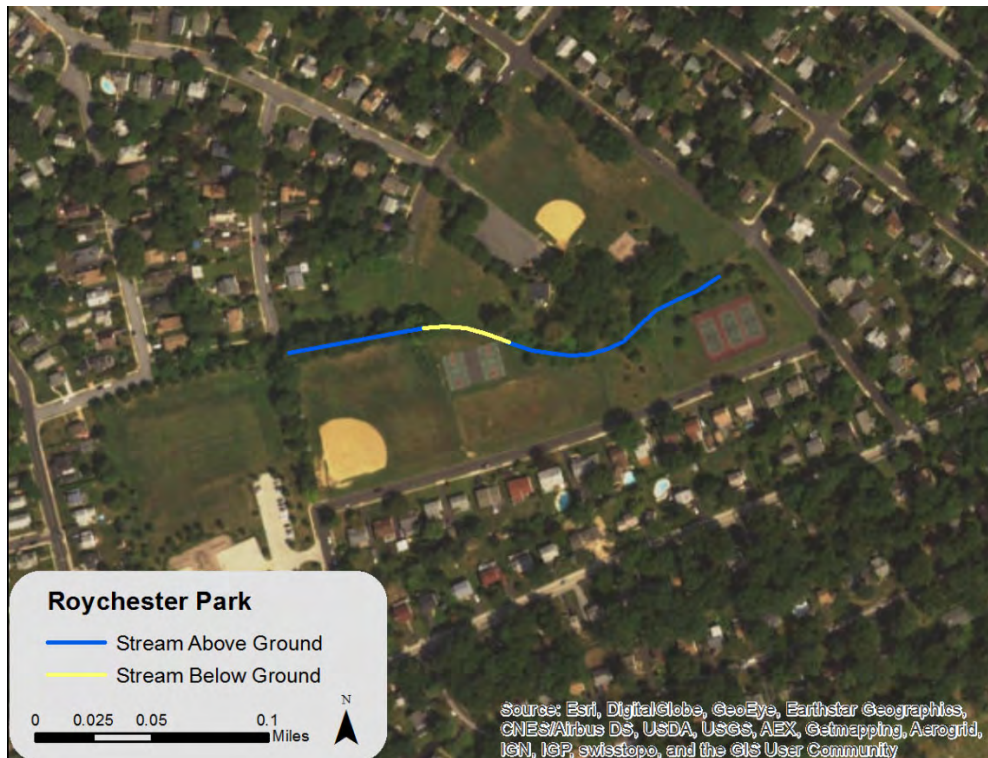
**Figure 2: Map of Roychester Park showing location of Sandy Run Creek**

Roychester Park is a municipally owned park of approximately 12.7 acres. Many recreational and community features are present in the park including a playground, baseball fields, basketball courts, tennis courts, and the Roychester Community House, which serves as a venue for community functions and gatherings. The headwaters of Sandy Run Creek flow through Roychester Park. The park contains approximately 950 linear feet of stream, of which about 150 linear feet are currently diverted into a below-ground piped channel (Figure 2). The segment of stream diverted underground has no aquatic habitat value. The banks of the above ground segments of Sandy Run Creek within Roychester Park are severely eroded and the channel is deeply incised (Figure 3).

At Roychester Park, opportunities exist to stabilize eroding banks, reconnect the floodplains, and restore riparian and wetland habitat along the eroded above ground reaches of the creek (approximately 800 linear feet). This would include restoring riparian habitat within Roychester Park where the stream banks are currently extremely eroded (Figures 2 and 3). The proposed action includes the following components.

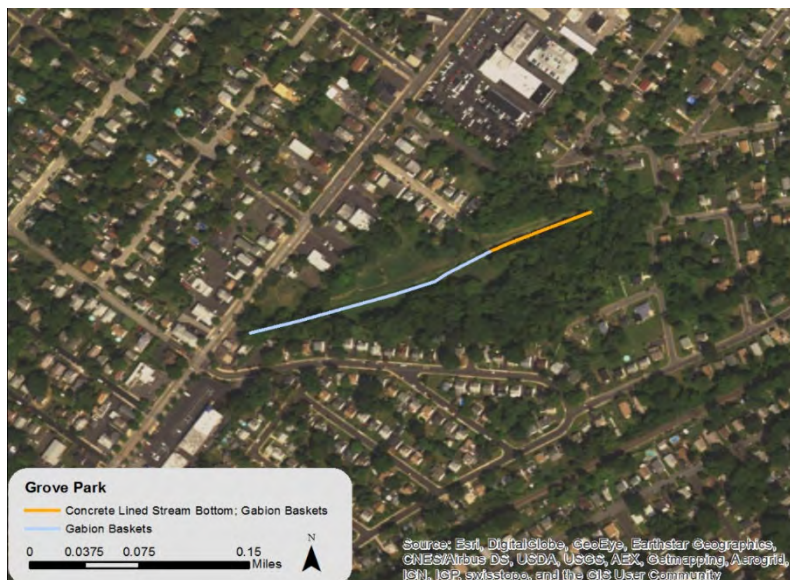
**Figure 4: Map of Grove Park showing location of Sandy Run Creek**

Grove Park is a municipally owned park of approximately two acres. The park contains approximately 1,300 linear feet of Sandy Run Creek (Figure 4). About 400 linear feet of stream within the park has a concrete channel bottom (24 feet wide and 12 inches thick and reinforced with rebar) and is lined with gabion baskets along the banks (Figure 5). The concrete channel provides no useful aquatic habitat and increases the velocity and temperature of the water, which further impairs downstream habitat through increased sedimentation and water temperature. Downstream of the concrete lined stream bottom, the stream banks are lined with gabion baskets (Figure 6). The gabions provide low quality habitat for aquatic species and prevent the stream bed from connecting to the surrounding floodplains.

At Grove Park, opportunities exist to reconnect the floodplains and restore riparian habitat by removing the concrete lining from approximately 400 linear feet of the stream bed (Figures 4 and 5), removing the gabion baskets lining approximately 1,300 linear feet of stream bank (Figures 5 and 6), and using natural stream stabilization methods and native vegetation plantings. The forested floodplain south of Sandy Run contains wetlands and two ephemeral tributaries; parts of these may be remnants of the former main stem of Sandy Run Creek within Grove Park (Figure 7). The forested floodplains are dominated by invasive species (especially multiflora rose [*Rosa polyantha*]). The tributaries are degraded due to sedimentation, disconnection from regular flow, and predominance of invasive plants. The forested floodplain and wetland habitat will be enhanced by relocating a tributary through the forested floodplain to increase storm water storage within the forested floodplain. The elements of the Proposed Action in Grove Park include the following:

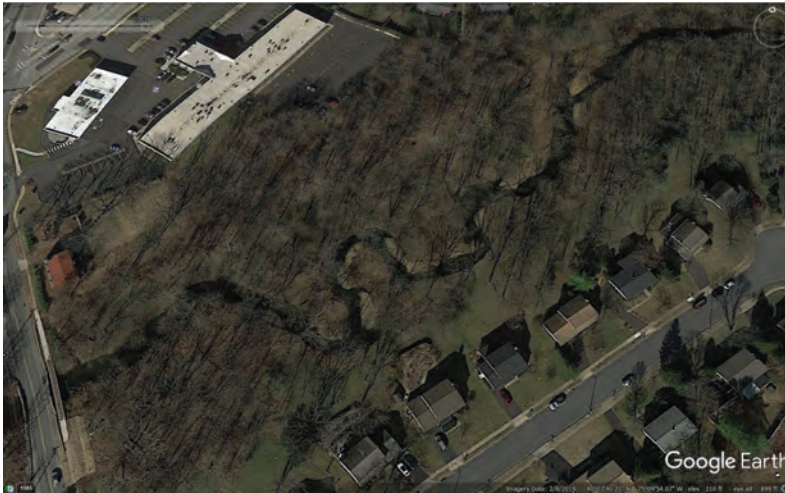
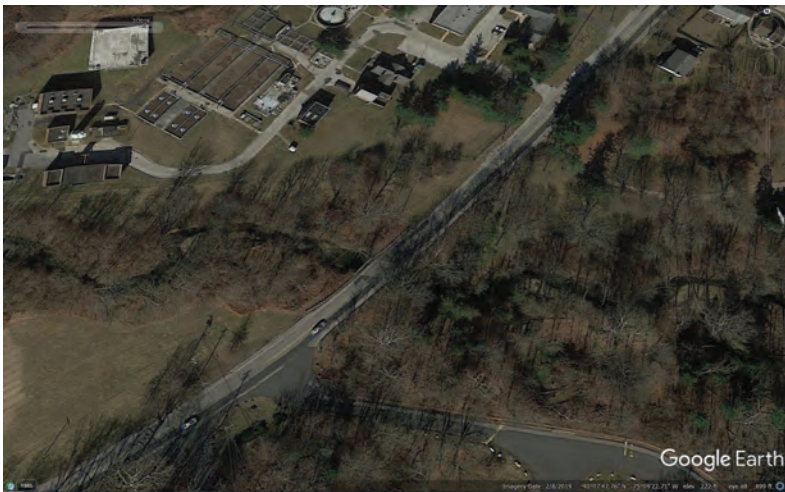
Figures 1 and 2: Wooded sections of Sandy Run, downstream of Roslyn Park, demonstrating natural stream sinuosity where encroachment of development has not led to channelization and elimination of natural stream meanders that help to maintain stream channel stability.

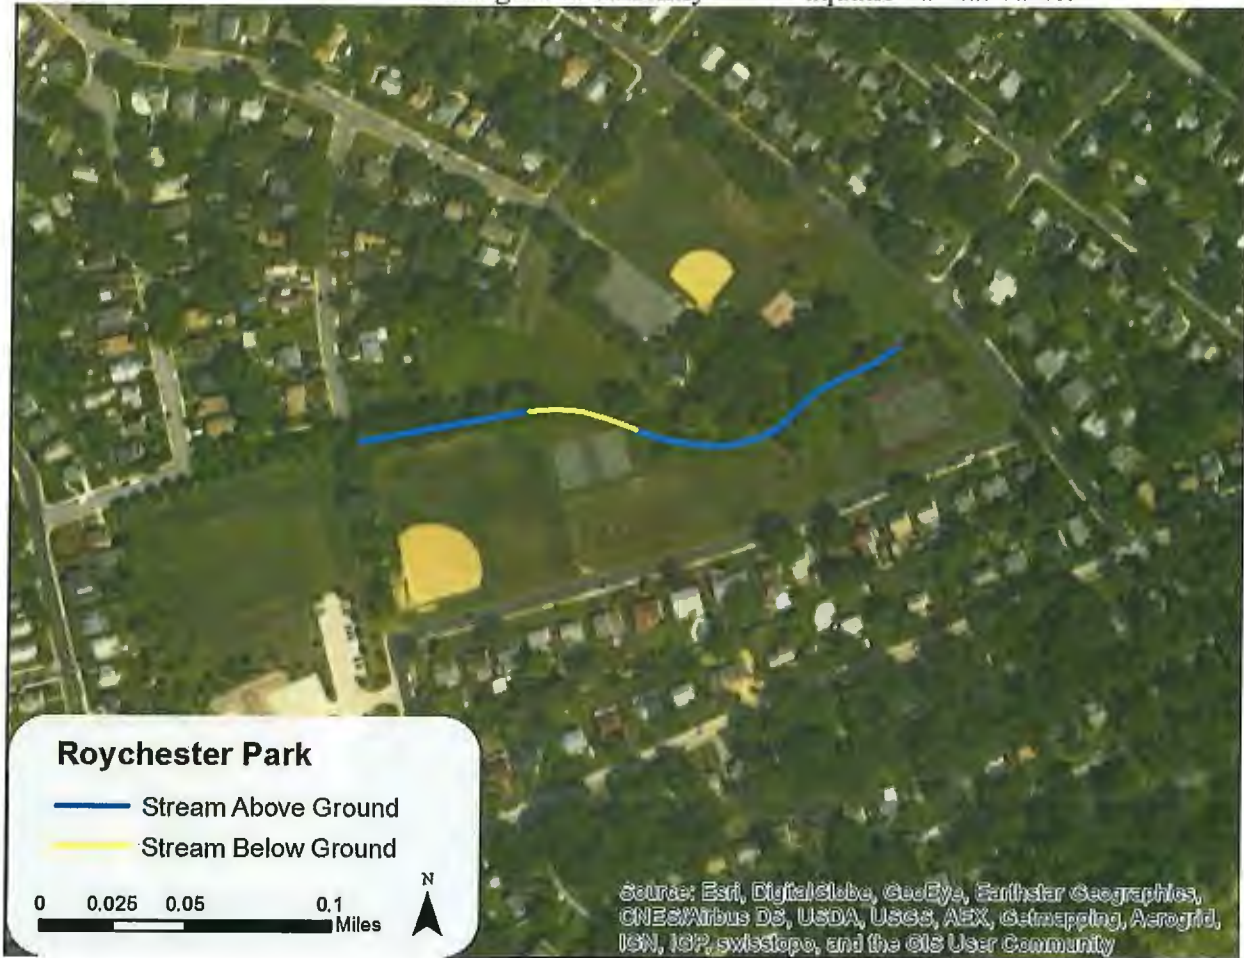
Figure 1: Map of Roychester Park showing location of Sandy Run Creek

Roychester Park is a municipally owned park of approximately 12.7 acres. Many recreational and community features are present in the park including a playground, baseball fields, basketball courts, tennis courts, and the Roychester Community House, which serves as a venue for community functions and gatherings. The headwaters of Sandy Run Creek flow through Roychester Park. The park contains approximately 950 linear feet of stream and about 150 linear feet of which is currently diverted into a below ground channel (Figure 2). The segment of stream which has been diverted underground currently has no aquatic habitat value.

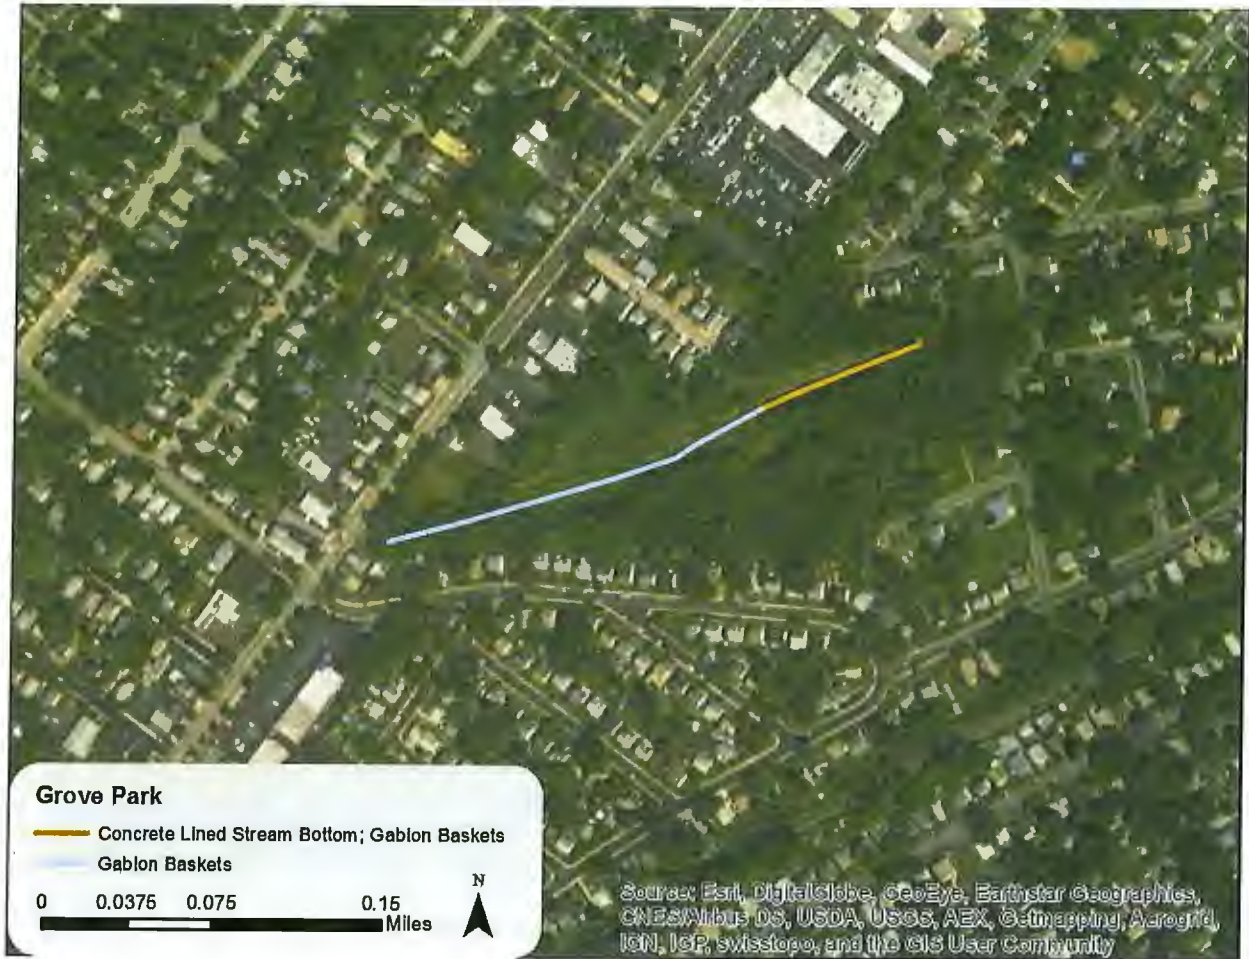
Figure 3: Map of Grove Park showing location of Sandy Run Creek

Grove Park is a municipally owned park of approximately 2 acres. The park contains approximately 1,300 linear feet of Sandy Run Creek (Figure 4). About 400 linear feet of stream within the park are lined with gabion baskets on the banks and a 24 foot wide and 12 inches thick rebar enforced concrete channel on the stream bottom (Figure 5). The concrete channel provides no useful aquatic habitat and increases the velocity and temperature of the water, which further impairs downstream habitat through increased sedimentation and water temperature. Downstream of the concrete lined stream bottom, the stream banks are lined with gabion baskets (Figure 6). The gabions provide lower quality habitat for aquatic species and prevent the stream bed from connecting to the surrounding floodplains.

At Grove Park, opportunities exist to remove the concrete lining on an approximately 400 linear foot portion of the stream bed (Figures 4 and 5) and the gabion baskets lining the approximately 1,300 linear feet of stream banks (Figures 5 and 6) and use natural stream stabilization methods and native vegetation plantings to reconnect the floodplains and restore riparian and wetland habitat of the banks of Sandy Run Creek. The former main stem of Sandy Run Creek within Grove Park (Figure 7) is populated by the invasive species multiflora rose (*Rosa polyantha*), which degrades the existing habitat by competing with native species. Removal of multiflora rose from this section of the park will be a priority as a way to improve the success of the native vegetation plantings around the main stem of Sandy Run Creek at Grove Park.

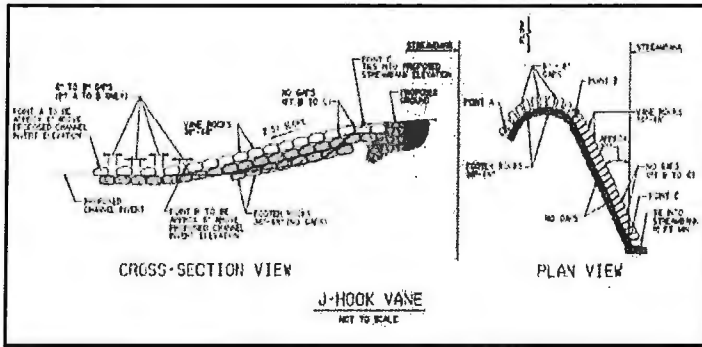
**J-Hook Vanes:** redirect higher velocity flows away from outside banks reducing erosion and create aquatic habitat through riffle formation

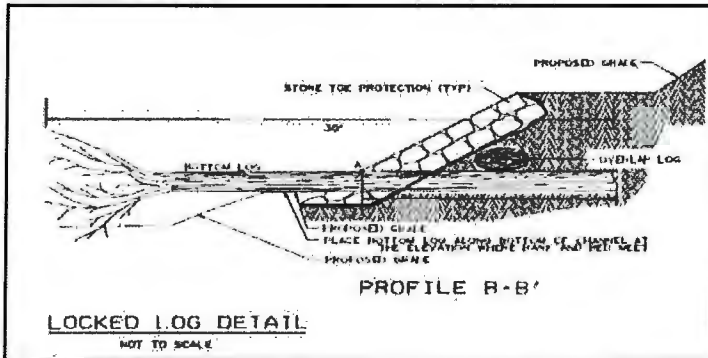
**Locked Logs:** Dissipate energy, reduce near-field scour, provide toe protection, and provide aquatic habitat complexity

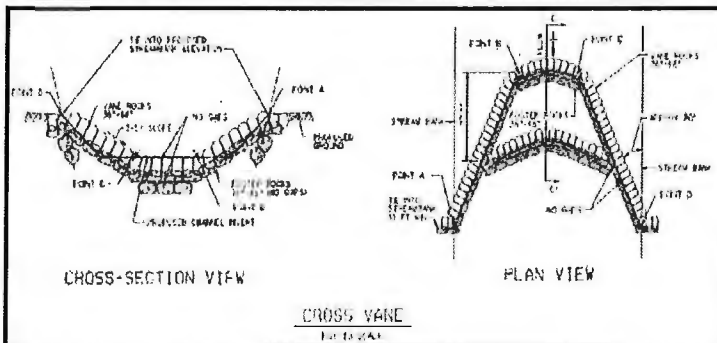
**Cross vanes:** Redirect water away from stream banks and into the center of the channel, decreasing stress on unstable banks and forming pool habitat in the channel center. Double cross vanes (W weirs) are a variation suitable for wider channels.

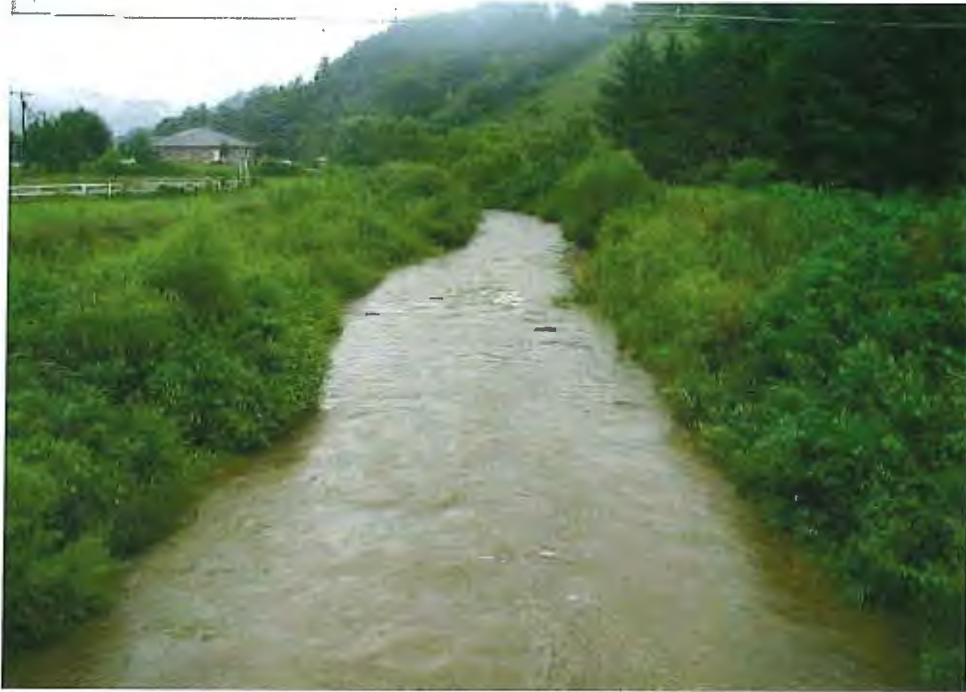
Figure 9: Example of a stream that was restored using natural stream stabilization structures and native vegetation Image Source: .Doll, B.A., Grabow, G.L., Hall, K.R., Halley, J, Harman, W.A., Jennings, G.D., & D.E. Wise. 2003. Stream Restoration: A Natural Channel Design Handbook. NC Stream Restoration Institute, NC State University.

This project will investigate, select, design and construct the best alternative to restore ecosystem function along Sandy Run Creek at Roychester Park and Grove Park using natural stream stabilization methods such as J-hook vanes, locked logs, cross vanes, bendway weirs, longitudinal stone toe protection, and native streambank vegetation (Figures 8 and 9).

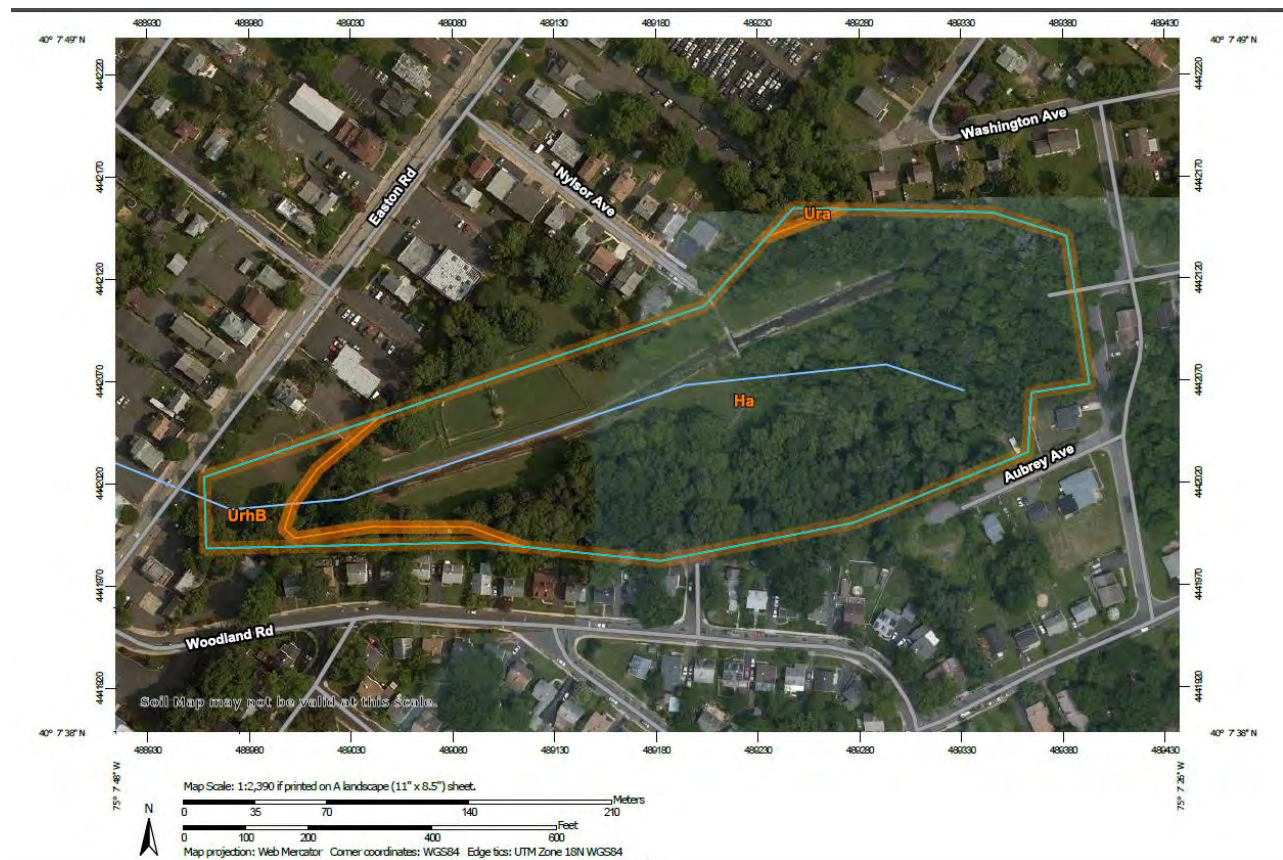
Figure 4: Soil Boring Locations (USACE Regulatory Dept., Oct. 8, 2019)

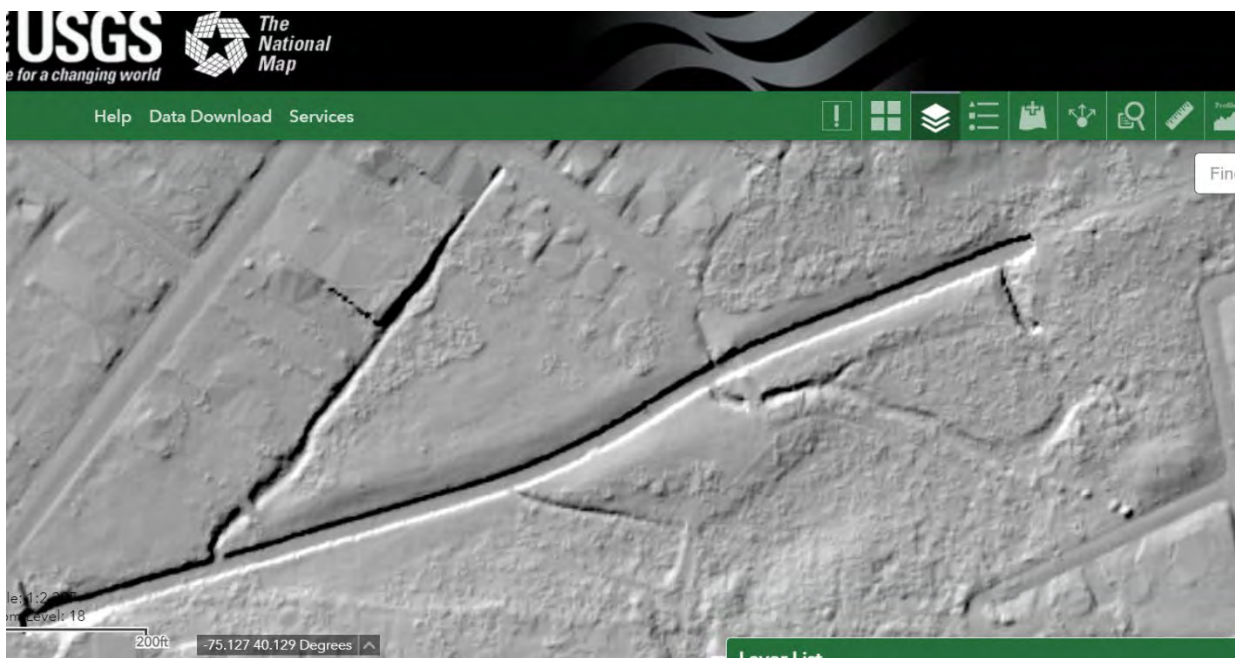
**Figure 7: Grove Park Wetland and Stream Location Drawing**  
(USACE Environmental Resources Dept., Nov. 10, 2020)
