COMBINED PHASE I/II ARCHAEOLOGICAL SURVEY
ASSUNPINK CREEK RESTORATION
CITY OF TRENTON, MERCER COUNTY, NEW JERSEY

TECHNICAL REPORT

U.S. ARMY CORPS OF ENGINEERS, PHILADELPHIA DISTRICT
CITY OF TRENTON

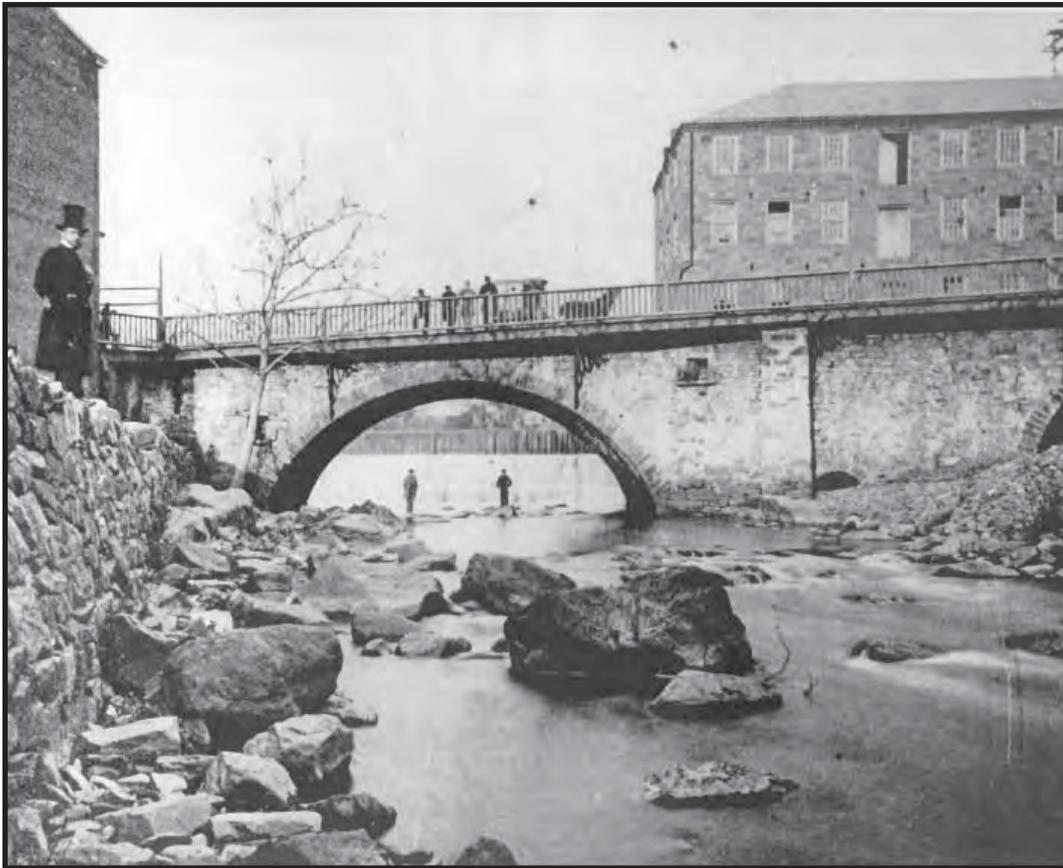
Plate 4.7. Historic photograph of the South Broad Street bridge over the Assunpink Creek and the McCall Paper Mill. *Circa* 1870. (Source: Trenton Public Library, Trentoniana Collection).

shown in the Barber and Howe engraving. This railing was apparently replaced in 1870 and taken to Olden Avenue where it was re-erected over the creek (Cleary 1936). The dating of the two other photographs (see above, Plates 4.8 and 4.9) to the same period is also based partly on the fact they appear to show the bridge approaches immediately after the bridge widening and improvement project that was undertaken in 1870, just before the paper mill was pulled down and before the development of the Assunpink Block began to take place on the bridge itself in the mid- to late 1870s (see below).

some local historians (notably, Cleary 1936) that the entire bridge was replaced to facilitate this widening. However, Harry Podmore (31 August 1957) notes more correctly that this improvement was carried out around the earlier bridge in a way that preserved the structure erected in the early 1840s. The guardrail of the earlier structure – removed as part of the widening project - reportedly incorporated a line of cannon that were placed there in memory of the Second Battle of Trenton. Unfortunately, these elements are not obviously apparent in the Barber and Howe engraving of 1868 (see above, Plate 4.6), nor in photographs of the bridge taken around 1870 (see above, Plates 4.7 to 4.9).

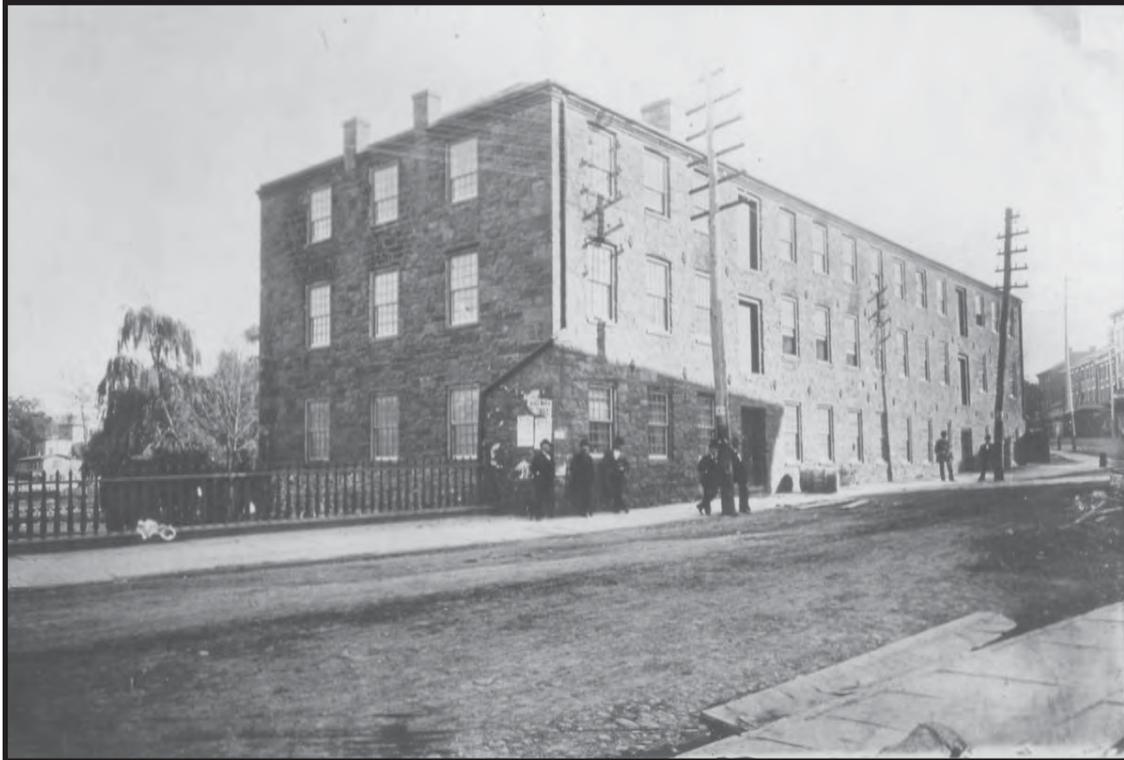
Plate 4.9. Historic photograph of McCall Paper Mill taken from the Assunpink Bridge. *Circa 1870.*
(Source: Trenton Public Library, Trentoniana Collection).

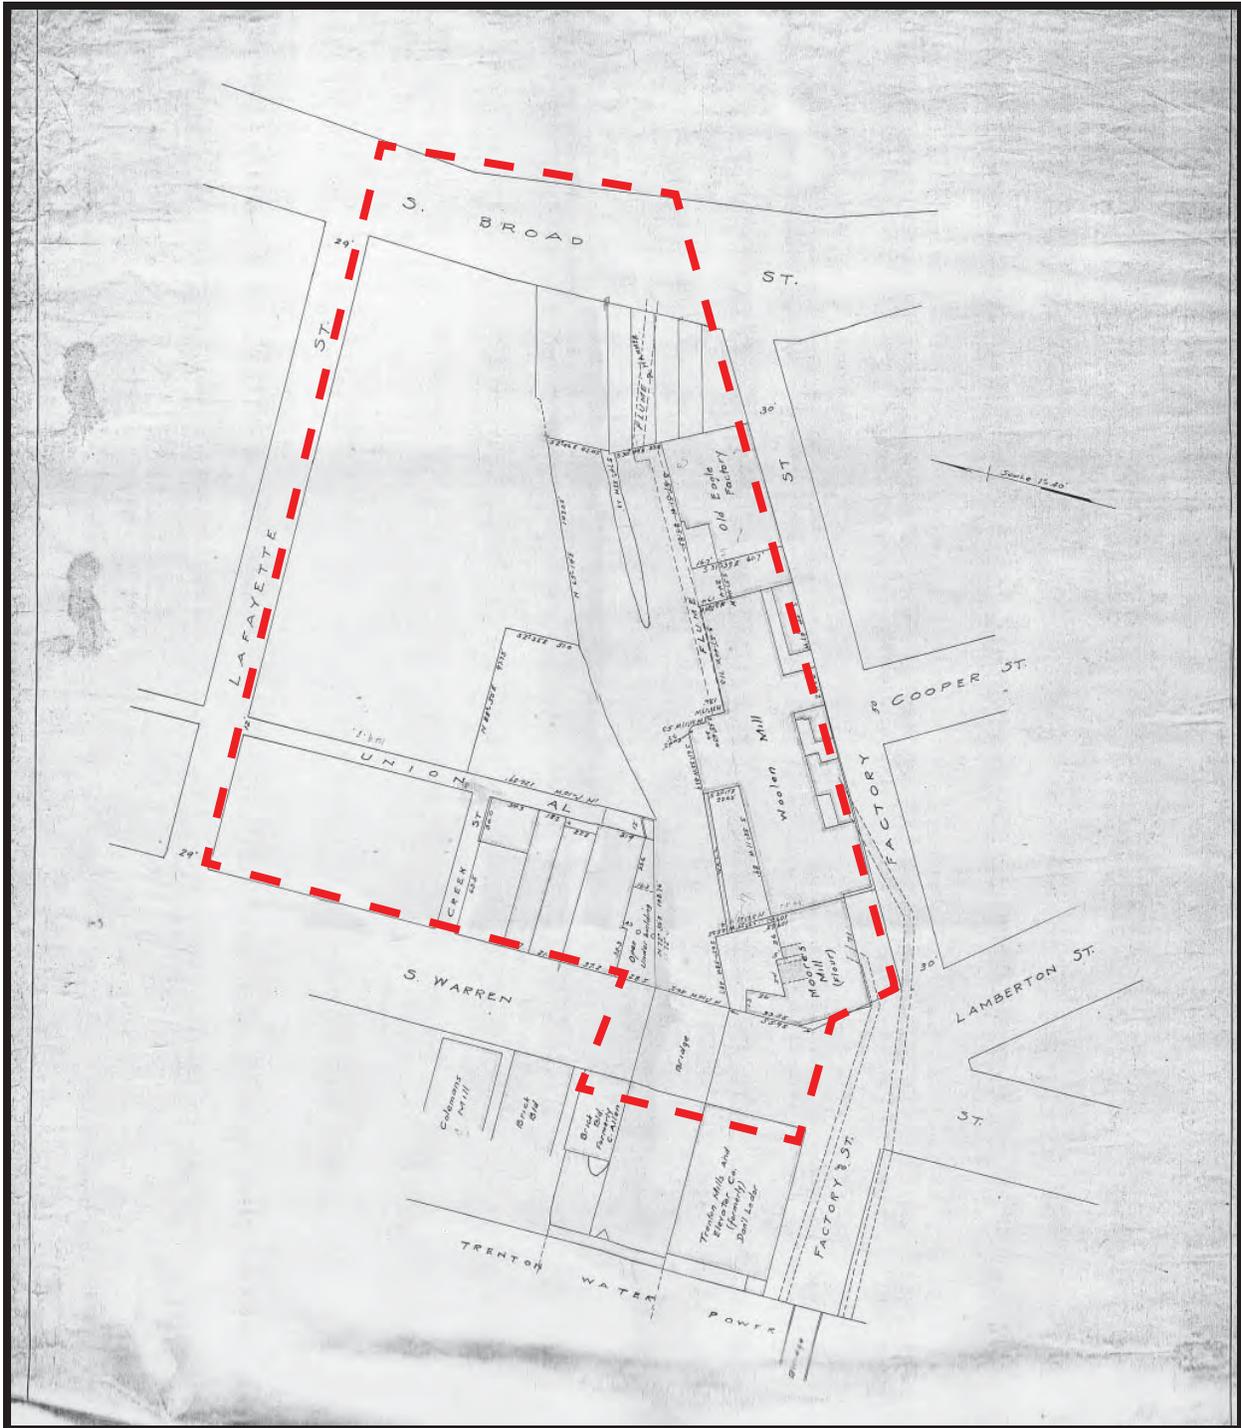
Figure 4.26. Map of the Assunpink Creek between South Broad and South Warren Streets. Circa 1905. Scale: 1 inch: 93 feet (approximately). Study area outlined. Source: City of Trenton Engineering Department.

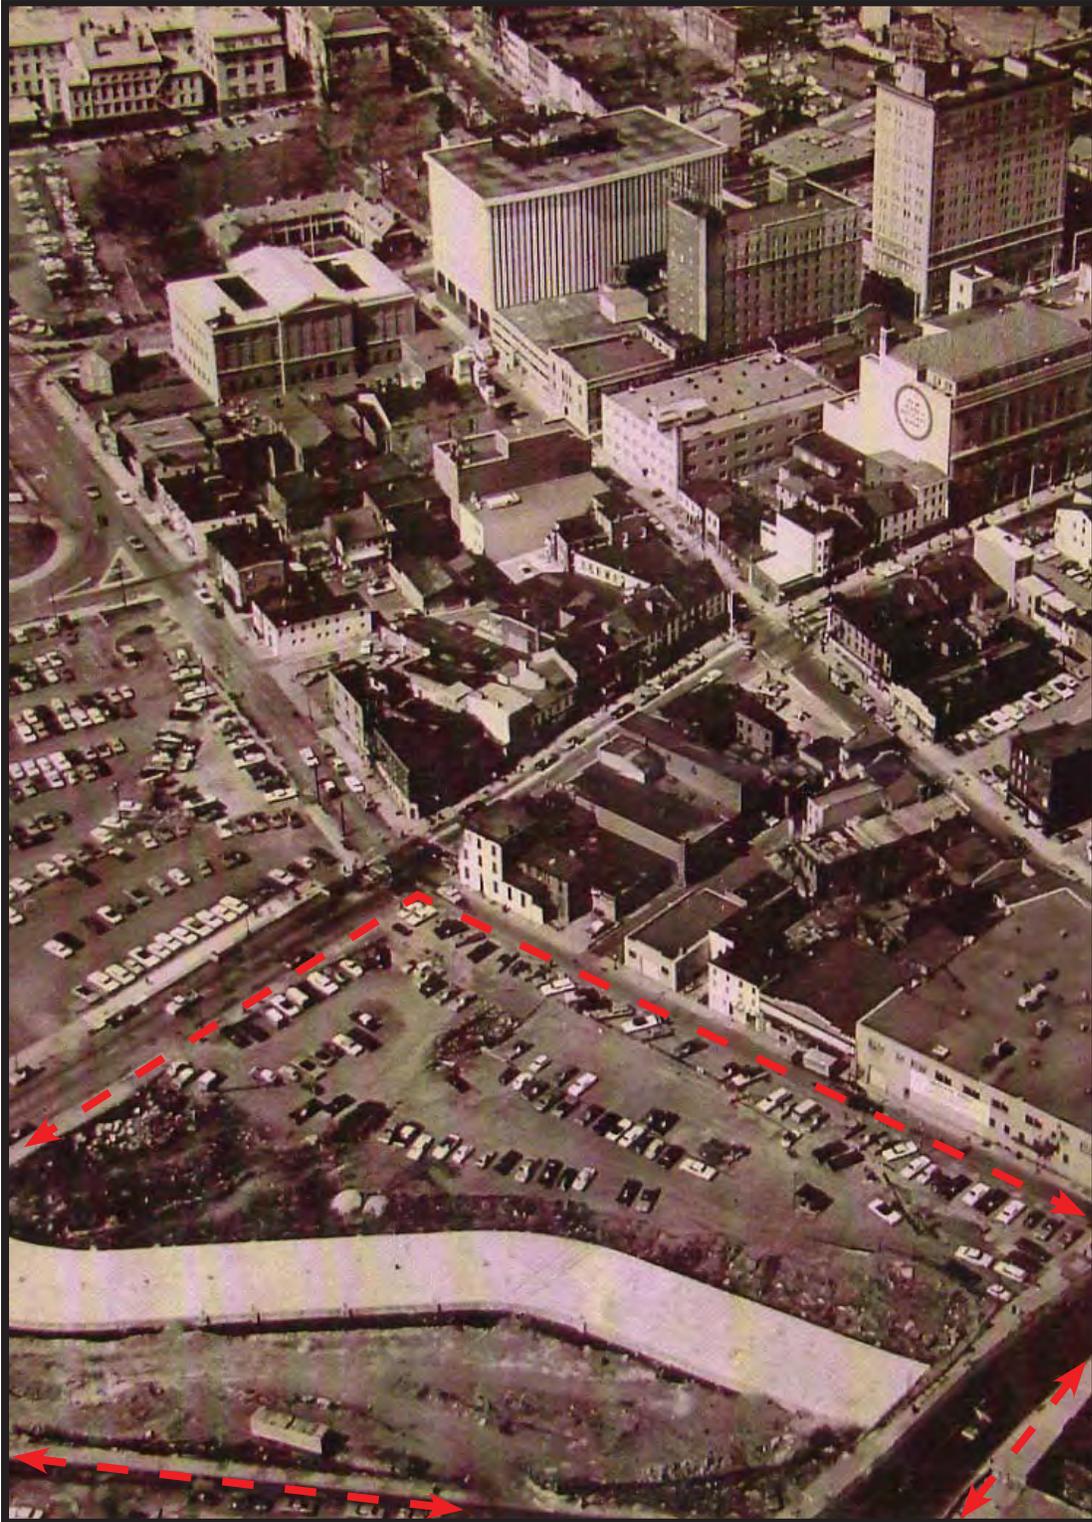
Plate 4.20. Aerial photograph of the Assunpink Creek taken during the construction of the culvert downstream of the South Broad Street Bridge. Circa 1973. Study area outlined. (Source: City of Trenton, Engineering Department).

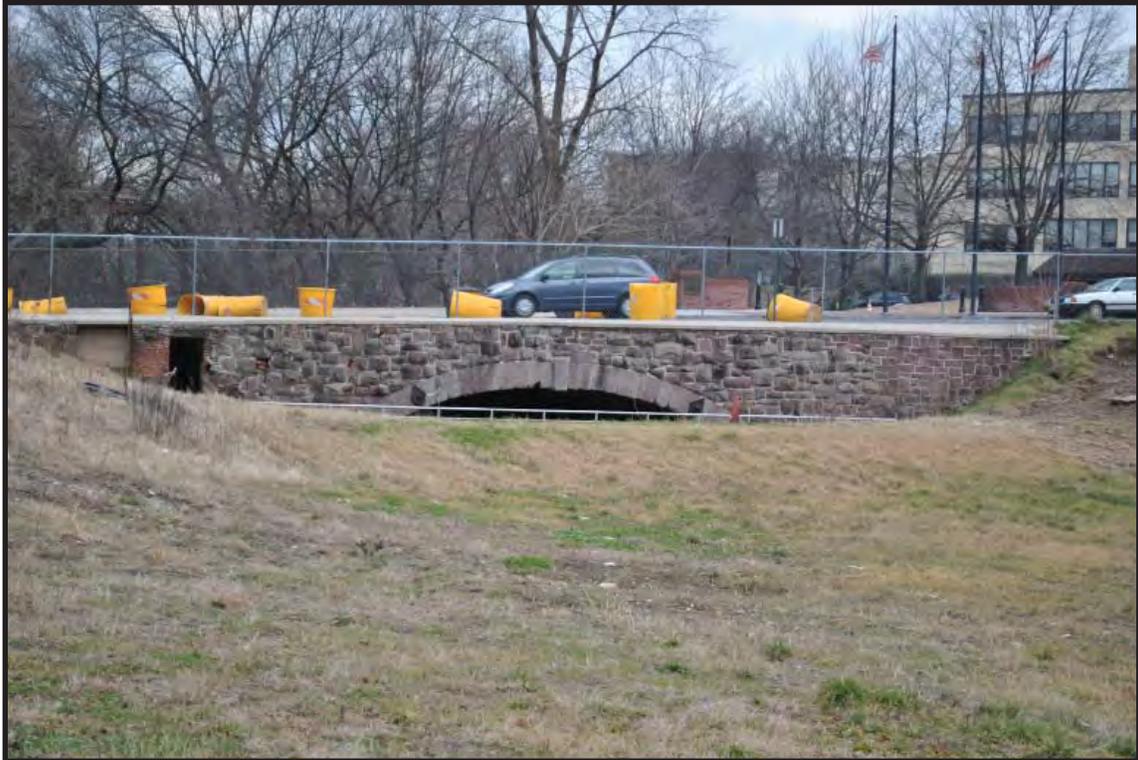
Plate 5.1. View looking east (upstream) from the New Jersey State Department of Human Services office building toward the South Broad Street Bridge. Only the crown of the bridge's northern arch opening is visible above the railing that marks the upstream end of the culvert that carries the Assunpink Creek underground (Photographer: Patrick Harshbarger, January 2012)[HRI Neg.# 10055/D6:008].

The presently visible portion of the South Broad Street Bridge over the Assunpink consists of a 60-foot-wide stone arch that straddles the creek in a 50-foot span (Plate 5.1). The interior height of the arch from the base of the keystone (apex of the vault) to the creek bed is approximately 14 feet. The bridge masonry shows abundant evidence of multiple "builds" and patching. While only 85 feet or so of the length of the bridge is presently visible, the entire structure is estimated to extend for a distance of around 160 feet. Much of the bridge fabric lies concealed beneath the existing roadway and behind the extensive fill that was placed to either side of the creek during the late 1960s or early 1970s when the stretch of the Assunpink between South Broad and South Warren Streets was placed within a culvert.

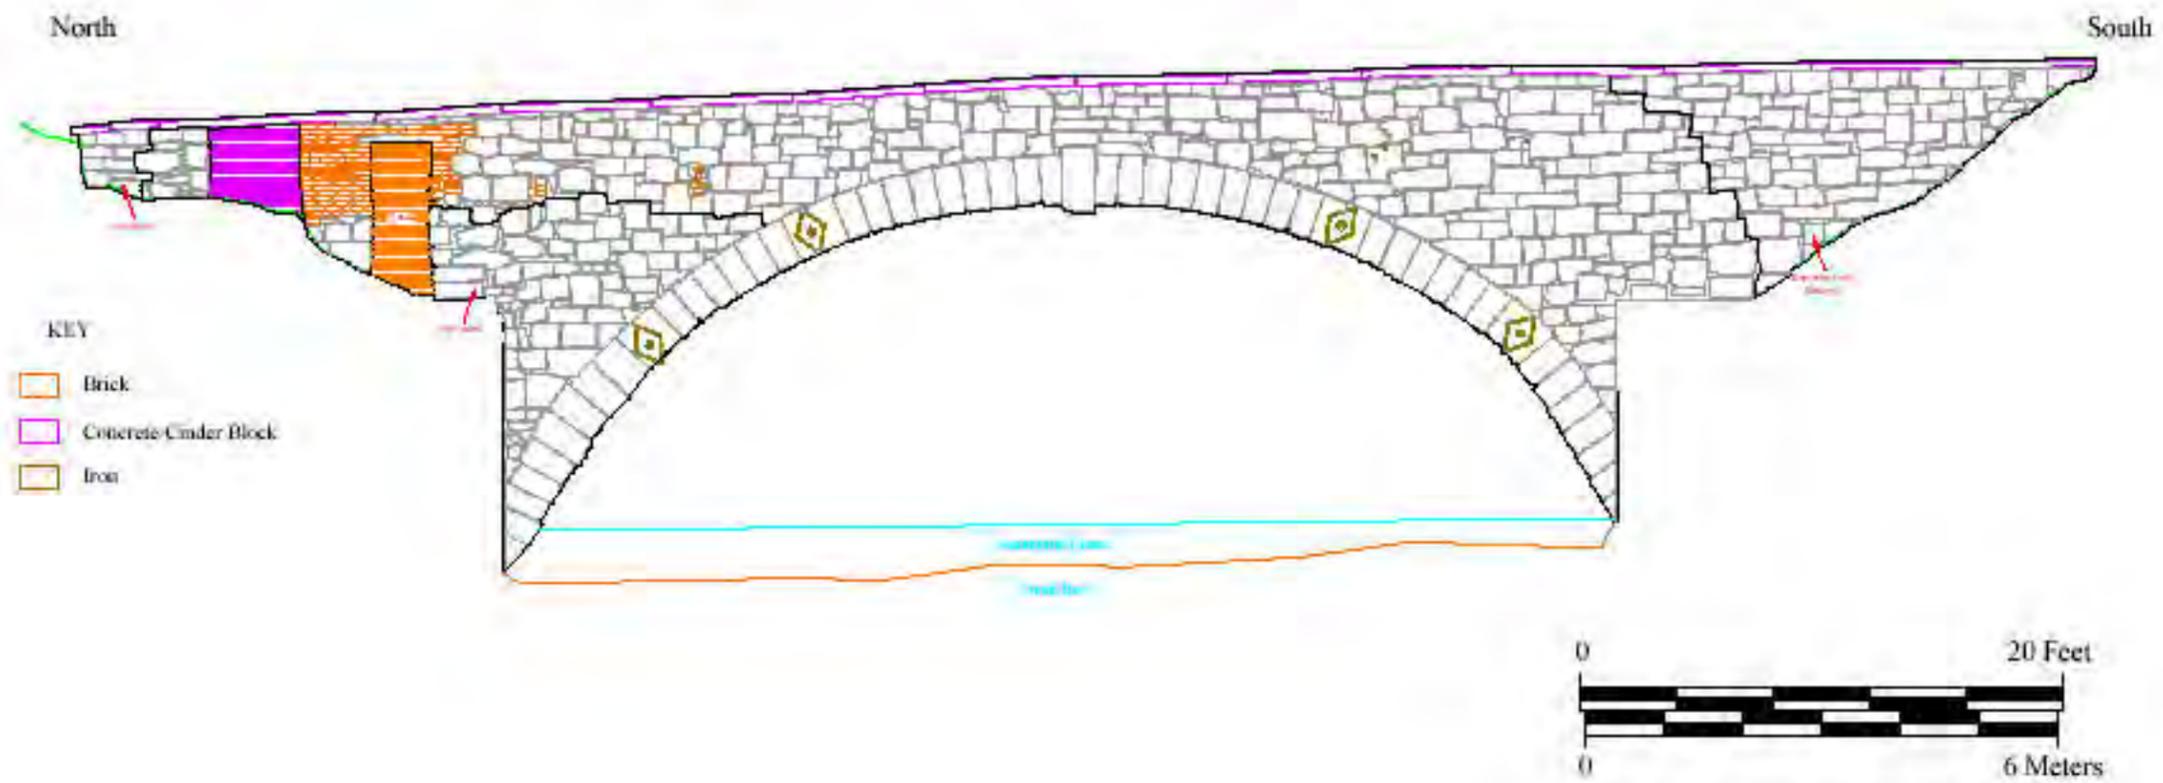
Figure 5.1. South Broad Street Bridge – West (Downstream) Elevation of Northern Arch. Source: Hunter Research, Inc. 2003b.

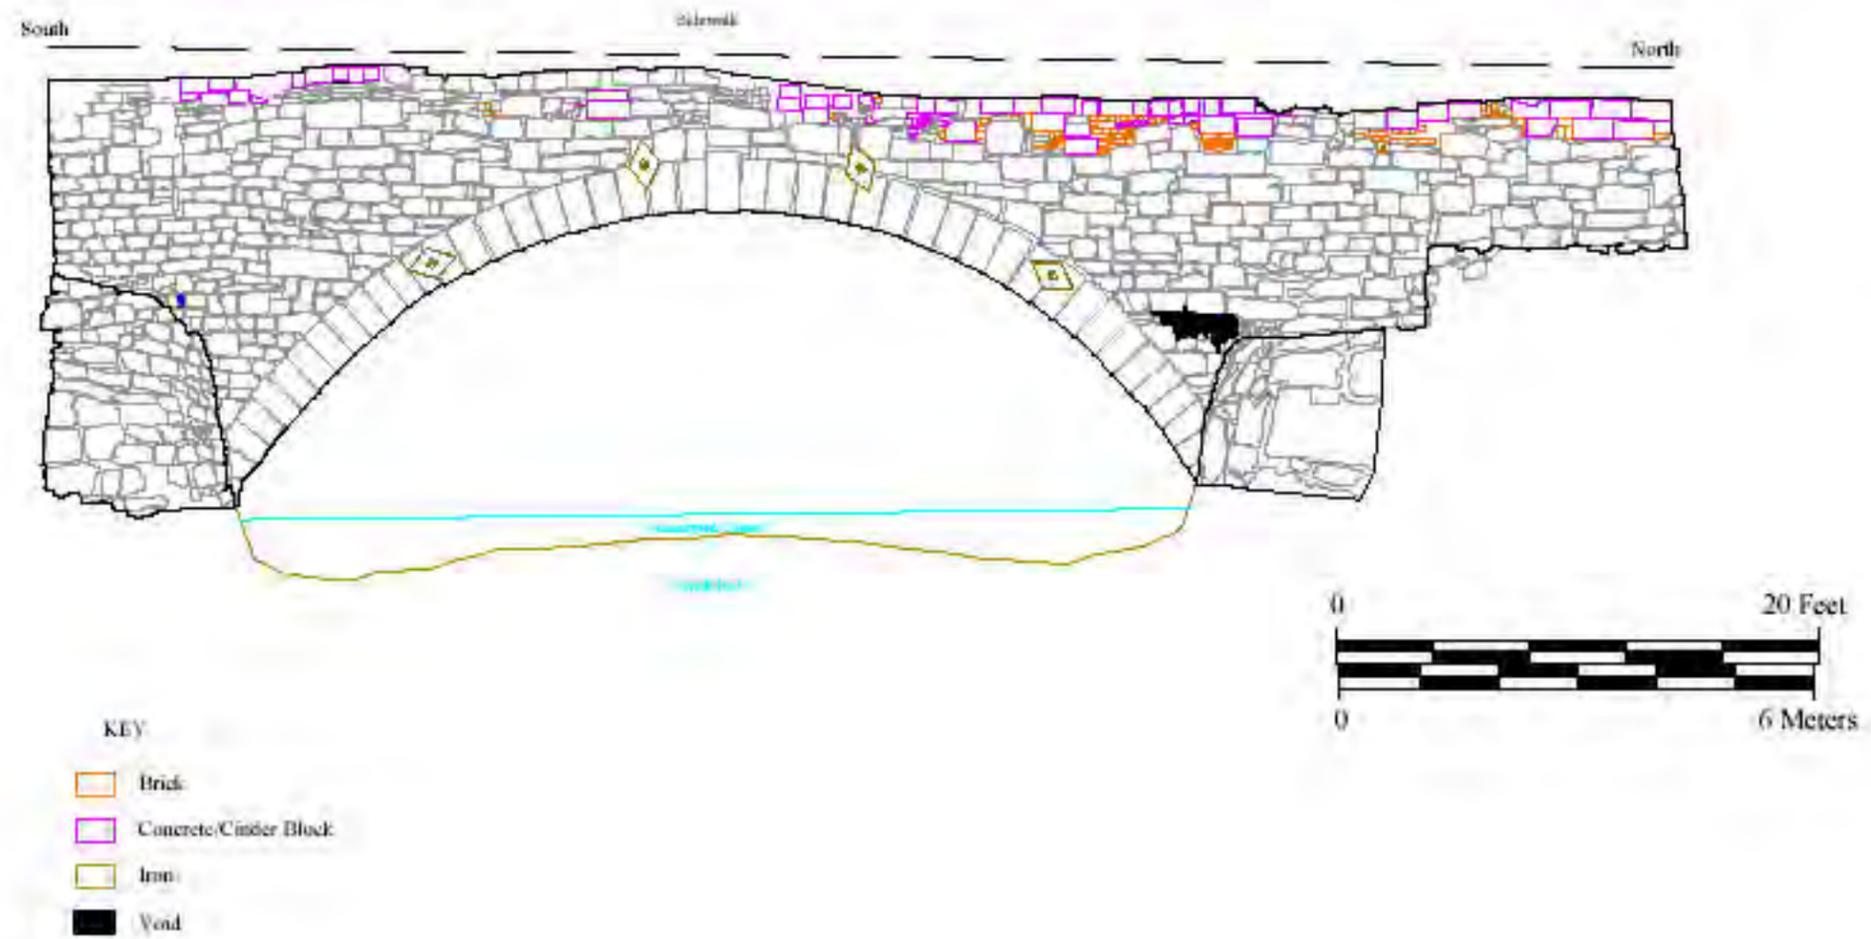
Figure 5.2. South Broad Street Bridge – East (Upstream) Elevation of Northern Arch. Source: Hunter Research, Inc. 2003b.

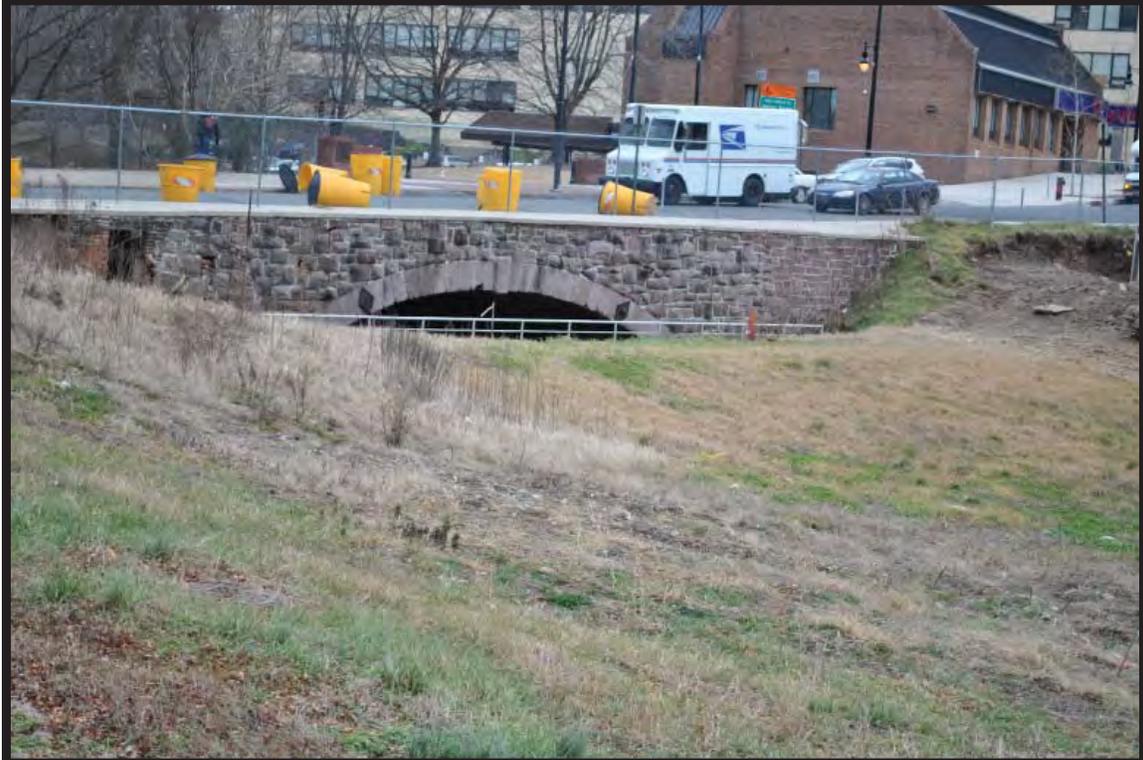
Plate 5.3. View looking southeast from East Lafayette Street at the west (downstream) elevation of the South Broad Street Bridge (Photographer: Patrick Harshbarger, January 2012)[HRI Neg.# 10055/D6:006].

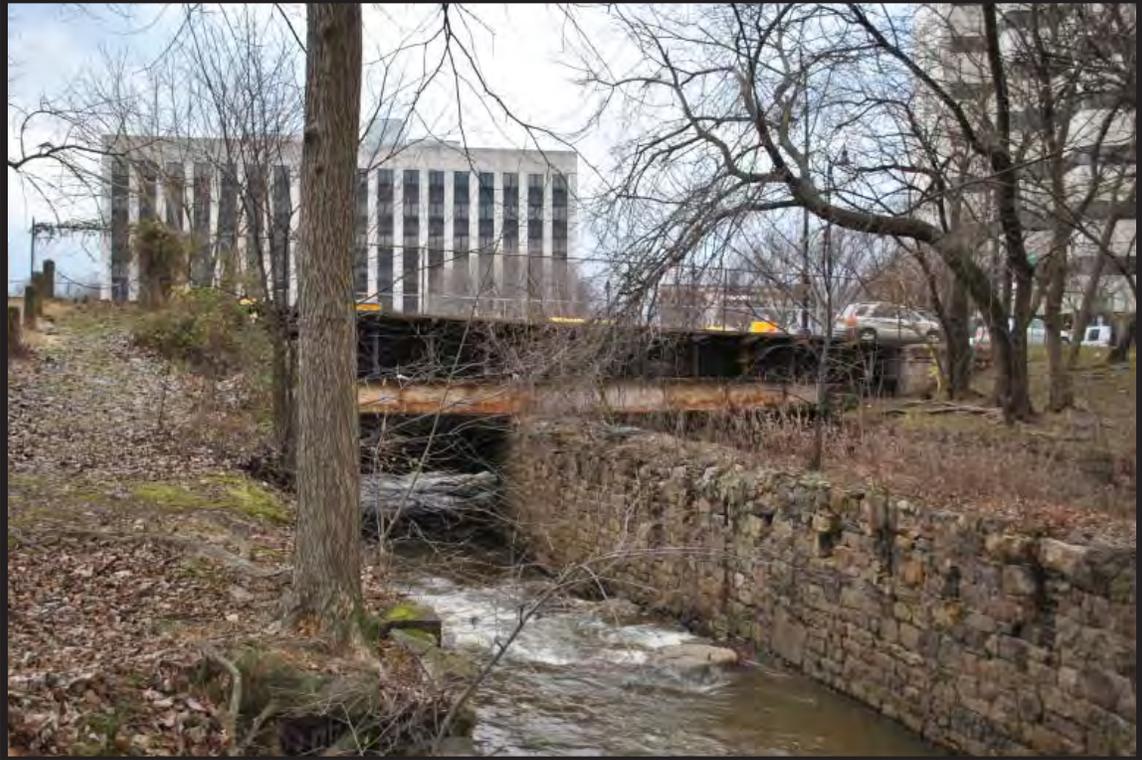
Plate 5.4. View looking west from the south bank of the Assunpink Creek upstream of the South Broad Street Bridge showing the bridge’s east elevation. The stone wall in the stream is a remnant of the foundation of the Assunpink Block (Photographer: Patrick Harshbarger, January 2012)[HRI Neg.# 10055/D6:003].

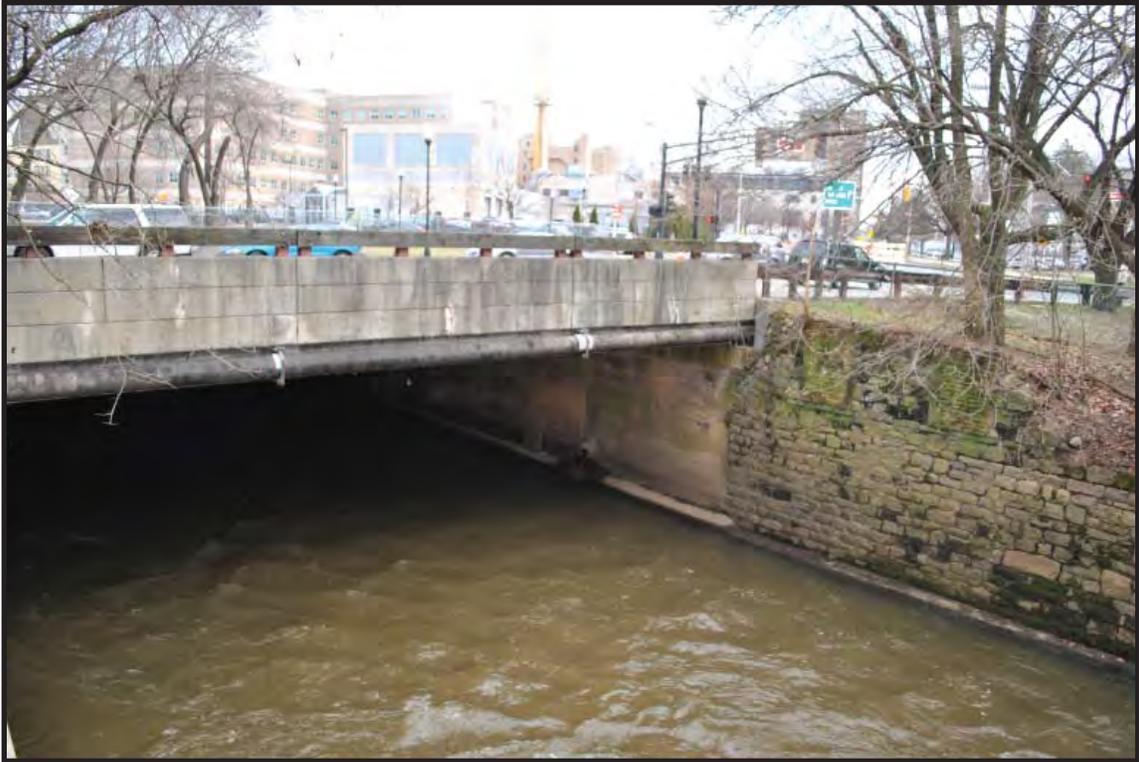
Plate 5.5. View looking southeast from the north bank of the Assunpink Creek west (downstream) of the South Warren Street Bridge showing the bridge’s west elevation (Photographer: Patrick Harshbarger, January 2012)[HRI Neg.# 10055/D6:001].

Reconnaissance-level investigation of the South Warren Street Bridge in 2011 identified the bridge as a modern precast-concrete slab structure, built *circa* 1980. The bridge's clear span is approximately 48 feet, and its out-to-out width is approximately 68 feet. The western (downstream) elevation has a plain slab fascia topped by a blocky concrete parapet with timber handrail (Plate 5.5). Its eastern (upstream) elevation is not visible and abuts the Assunpink Creek culvert and a plaza on the south side of the State of New Jersey's Department of Human Services Building (Plate 5.6). A parapet on the upstream side, similar to the one on the downstream side, separates the sidewalk from the plaza. The bridge is supported on masonry and concrete abutments that are continu-

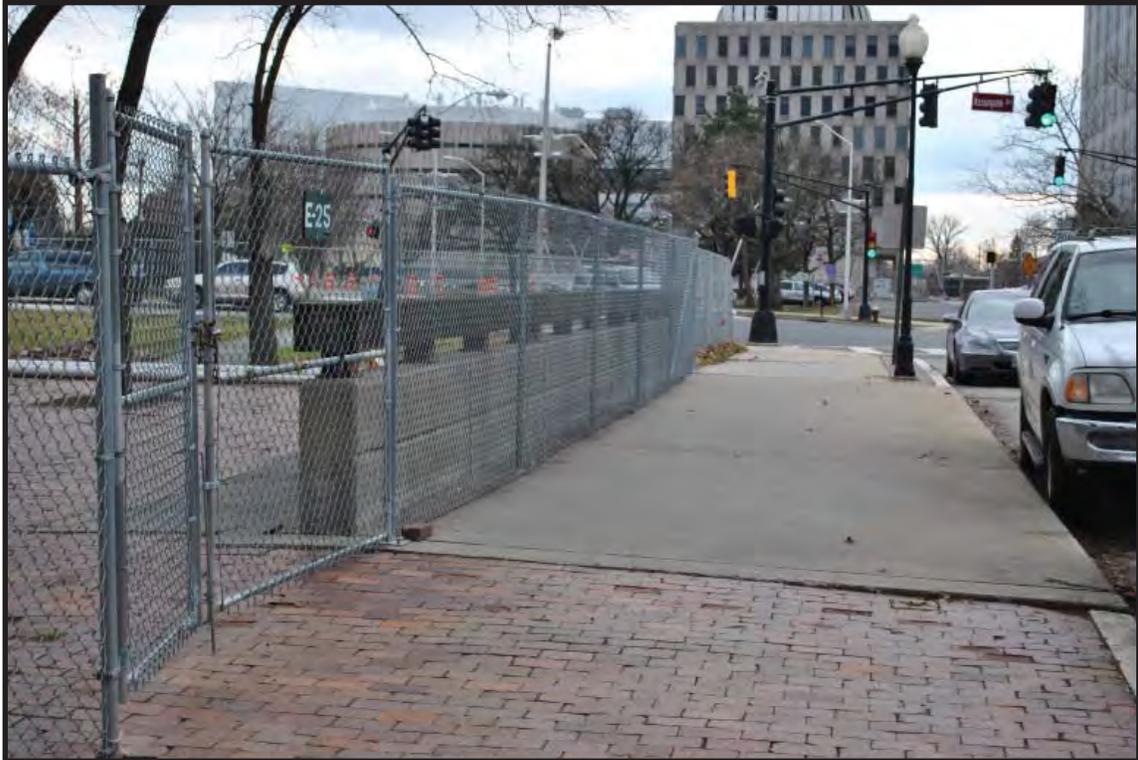
Plate 5.6. View looking south along the east (upstream) side of the South Warren Street Bridge showing the concrete parapet at the interface between the bridge and the plaza built over the creek on the east side of the bridge (Photographer: Patrick Harshbarger, January 2012)[HRI Neg.# 10055/D6:002].

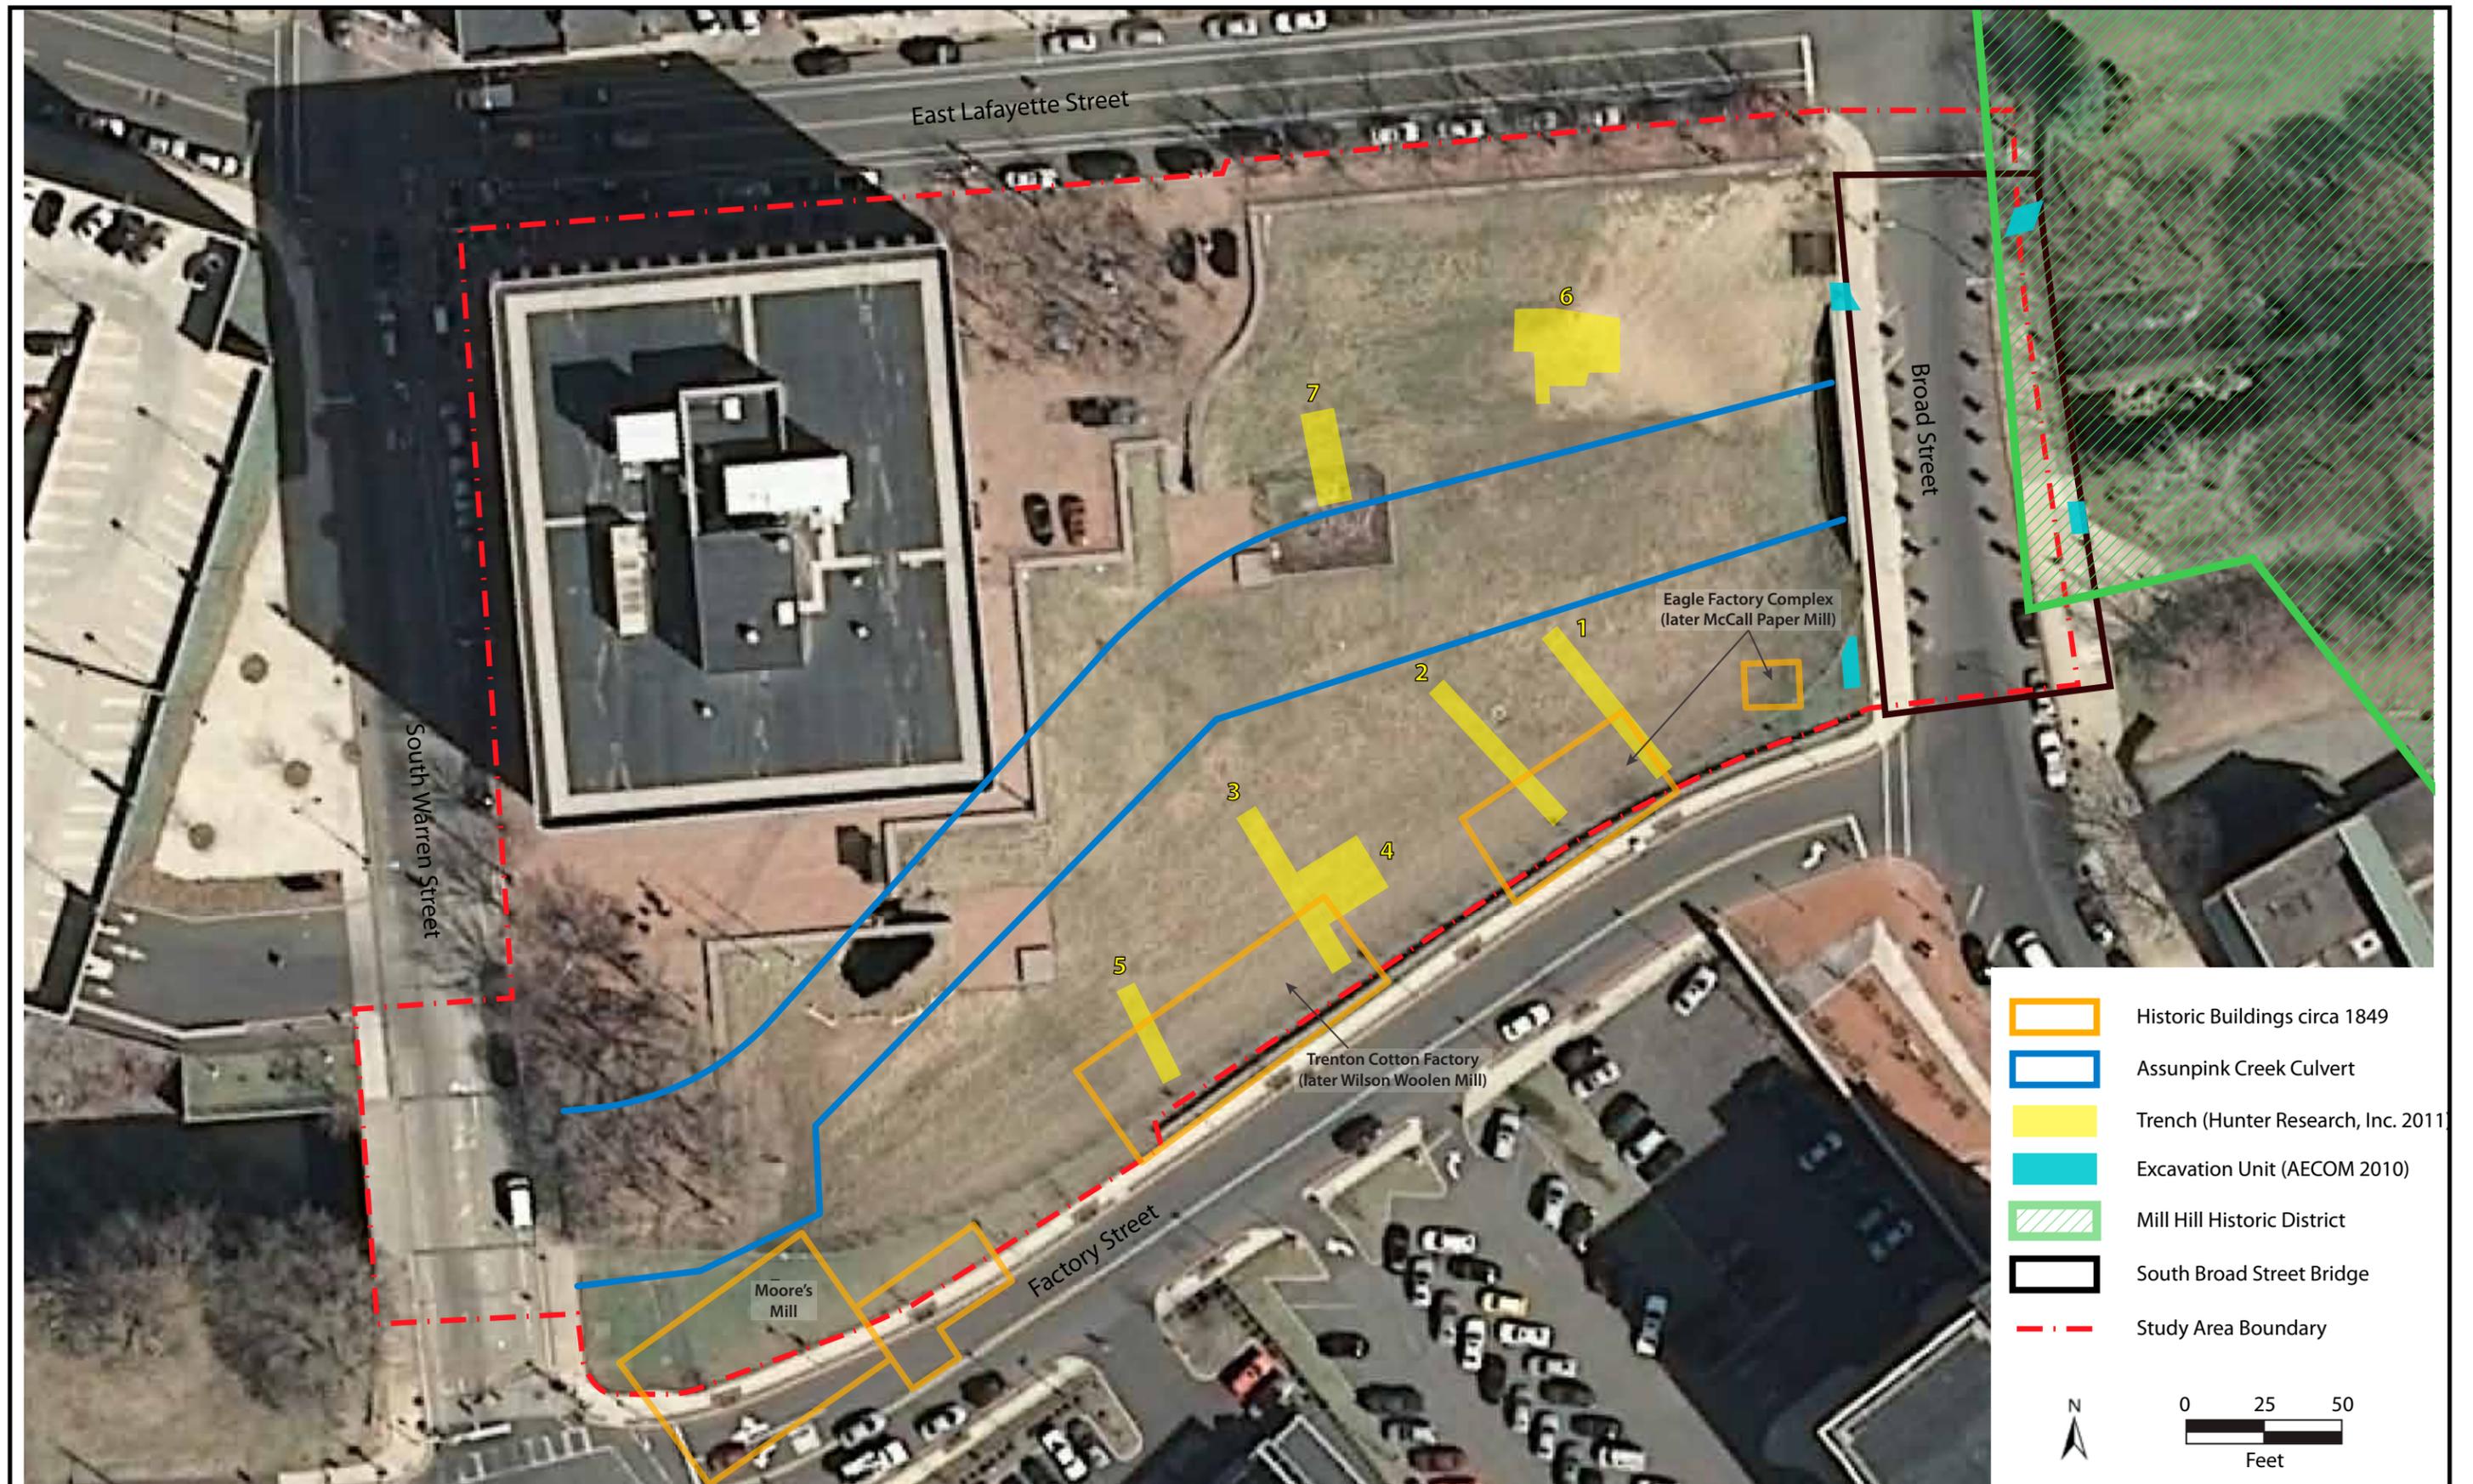
Figure 5.3. Site Plan Showing the Location of Archaeological Test Trenches.

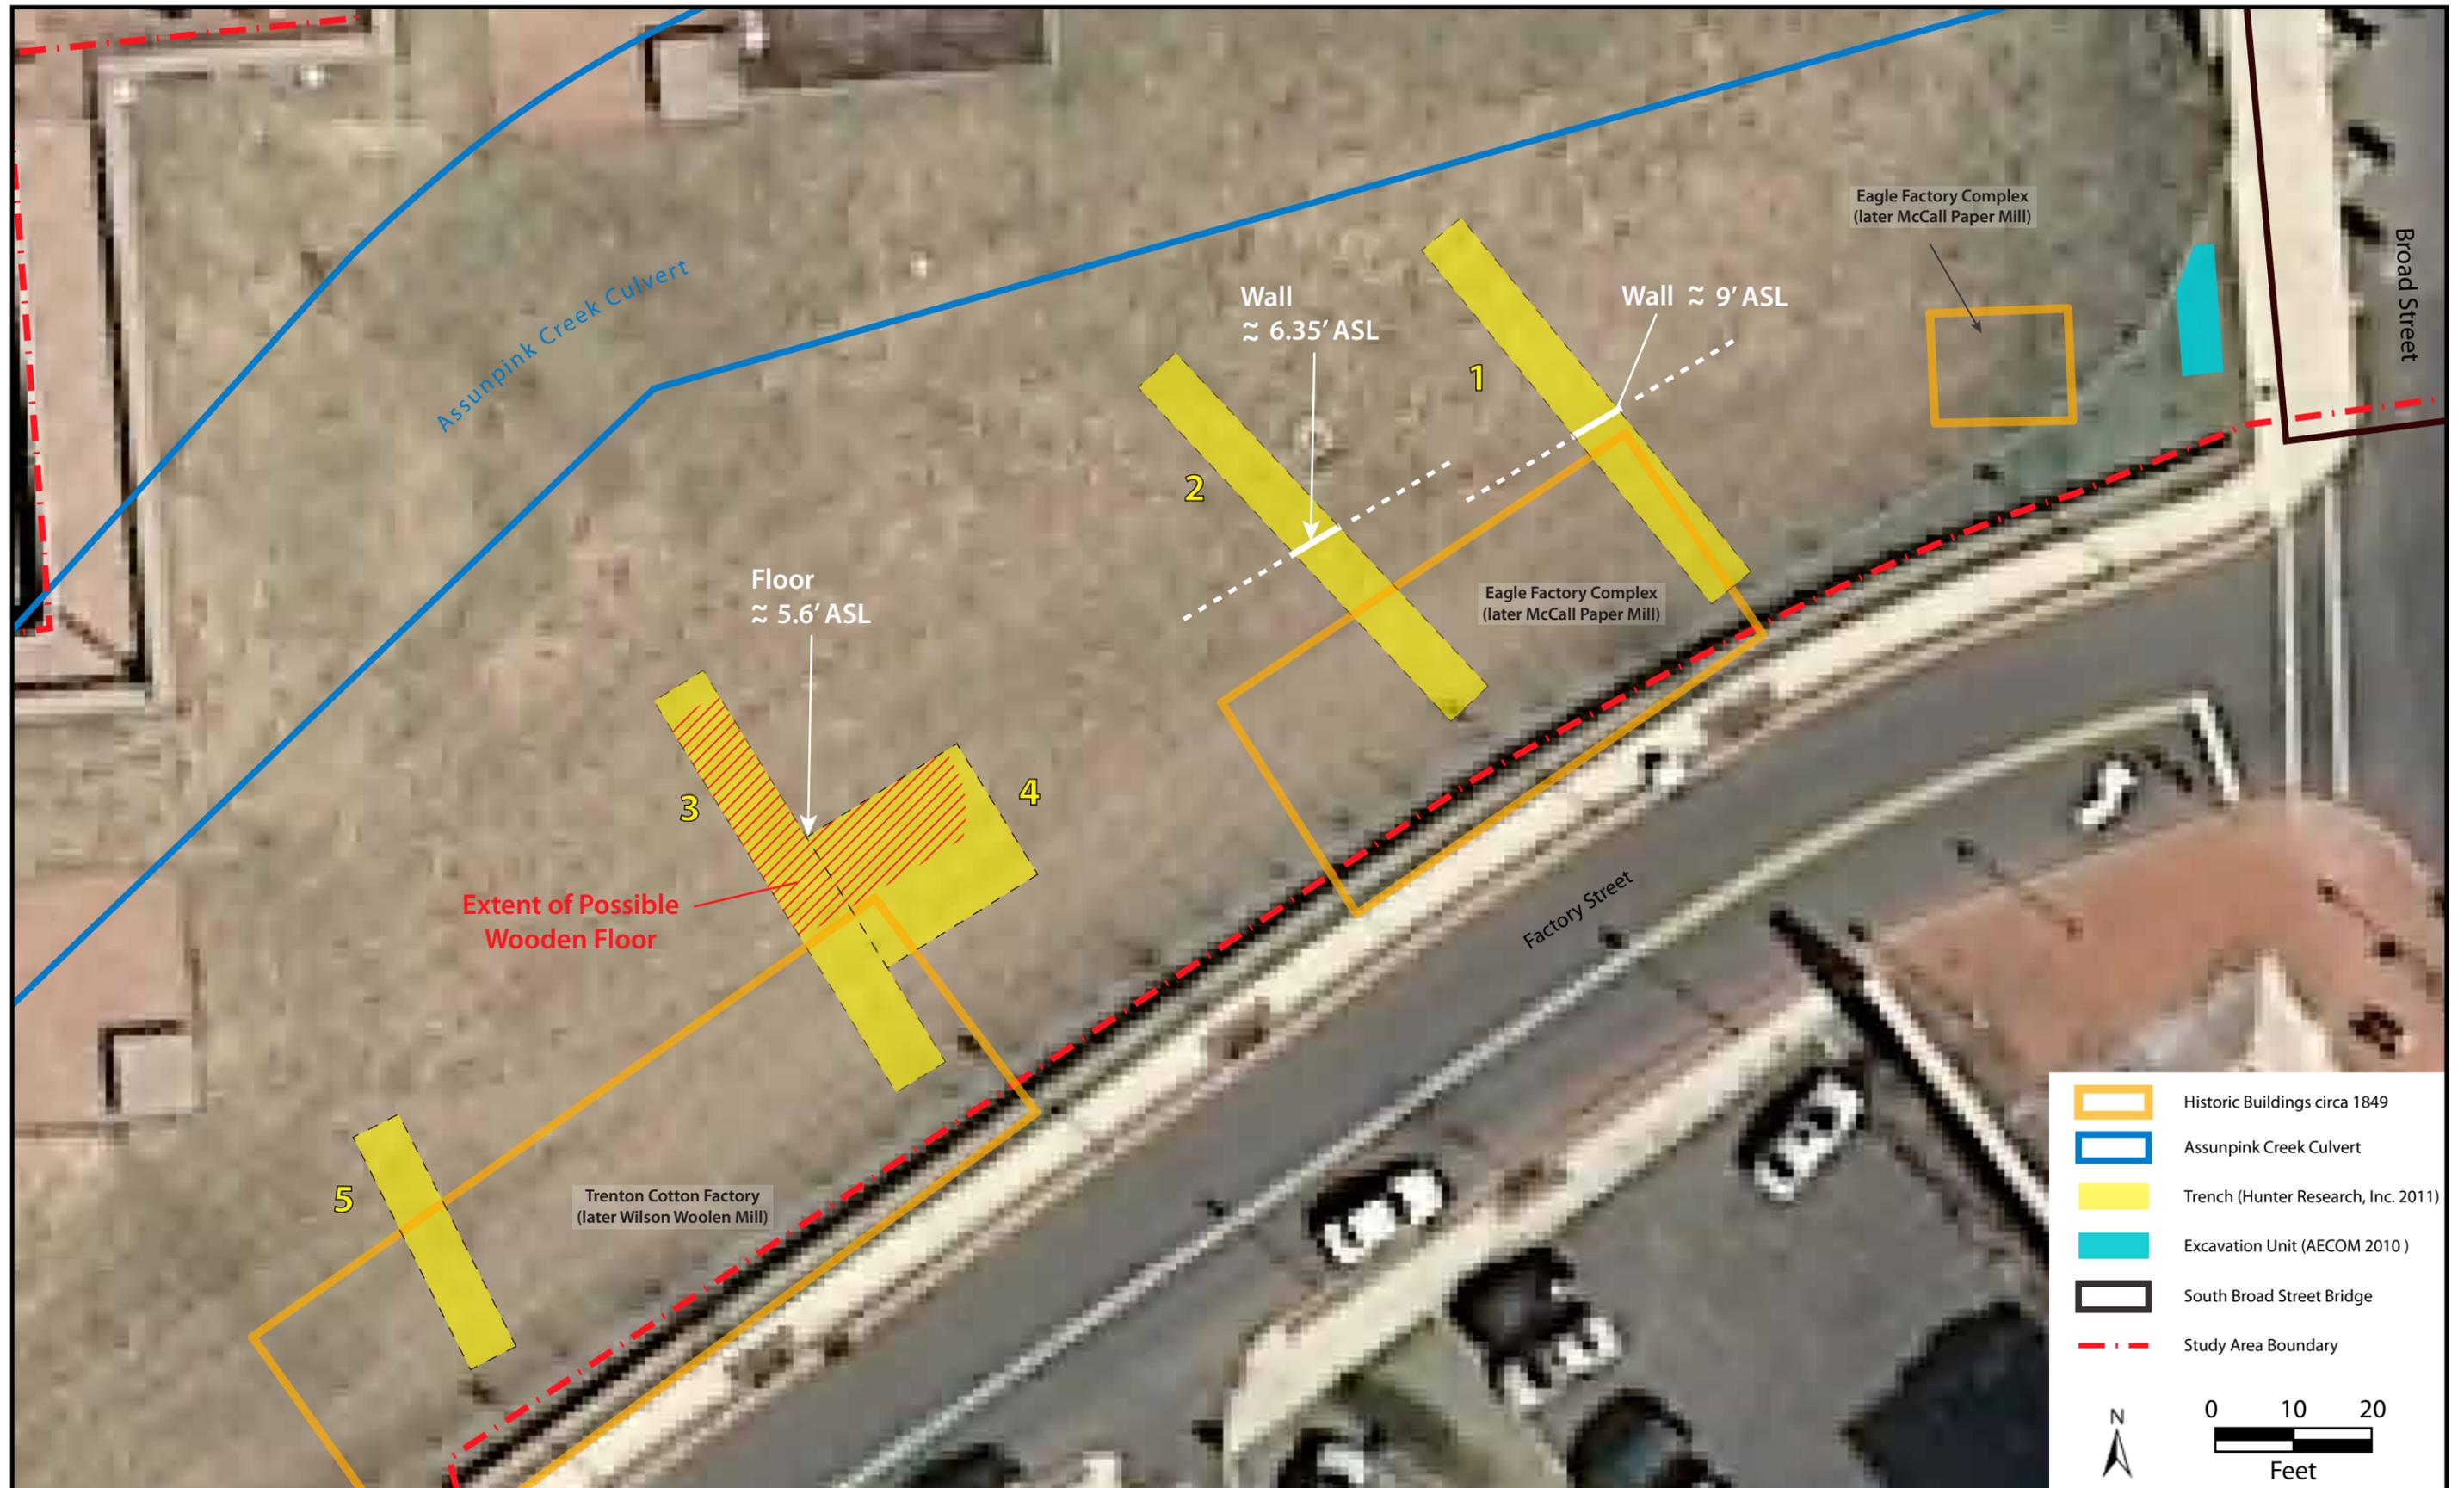
Figure 5.5. Trenches 1, 2, 3 and 4, Plan View.
