COMBINED PHASE I/II ARCHAEOLOGICAL SURVEY
ASSUNPINK CREEK RESTORATION
CITY OF TRENTON, MERCER COUNTY, NEW JERSEY

TECHNICAL REPORT

U.S. ARMY CORPS OF ENGINEERS, PHILADELPHIA DISTRICT
CITY OF TRENTON

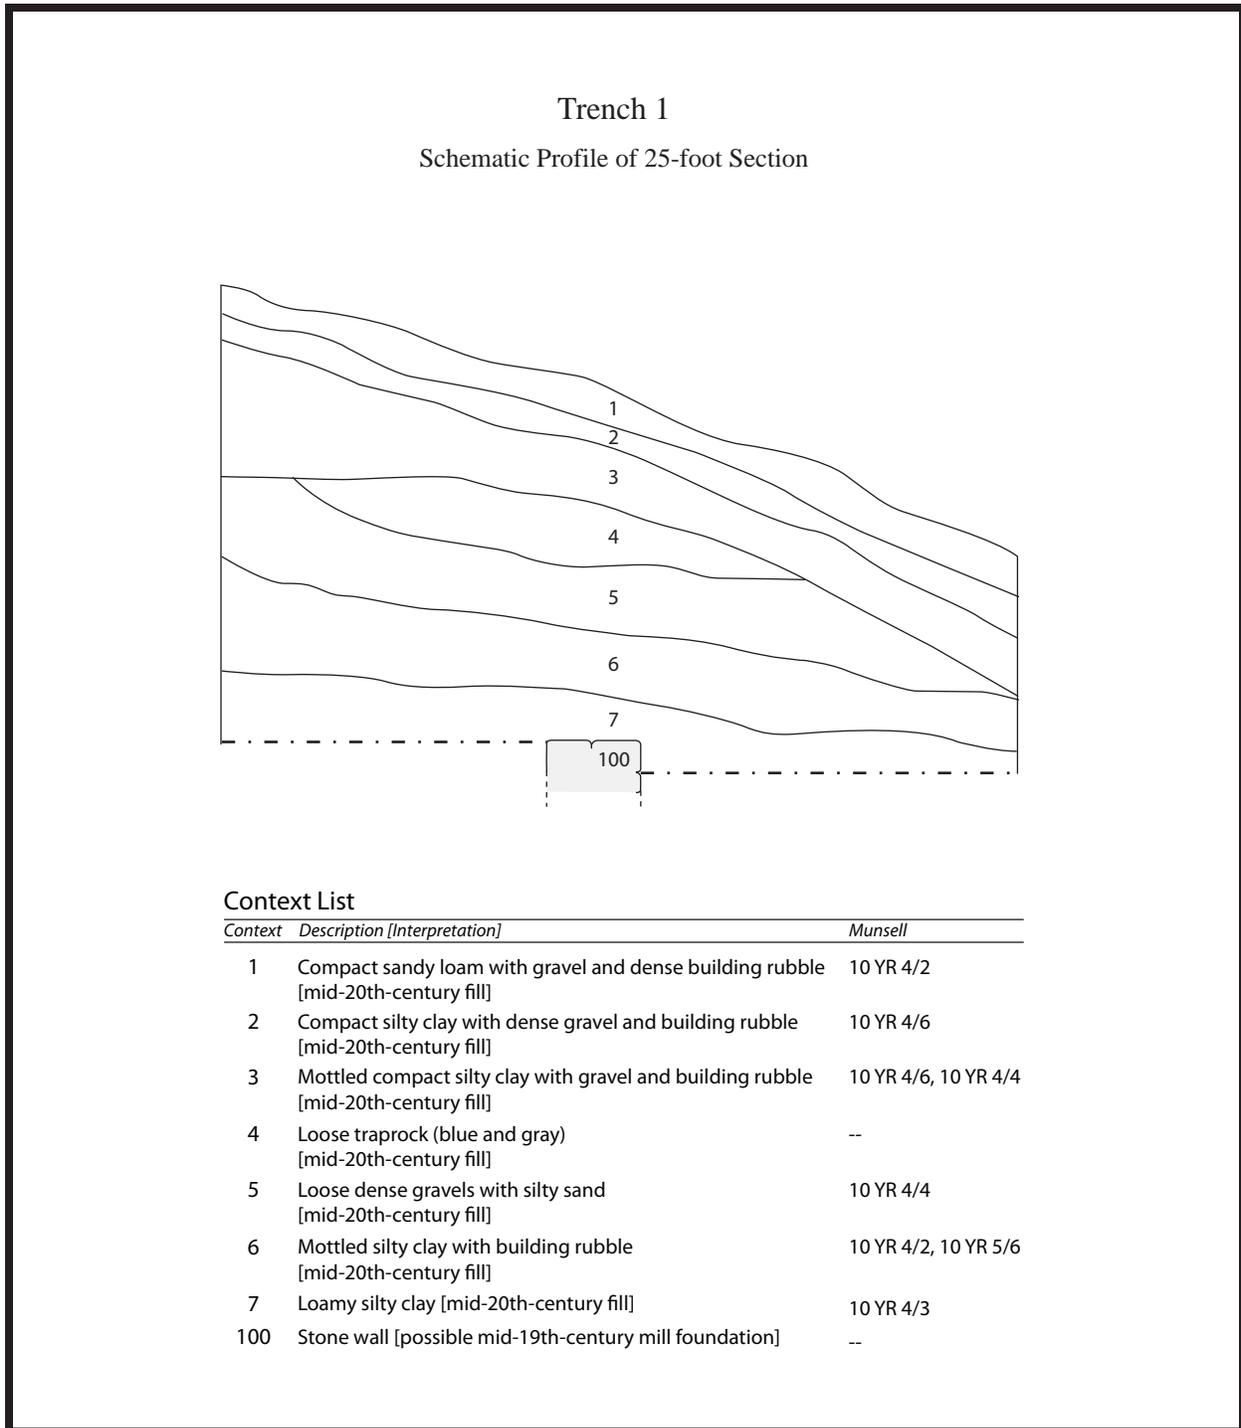
Figure 5.4. Trench 1, Schematic Profile.

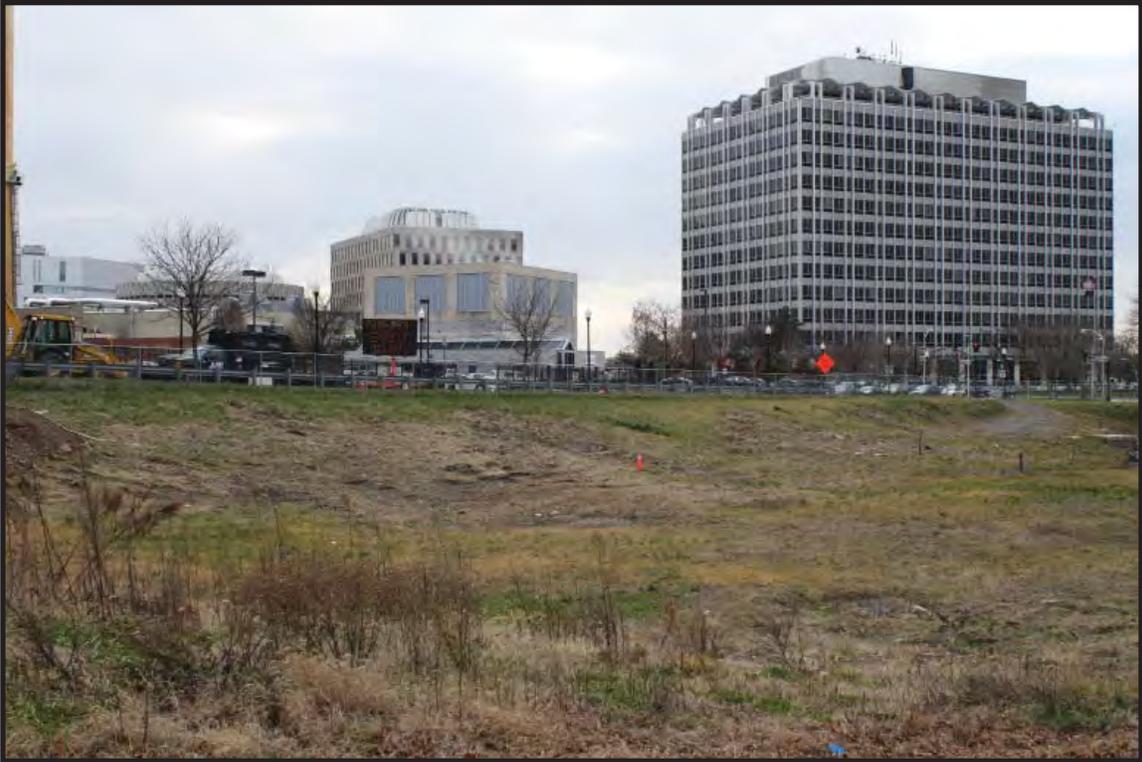
Plate 5.7. View looking southwest showing the project site south of the Assunpink Creek culvert. Trench locations indicated with arrows (Photographer: James Lee, January 2012)[HRI Neg.#10055/D6:025].

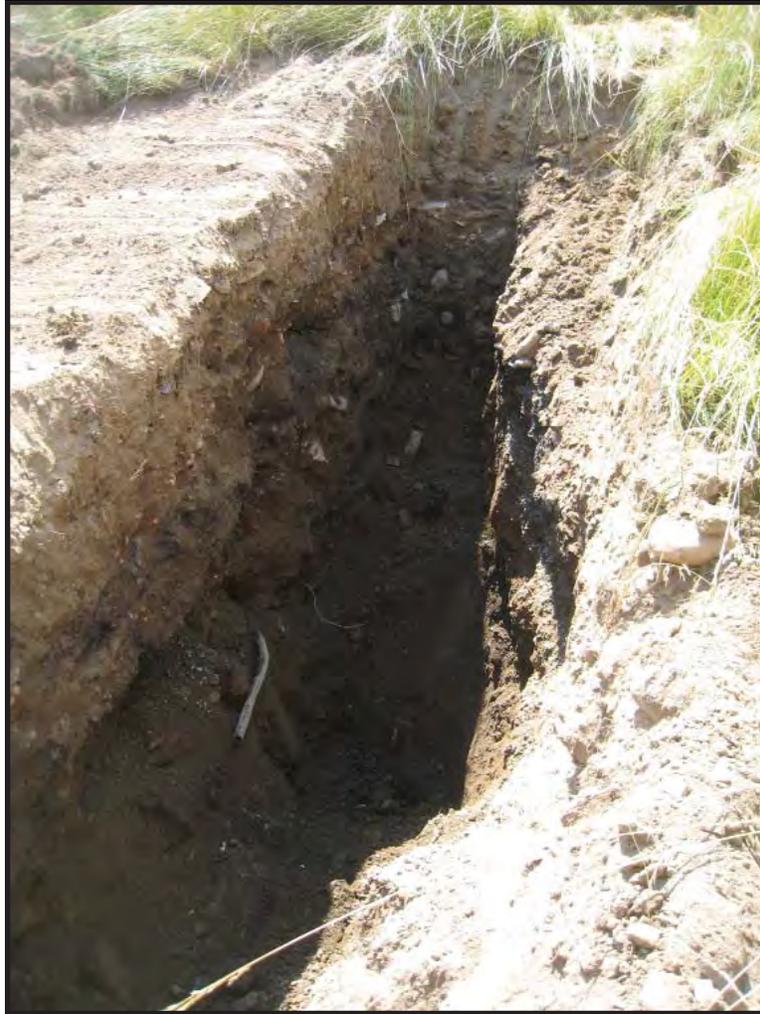
Plate 5.8. View looking south showing Excavation of Trench 1 in progress (Photographer: James Lee, July 2011)[HRI Neg.#10055/D3:005].

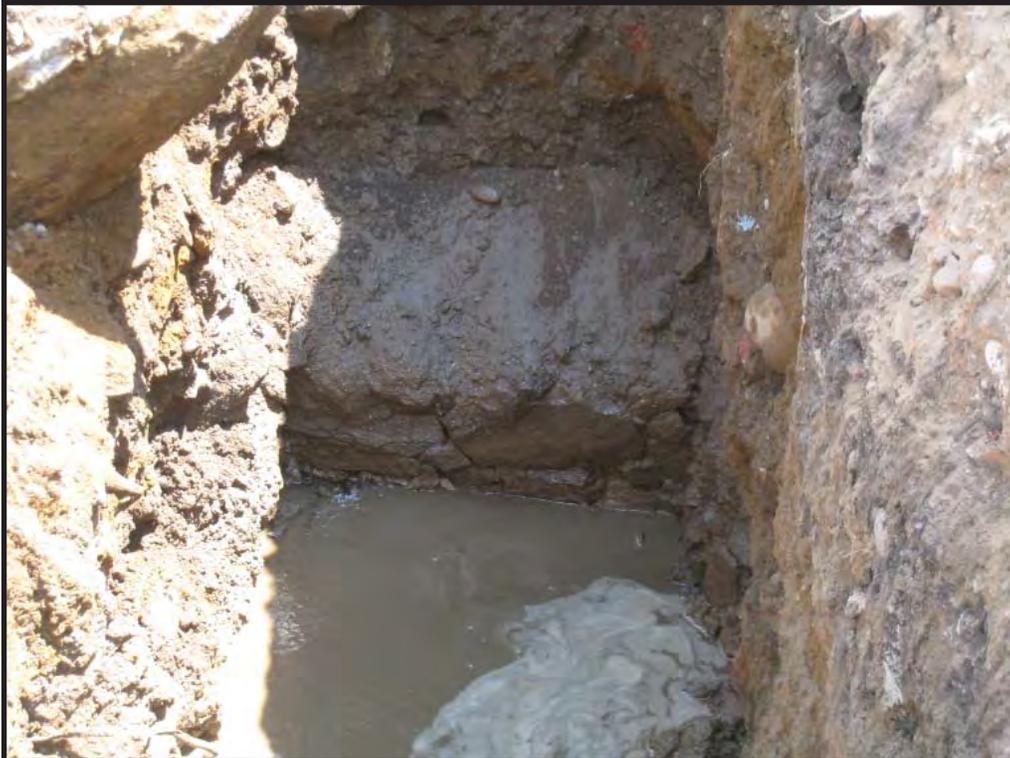
Plate 5.9. View looking south showing the wall identified at the base of Trench 1 (Photographer: James Lee, July 2011)[HRI Neg.#10055/D3:021].

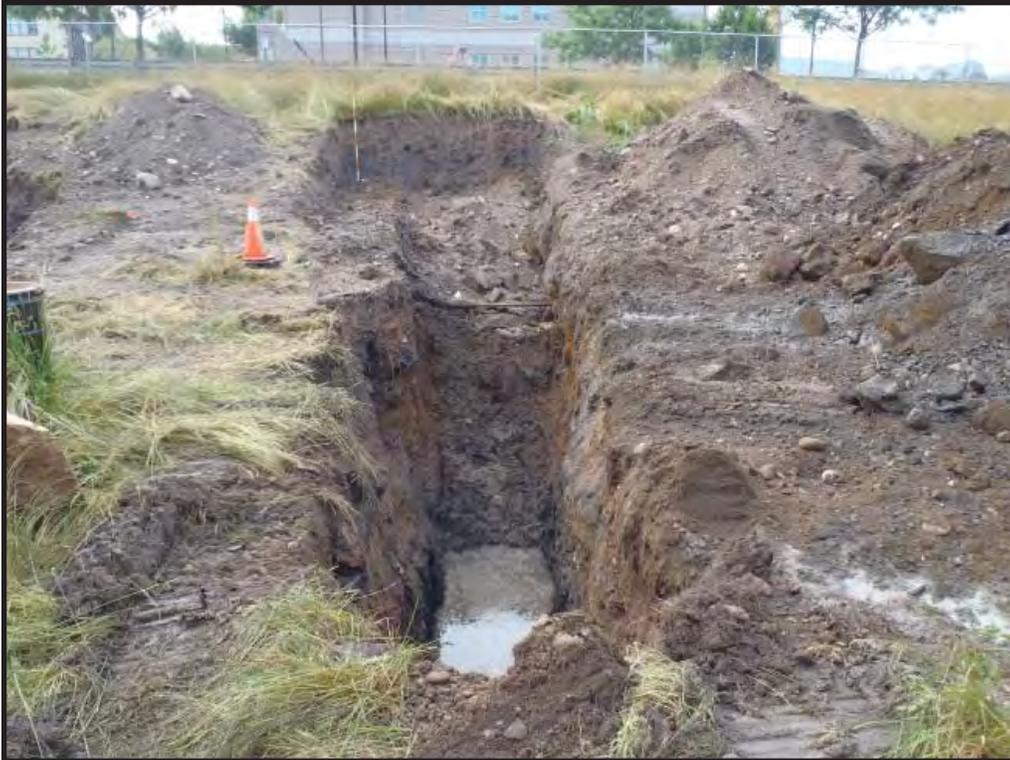
Plate 5.10. View looking south showing Trench 2. The southern section of the trench was partially backfilled due to a collapse during excavation. Scale in feet (Photographer: Andrew Martin, July 2011)[HRI Neg.#10055/D1:020].

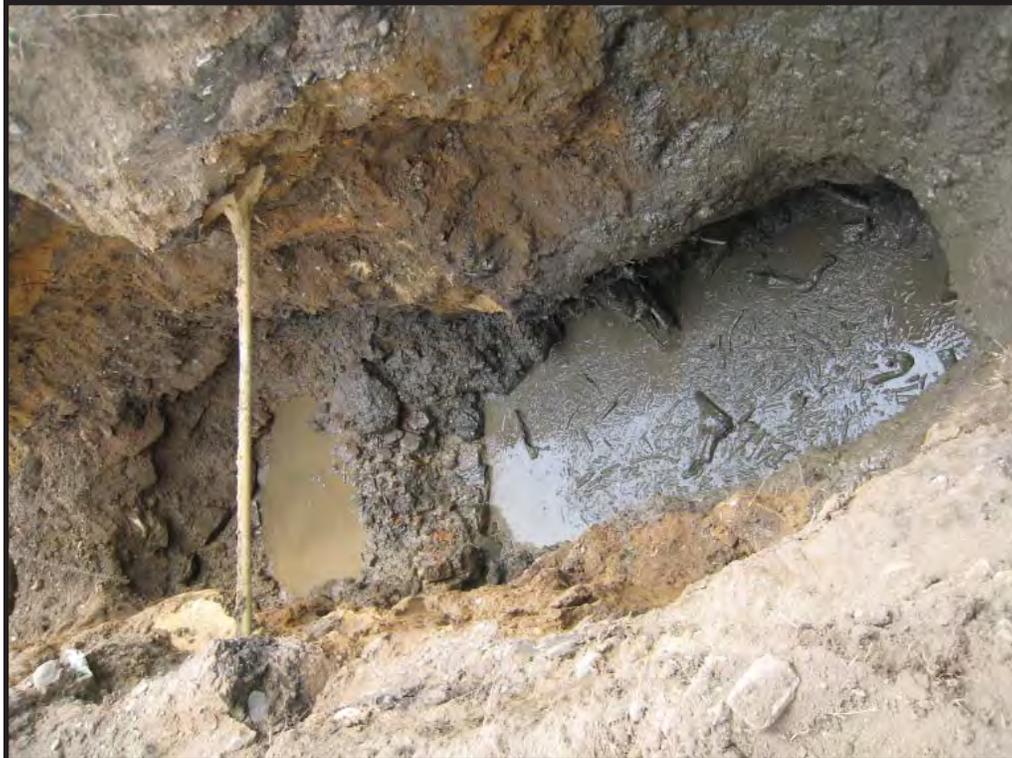
Plate 5.11. View looking south showing the wall identified at the base of Trench 2. Note the mass of sticks and branches in a dark silty context north of the wall (Photographer: James Lee, July 2011)[HRI Neg.#10055/D3:044].

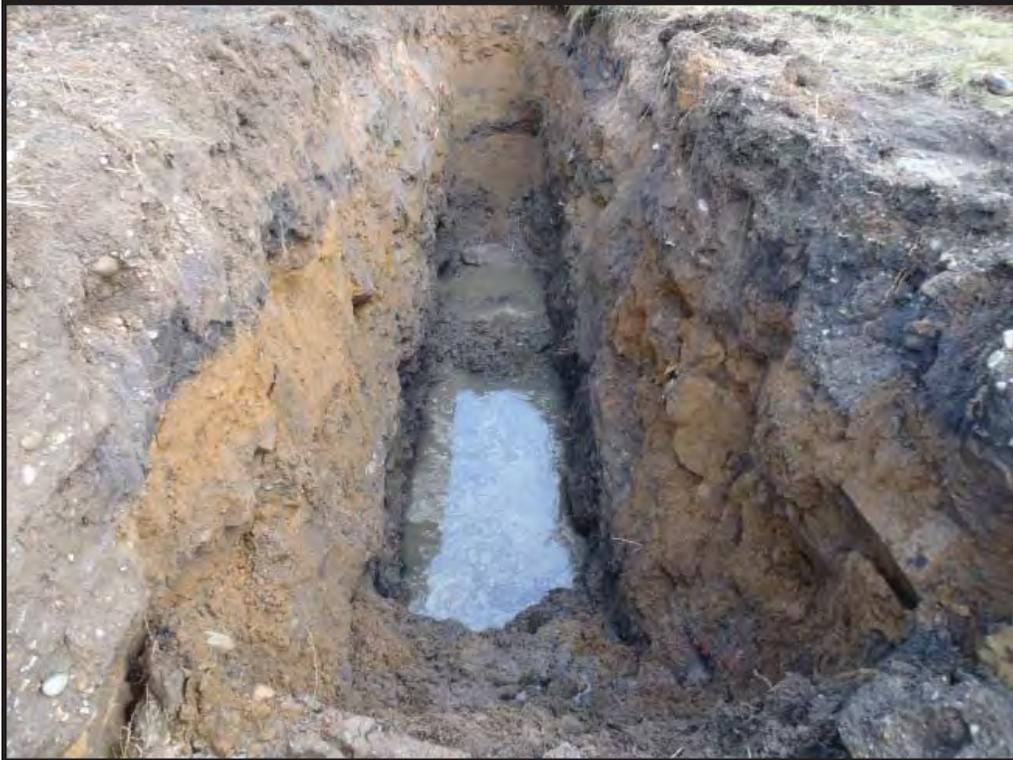
Plate 5.12. View looking north showing Trench 3. Slumping sidewalls and water infiltration prevented the entire trench from being left open during the course of excavation (Photographer: Andrew Martin, July 2011)[HRI Neg.#10055/D1:031].

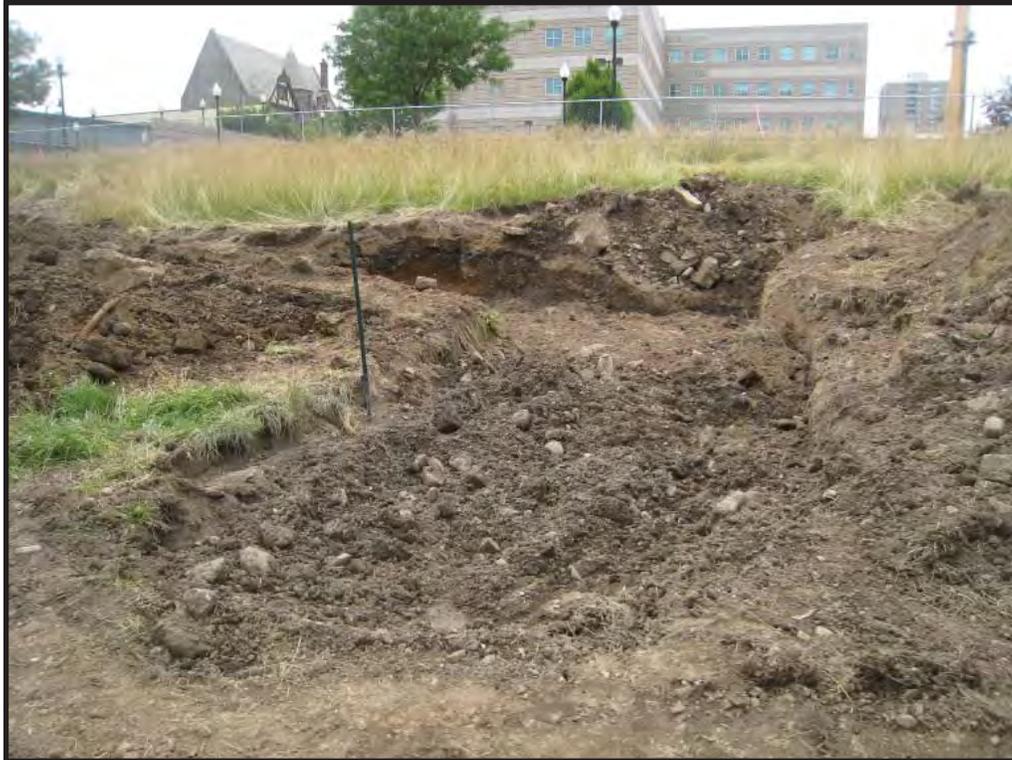
Plate 5.13. View looking south showing Trench 3 and Trench 4, extending to the east from the mid-section of Trench 3. Slumping sidewalls and water infiltration required the rapid refilling of the trenches (Photographer: James Lee, July 2011)[HRI Neg.#10055/D3:062].

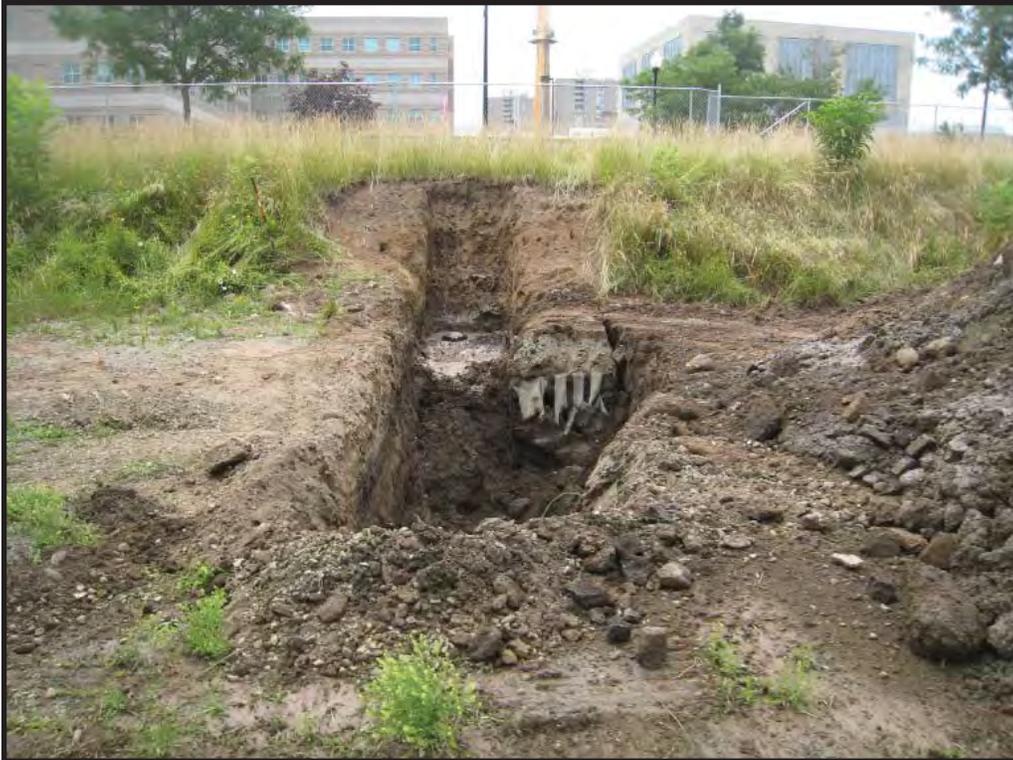
Plate 5.14. View looking south showing Trench 5. Note the section of trench wall breaking away (Photographer: James Lee, July 2011)[HRI Neg.#10055/D3:067].

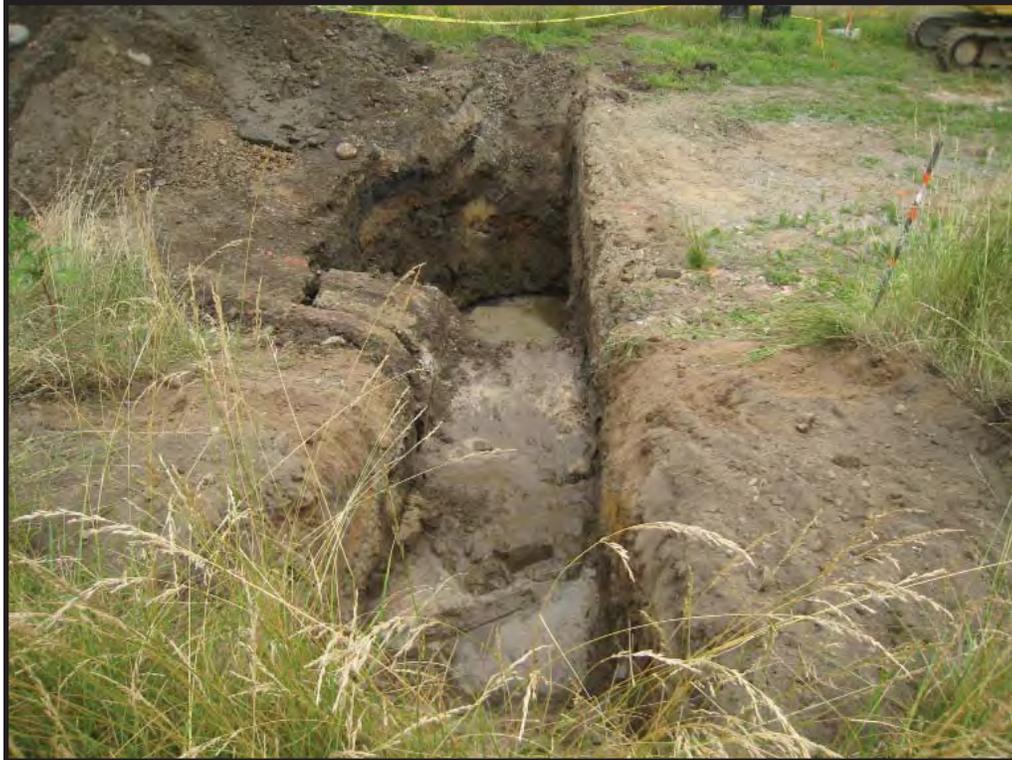
Plate 5.15. View looking north showing Trench 5. Unstable trench walls made approaching the excavation for documentation difficult (Photographer: James Lee, July 2011)[HRI Neg.#10055/D3:070].

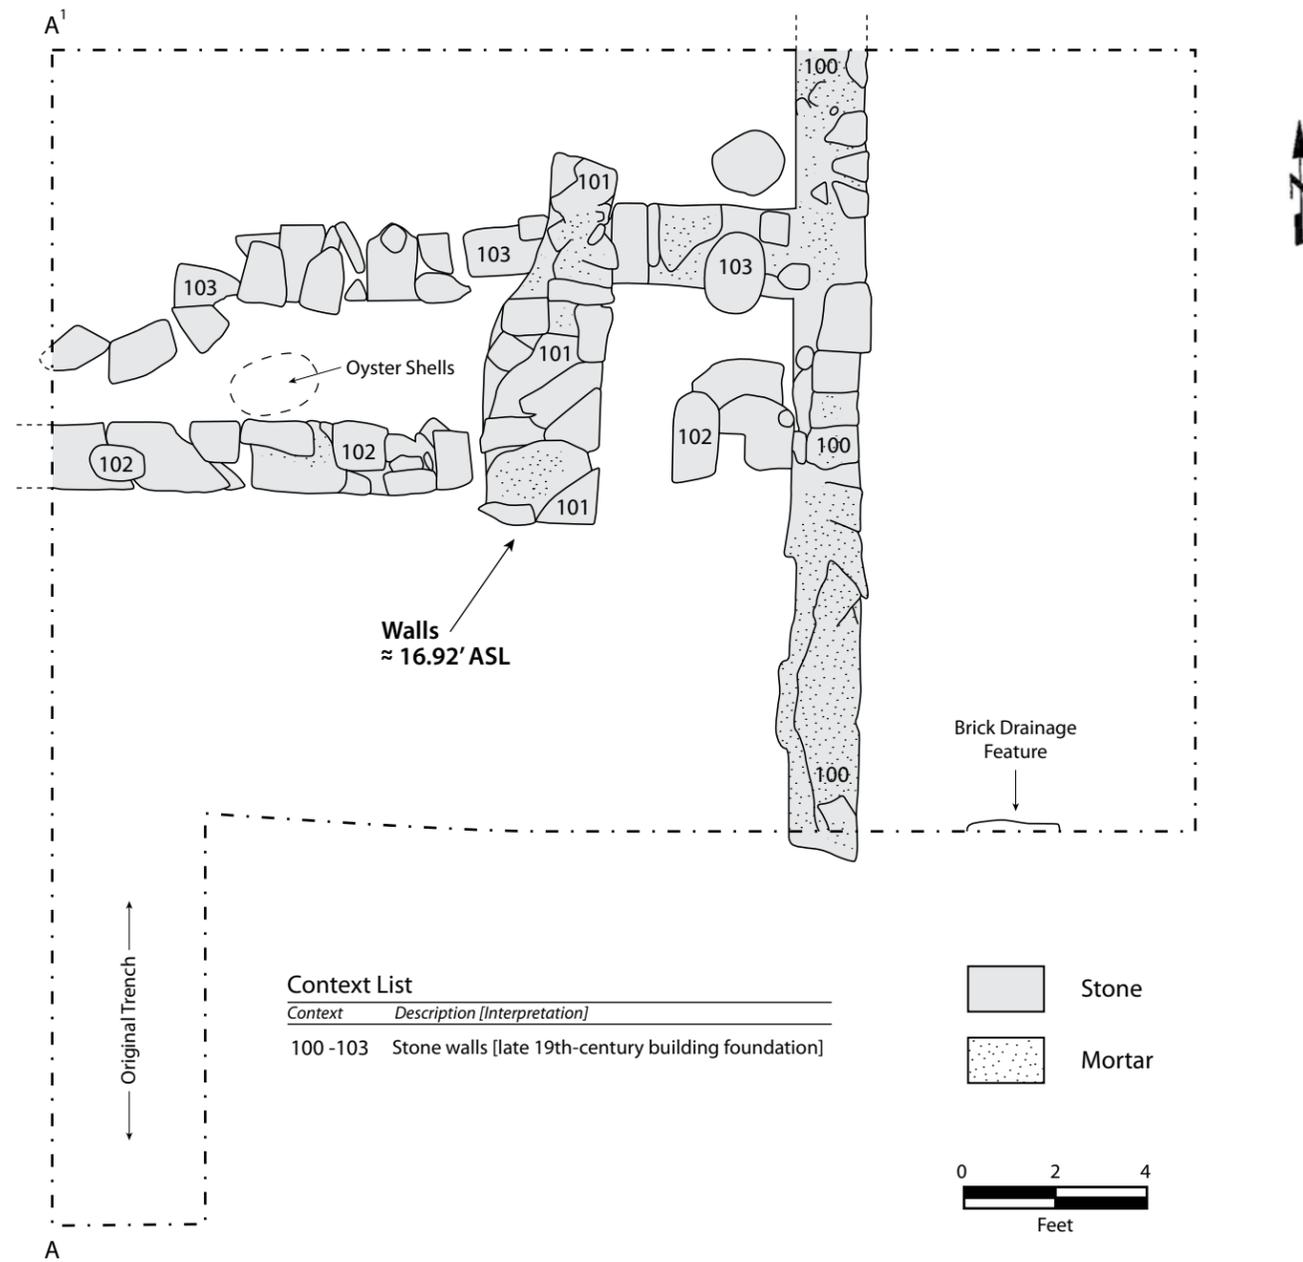
Figure 5.6. Trench 6, Plan View.

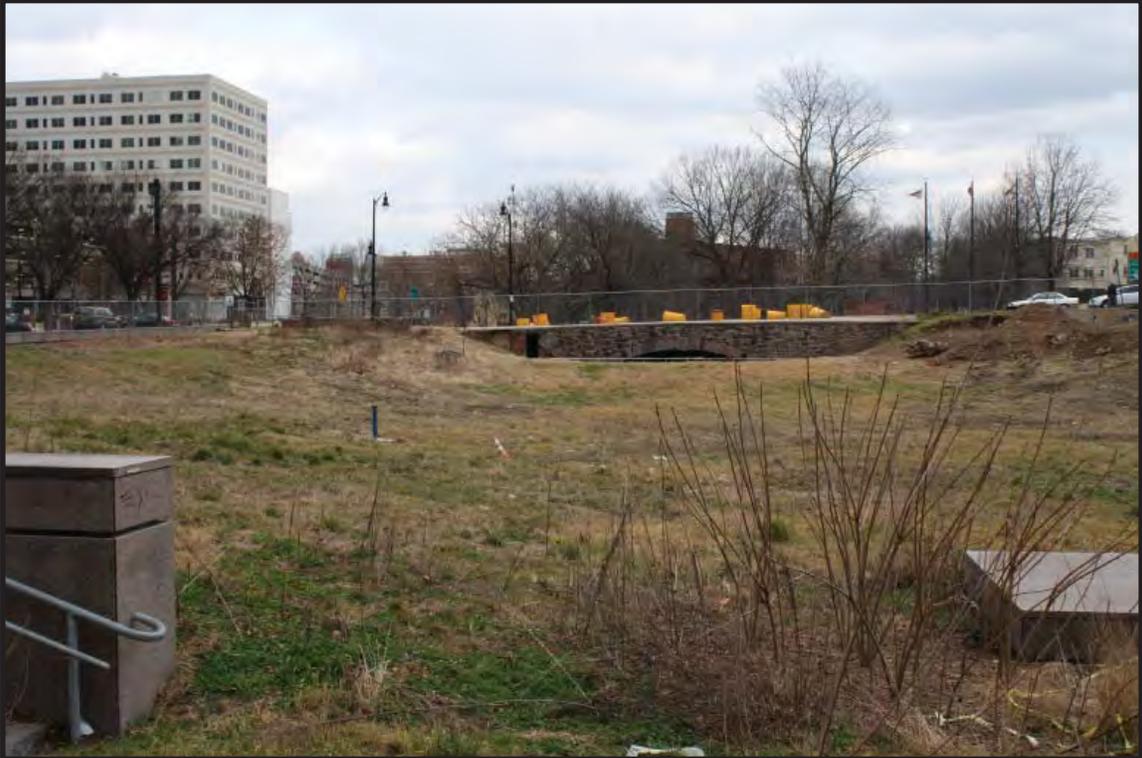
Plate 5.16. View looking east showing the project site north of the Assunpink Creek Culvert. Trench locations indicated with arrows (Photographer: James Lee, January 2012)[HRI Neg.#10055/D6:035].

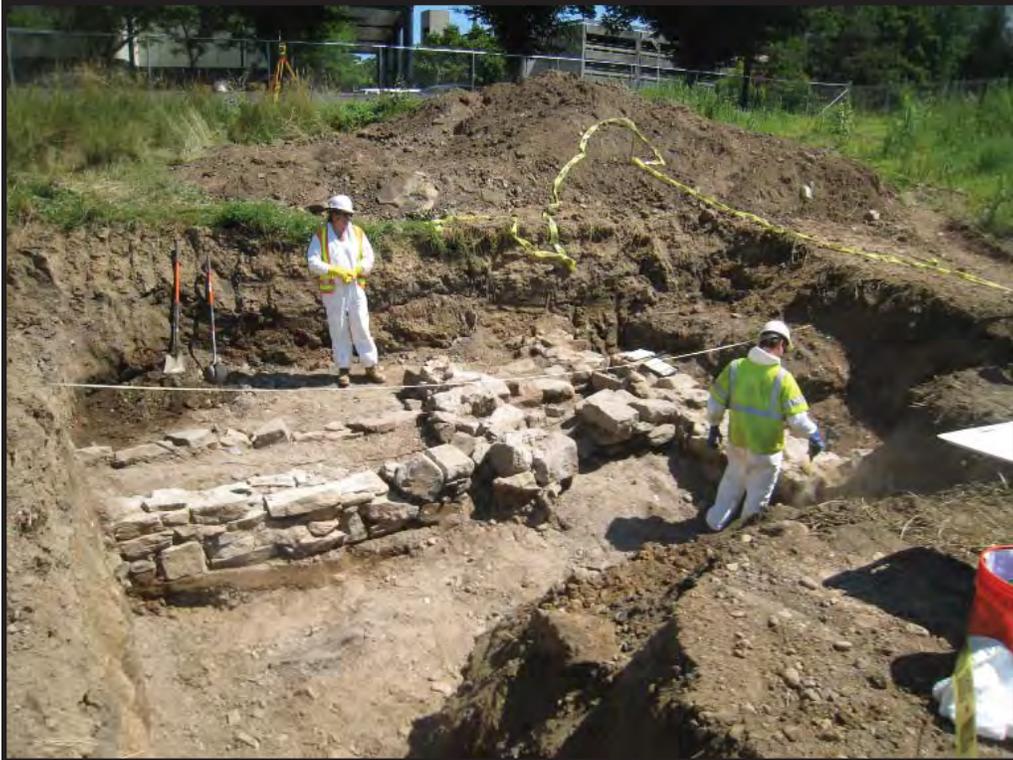
Plate 5.17. View looking north showing Trench 6 during excavation (Photographer: James Lee, July 2011)[HRI Neg.#10055/D3:085].

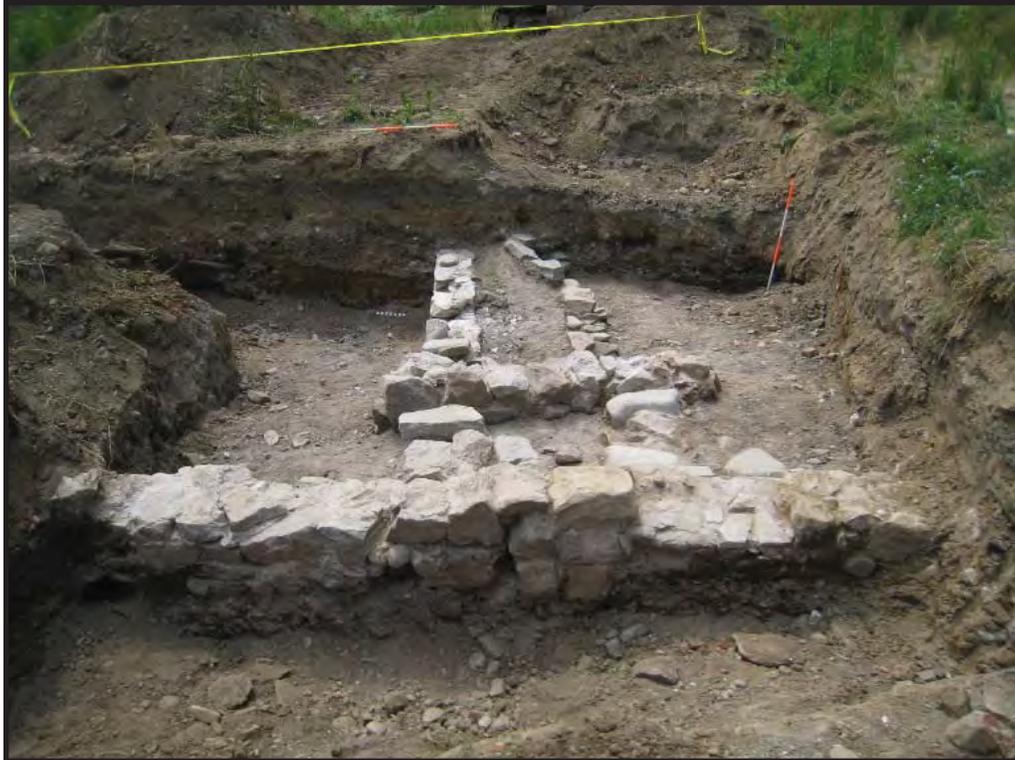
Plate 5.18. View looking west showing archaeological features identified in Trench 6. Scale in feet (Photographer: James Lee, July 2011)[HRI Neg.#10055/D3:102].

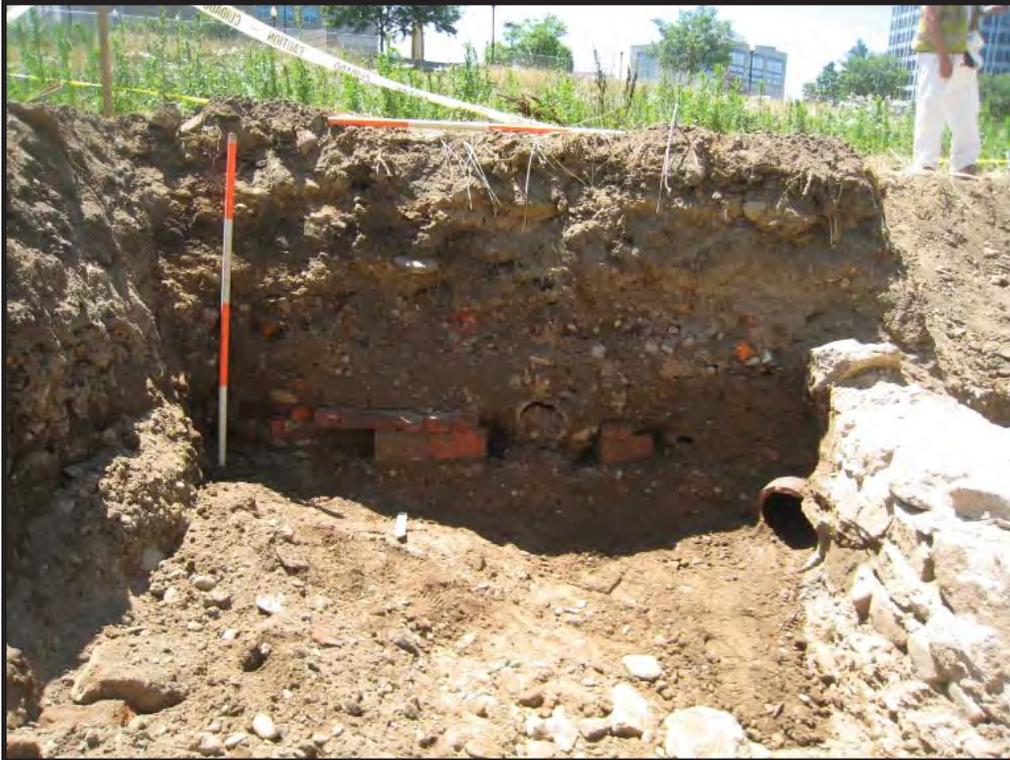
Plate 5.19. View looking south showing the eastern half of the southern profile of Trench 6. Note the brick drain to the right of the scale rod. Scales in feet (Photographer: Andrew Martin, July 2011)[HRI Neg.#10055/D3:087].

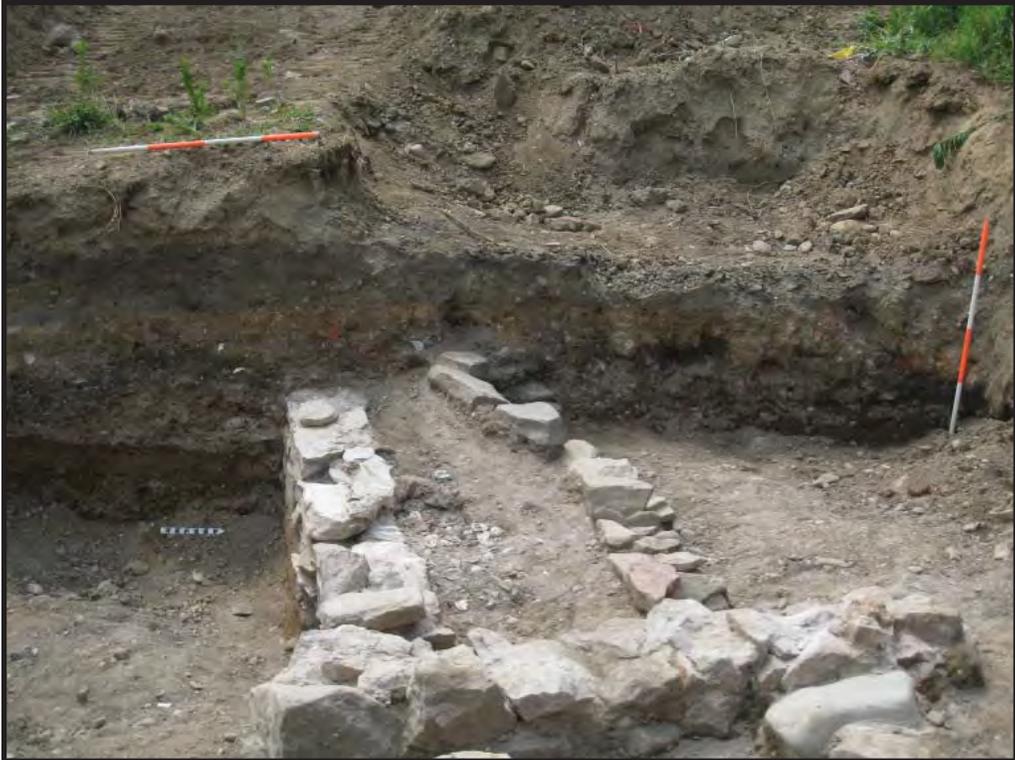
Plate 5.20. View looking west showing the western profile of Trench 6. Note the thick clay fill (indicated with a blue arrow) underlying the foundation remains. Scales in feet and tenths of feet (Photographer: Andrew Martin, July 2011)[HRI Neg.#10055/D3:097].

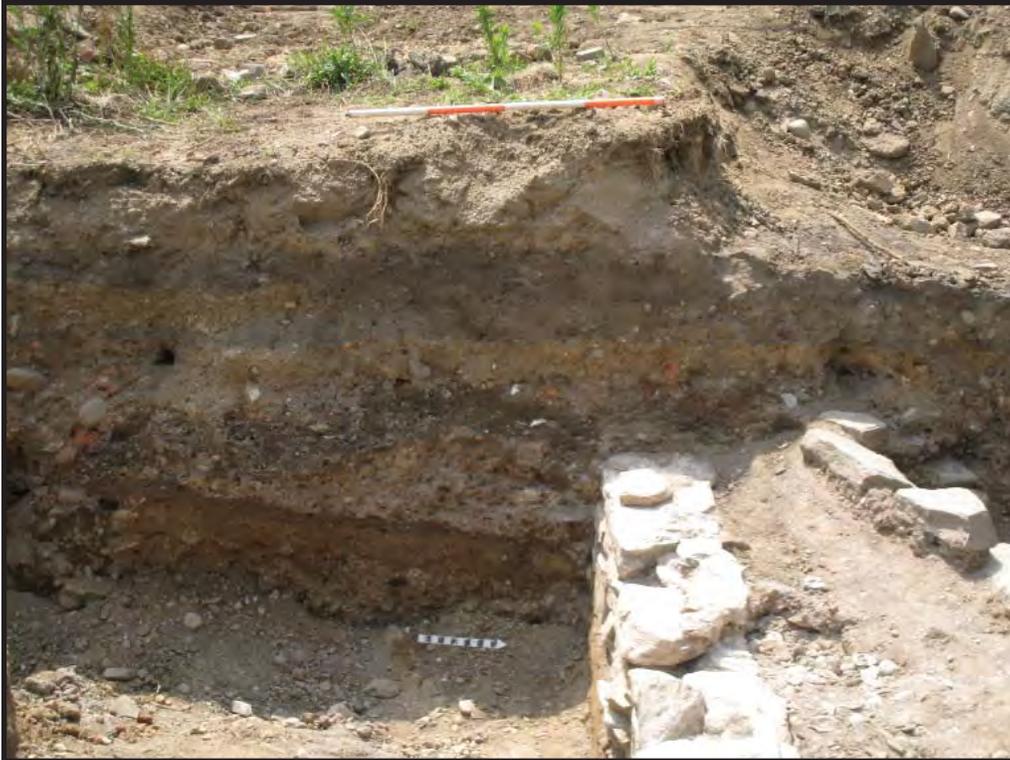
Plate 5.21. View looking west showing the southern half of the western profile of Trench 6. Note the thick clay fill (indicated with a blue arrow) underlying the foundation remains. Scales in feet and tenths of feet (Photographer: Andrew Martin, July 2011)[HRI Neg.#10055/D3:099].

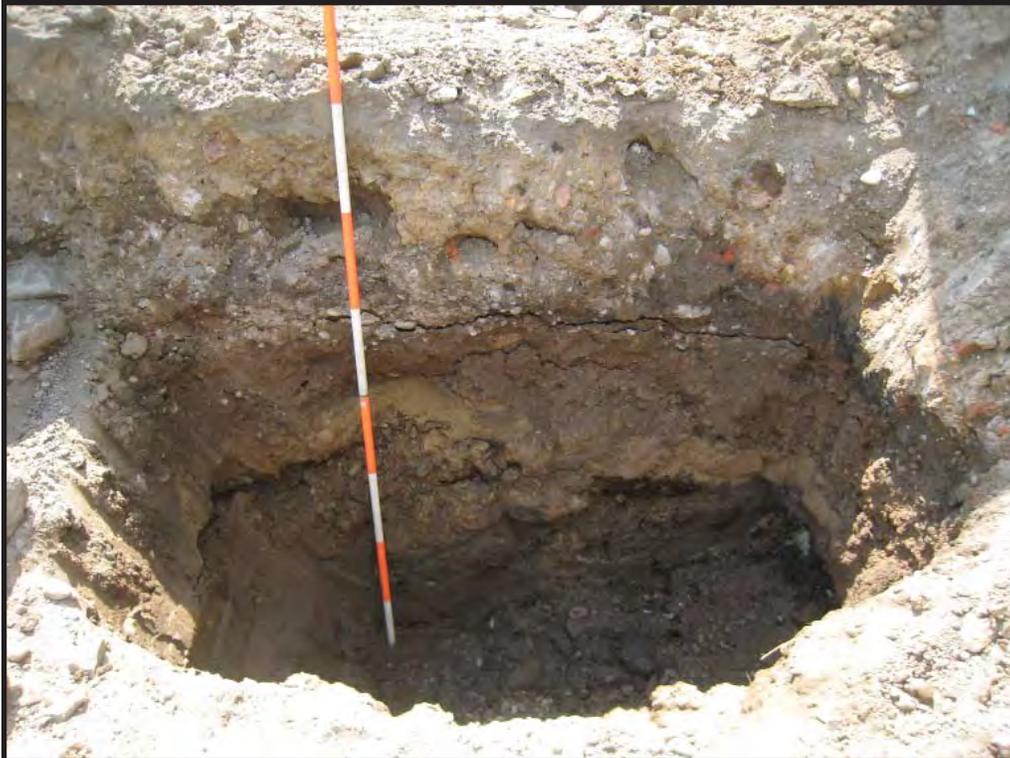
Plate 5.22. View looking west showing the northern half of the western profile of Trench 6. Note the dark brown to black wet soils at the base of excavation. Unstable soils prevented the cleaning of this profile. Scale in feet (Photographer: Andrew Martin, July 2011)[HRI Neg.#10055/D3:114].

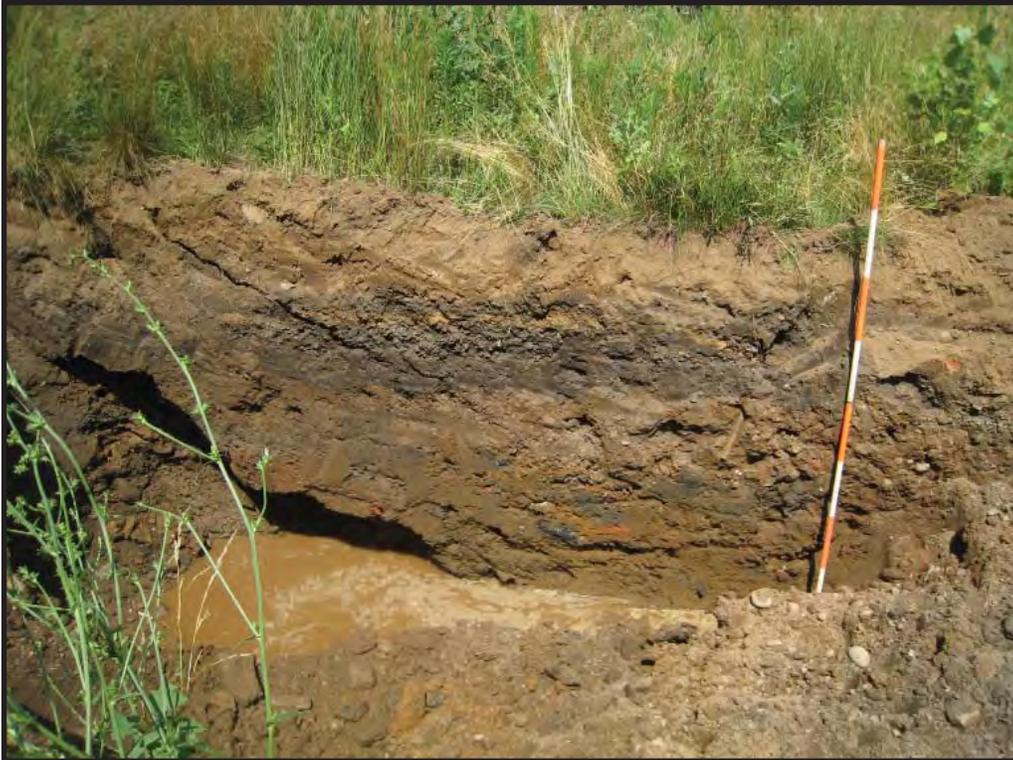
Plate 5.25. View facing east showing the eastern profile of Trench 7. Scale in feet (Photographer: James Lee, July 2011)[HRI Neg.#10055/D3:080].

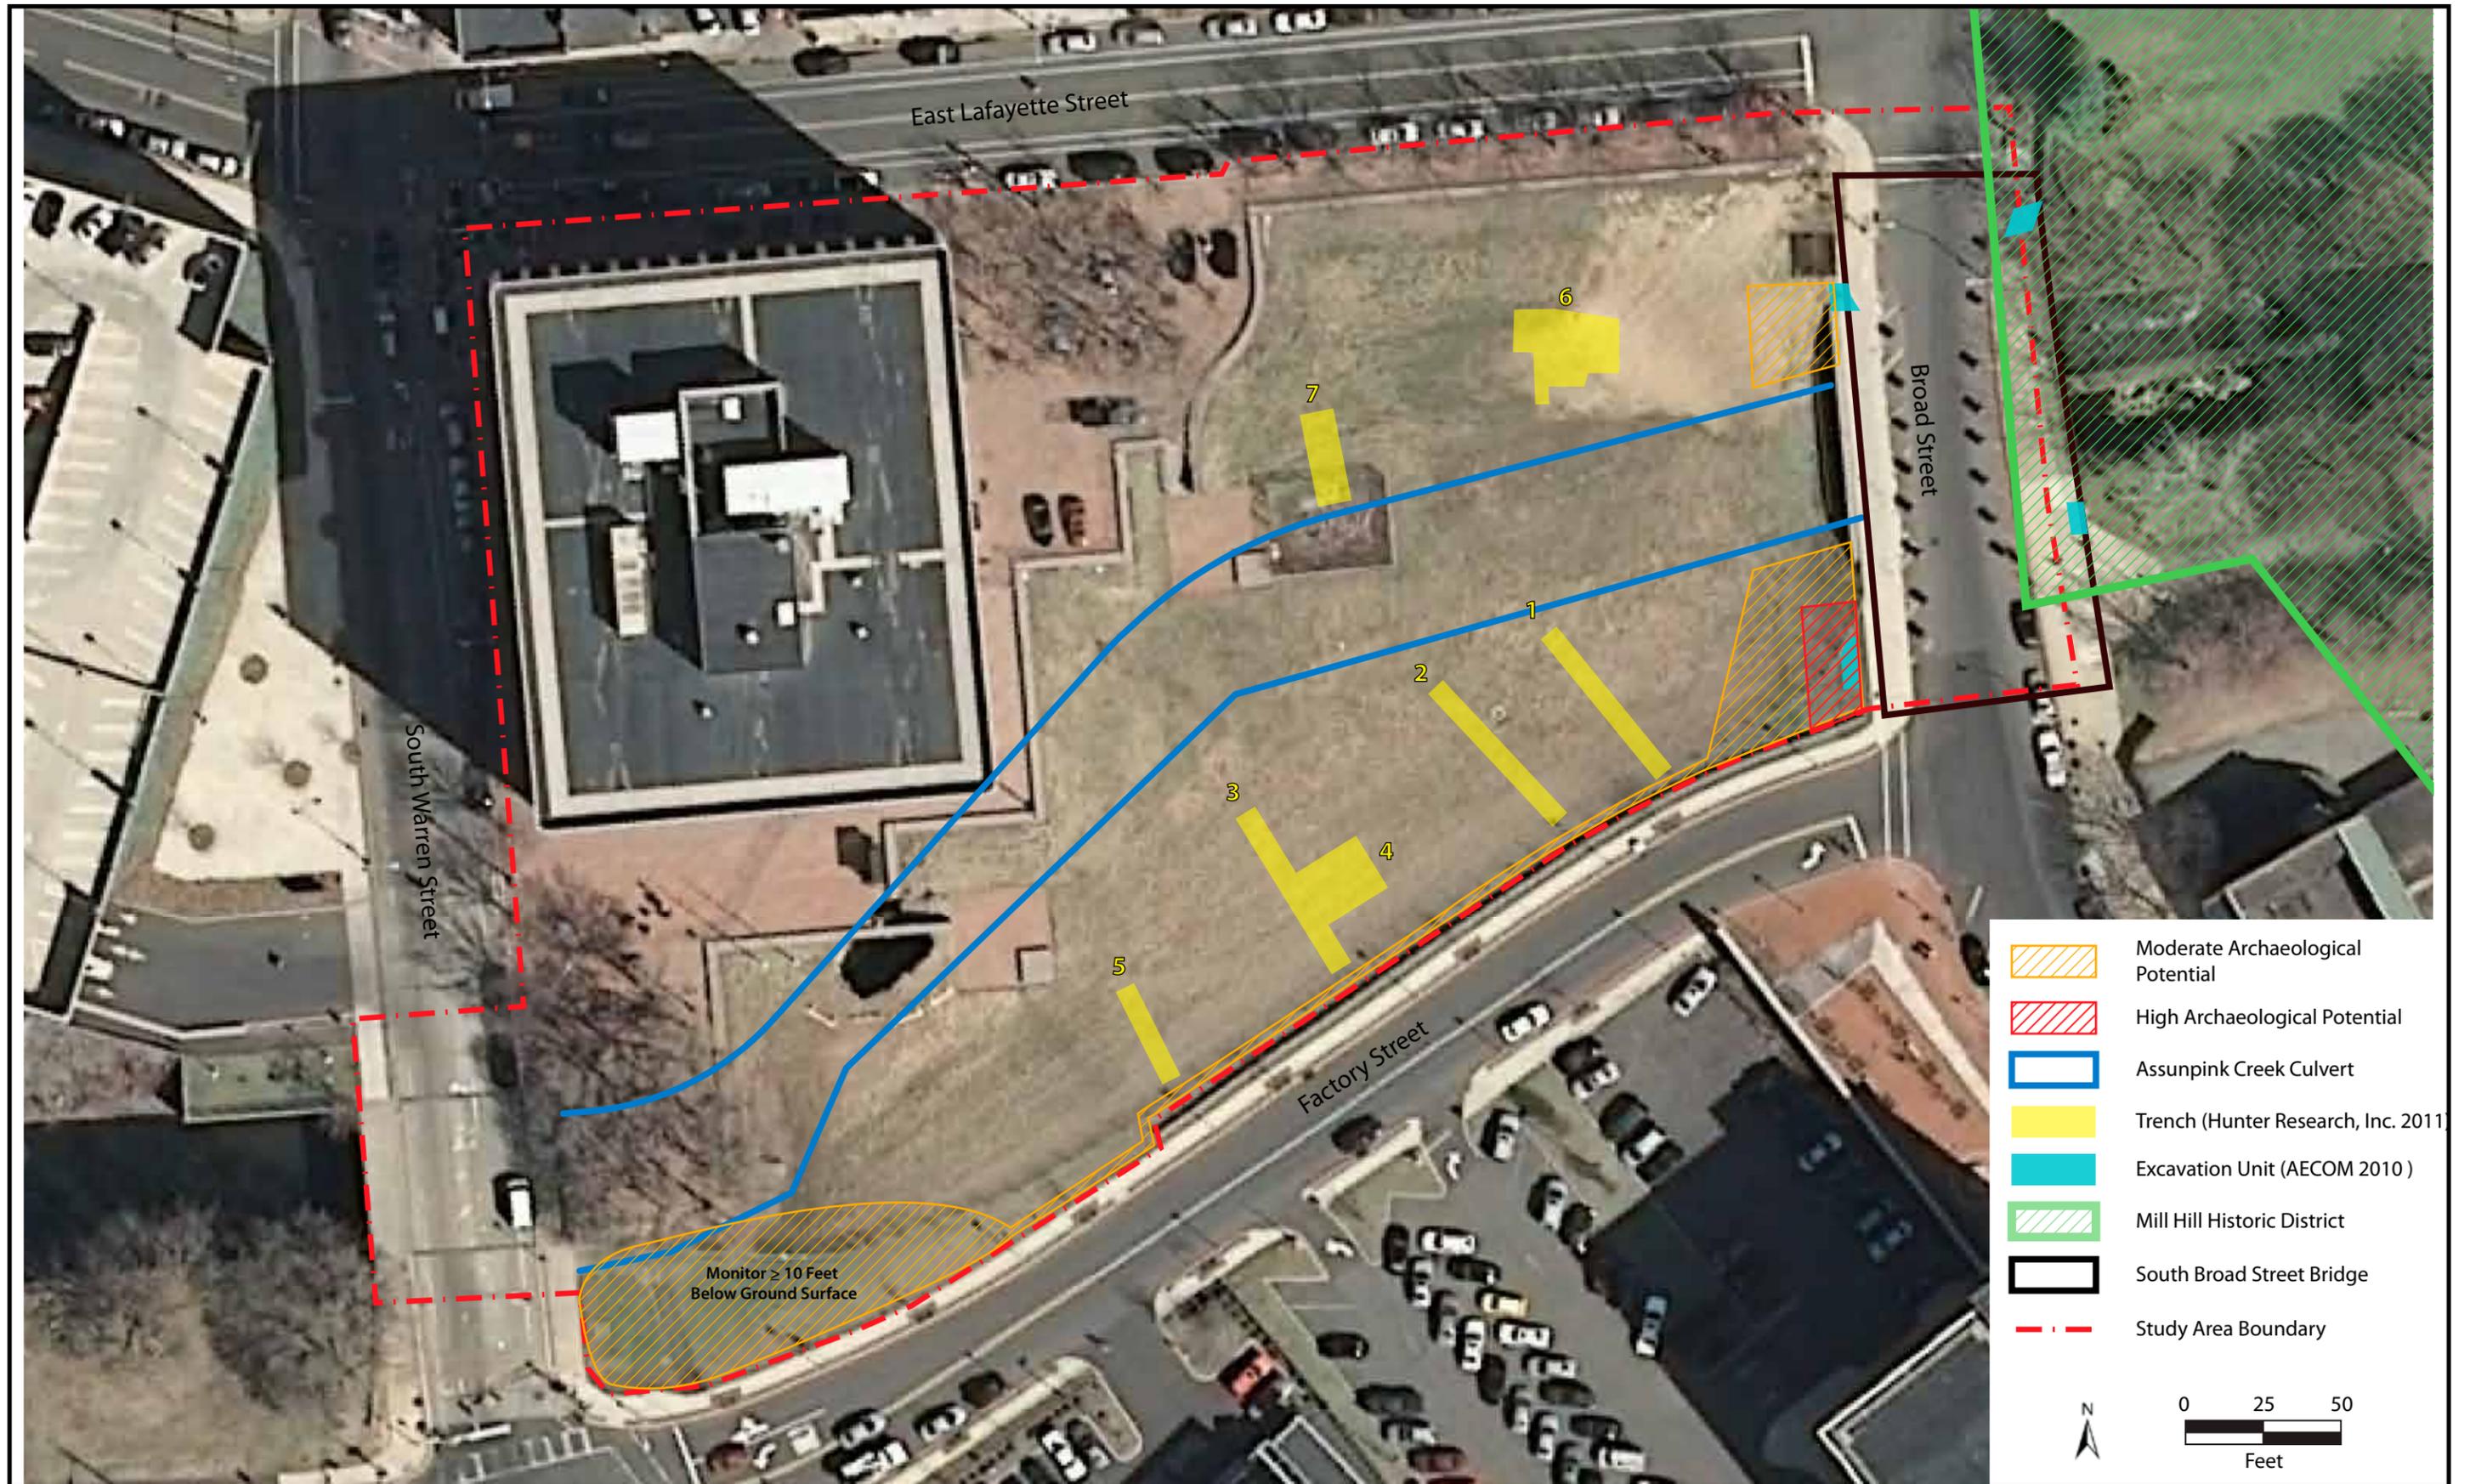
Figure 7.1. Aerial Photograph of the Project Site Showing the Location of Historic Resources and Areas of Archaeological Sensitivity/Concern.

It is also recommended that archaeological monitoring take place during construction within limited areas of potentially moderate to high archaeological sensitivity if they cannot be avoided by construction activities. The three areas of sensitivity are: 1) deeply buried remains below a depth of 10 feet above sea level on the south bank more than 10 feet from the southern edge of the existing culvert; 2) within approximately 25 feet of the west side of the South Broad Street Bridge; and 3) the southeast corner of the project area (northeast quadrant of the intersection of South Warren Street and Assunpink Way) where remains of the Moore's Flour Mill site may survive. A monitoring protocol should be developed that will allow for documentation of significant archaeological remains should work occur in these areas.
