Monitoring Marsh Enhancement and Near Shore Placement: Turbidity and Sediment Profile Imaging

Kelsey Fall (USACE-ERDC)

Seven Mile Island Innovation Lab Working Group Meeting

June 16, 2021

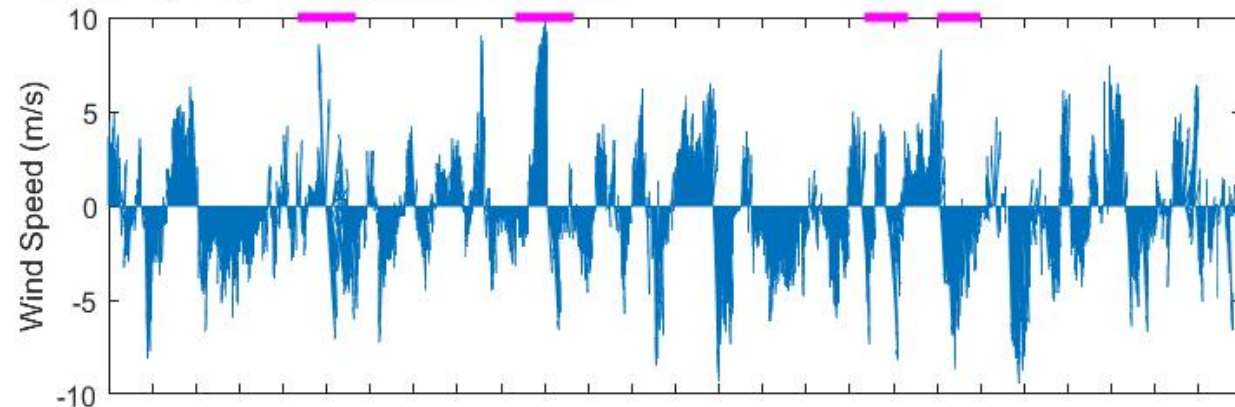
A. Cape May NJ, Winds Speed and Direction

*Wind arrow points to direction wind is blowing towards

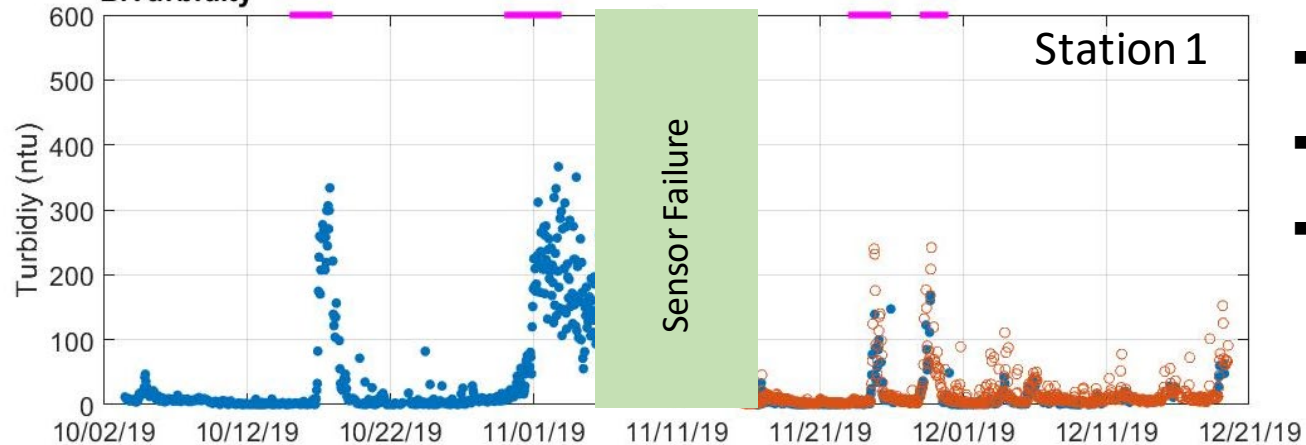
B. Turbidity

Spikes in turbidity (250-380 ntu) during periods of winds >5m/s (11 mph, correspond to passage of Nor'easter and southerly wind event.

Apart from punctuated wind events, the area is generally calm and waters are clear.

- Small waves, <0.25 m
- Weak current (~0.1 m/s),
- Low turbidity (~10 ntu)
- Low SSC (~10–20 mg/L).

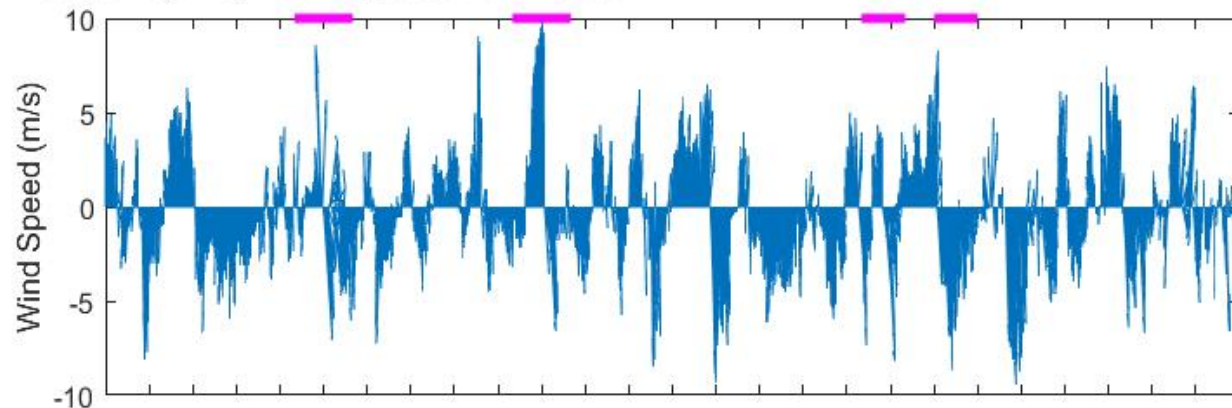
A. Cape May NJ, Winds Speed and Direction

*Wind arrow points to direction wind is blowing towards

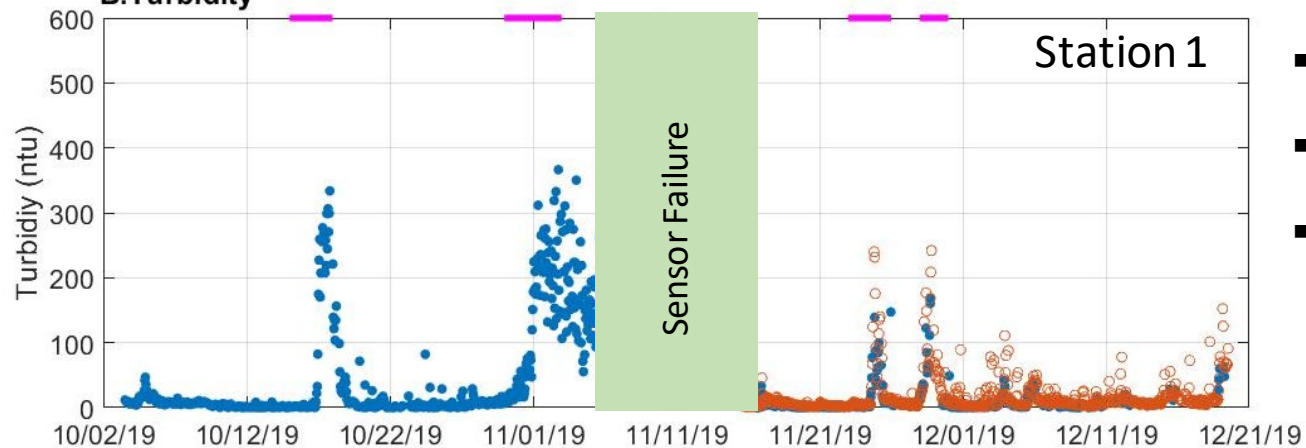
B. Turbidity

Apart from punctuated wind events, the area is generally calm and waters are clear.

- Small waves, <0.25 m
- Weak current (~0.1 m/s),
- Low turbidity (~10 ntu)
- Low SSC (~10–20 mg/L).

Spikes in turbidity (250-380 ntu) during periods of winds >5m/s (11 mph, correspond to passage of Nor'easter and southerly wind event.

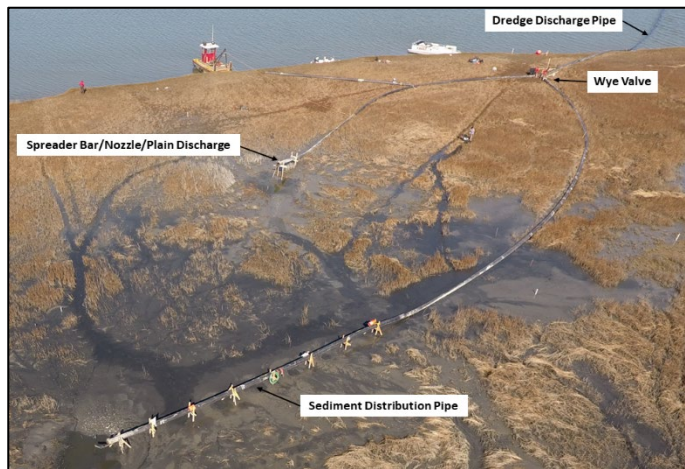
March 2020 Sturgeon Island (on Marsh)

Little to no turbidity plume, outside of the tidal creek mouth on NE side of island.

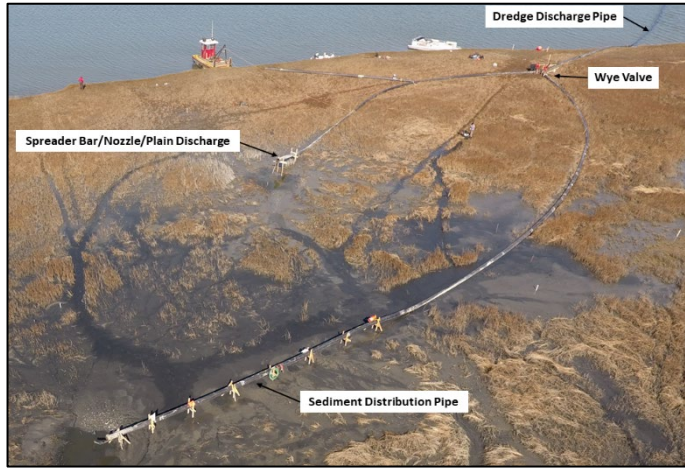
March 2020 Sturgeon Island (on Marsh)

Little to no turbidity plume, outside of the tidal creek mouth on NE side of island.

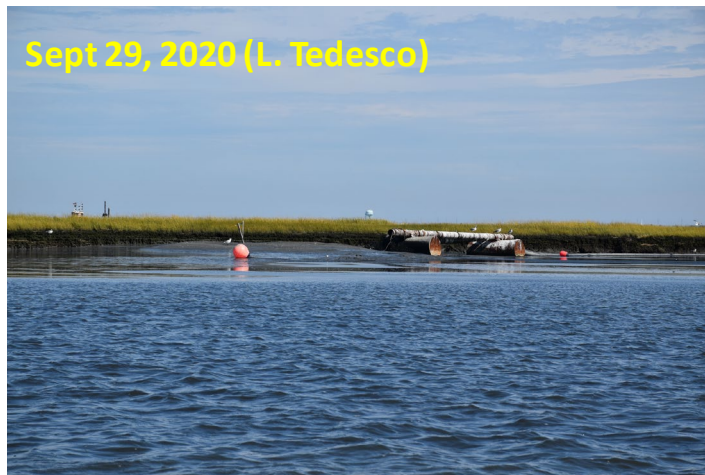
September 2020 Gull Island (in water, marsh edge)

High turbidity close to the pipe (~250-300 feet, ~300-400 ntus). Direction of plume related to the tide. Berm feature developed.

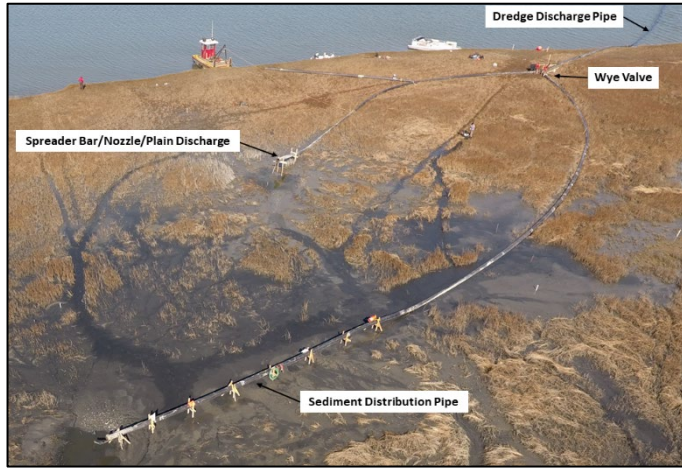
March 2020 Sturgeon Island (on Marsh)

Little to no turbidity plume, outside of the tidal creek mouth on NE side of island.

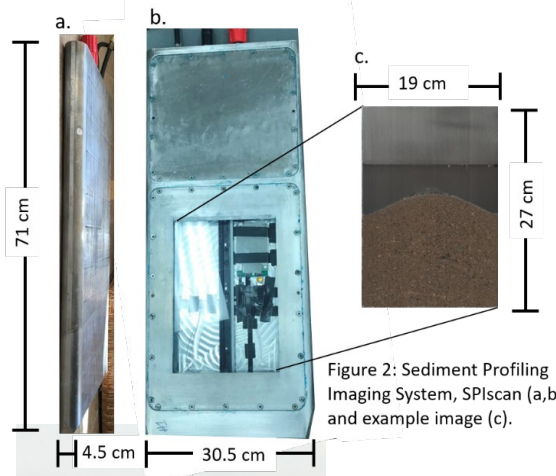
Figure 2: Sediment Profiling Imaging System, SPIScan (a,b) and example image (c).

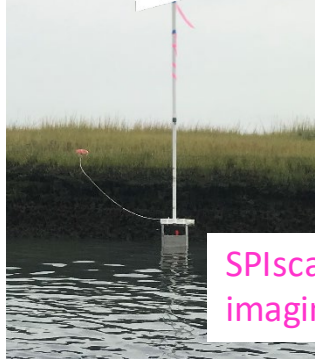
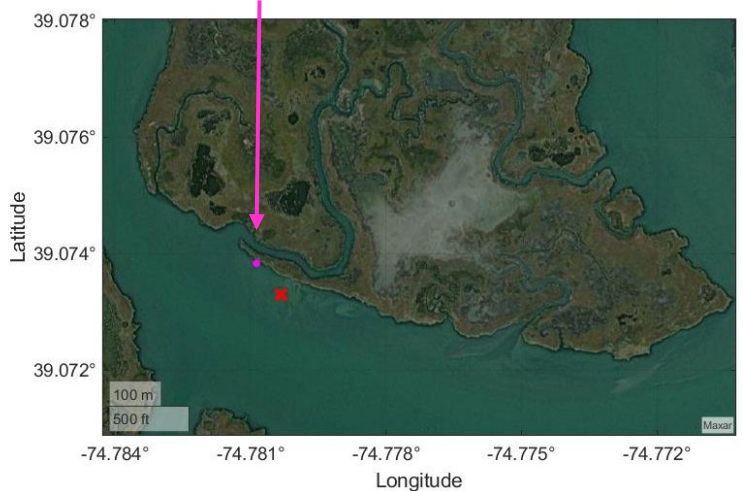
SPIScan ~70 m/200 ft. NW with imaging face parallel to pipe (red x).

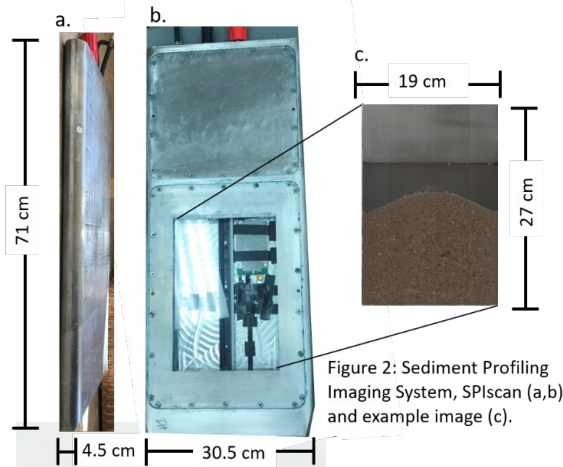
Figure 2: Sediment Profiling Imaging System, SPIScan (a,b) and example image (c).

Material placed from 9/23 to 10/8 (~7500 cu. Yards). SPIScan deployed from 9/23/20-10/30/20 and captured imaged every 2 hours.

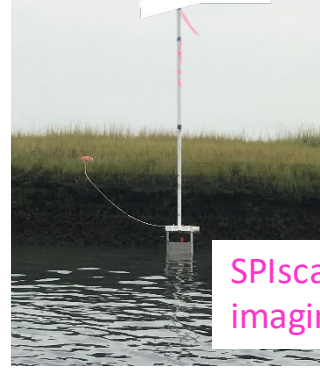
SPIScan ~70 m/200 ft. NW with imaging face parallel to pipe (red x).
