**Mordecai Island
Beach Haven, New Jersey
Project Modification for
Ecosystem Restoration (Section 1135)
Feasibility Study and Integrated
Environmental Assessment**

**February 7, 2022
DRAFT FEASIBILITY REPORT**

**U.S. Army Corps of
Engineers
Philadelphia District**

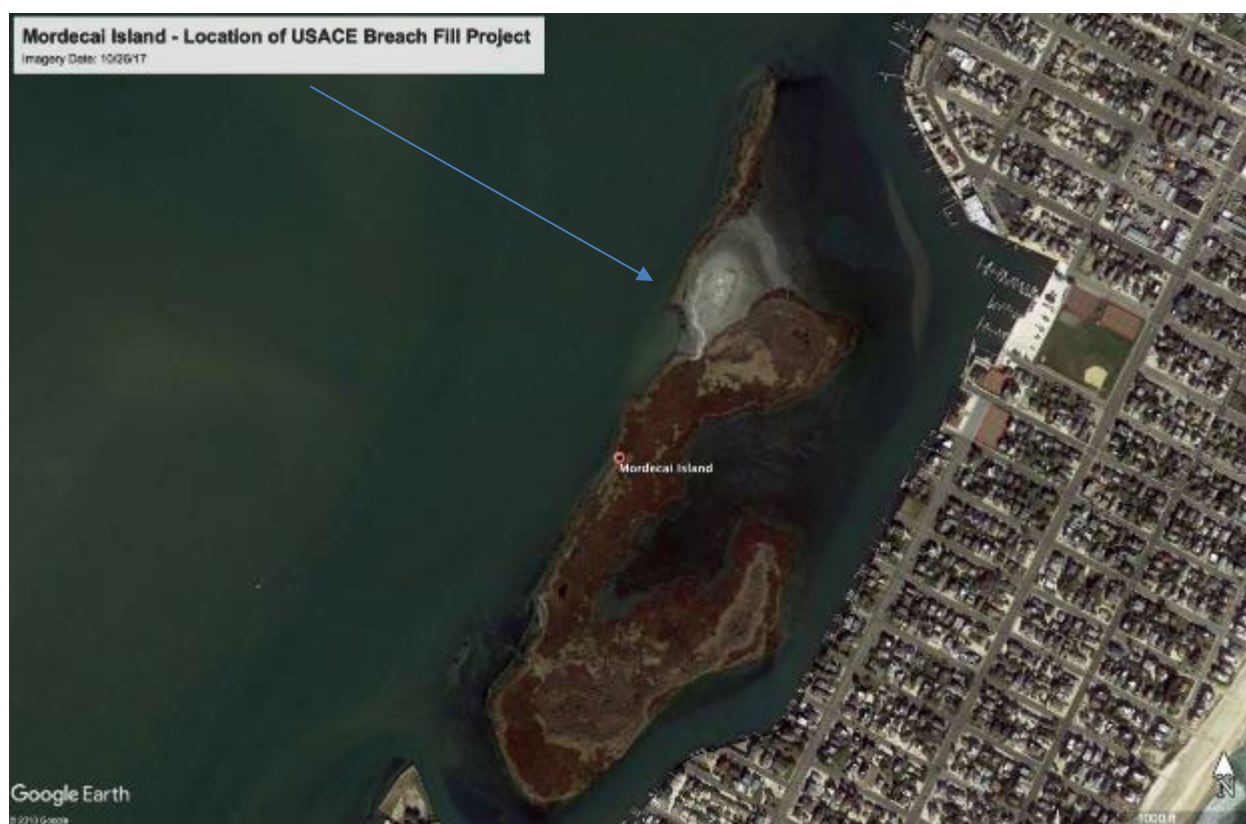
Figure 2.1: Location of Corps Breach Fill Project

In November 2015, the Corps used approximately 25,000 cubic yards of sediment dredged from the NJIWW to fill in an erosional gap that had effectively split Mordecai Island in two (see Figure 2.1). A thick mound (~3ft deep) of sediment was placed in the gap, to rejoin the two remaining lobes of the island. Planting of the filled area was completed in May 2016. The lowest zone of the fill area was planted with saltmarsh cordgrass (*Spartina alterniflora*). The next highest zone was planted with saltmeadow hay (*Spartina patens*) and salt grass (*Distichlis spicata*). The third zone, the highest zone above the intertidal influence, was originally planned to receive coastal shrub plantings, however, this zone, along with the shell cover, developed into beach nesting bird habitat. Therefore, this zone was left unvegetated to provide habitat for beach nesting birds.

The nesting portion of the filled area flooded, so the Philadelphia District added more material in December 2017 to raise the elevation of the habitat.

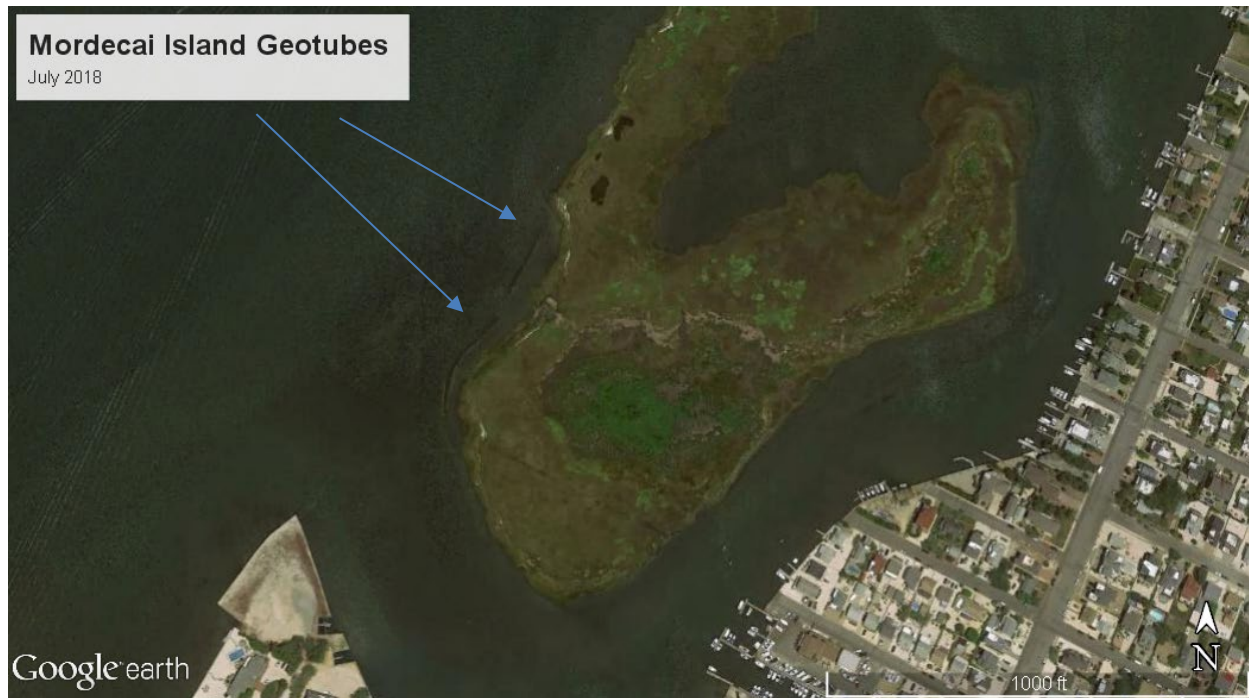
Figure 2.4: Aerial View of Installed MLT Geotubes®

Although there has not been scientific monitoring of the effectiveness of the Geotubes®, the following Google Earth image confirms that they were still in place in July 2018 and a Corps field trip in August 2018 confirmed their continued existence. In August 2016 MLT noted on their website that over the past 5 years an intertidal land bridge had been established between the tubes and the island. This is also visible on aerial photos and from the shoreline at low tide. The Land Trust intends to plant clumps of ribbed mussels and *Spartina* together. The stated goal is to have sediment accrete faster and hasten island growth toward the tubes. A site visit was made by the Corps on August 17, 2018 and it was noted that the tubes' intertidal surfaces are covered with bladderwrack seaweed and barnacles, with accompanying periwinkles and small forage fish. One of the tubes had broken open at the end but had been effectively closed off by having bags of oyster shells piled onto the flaps of the open end.

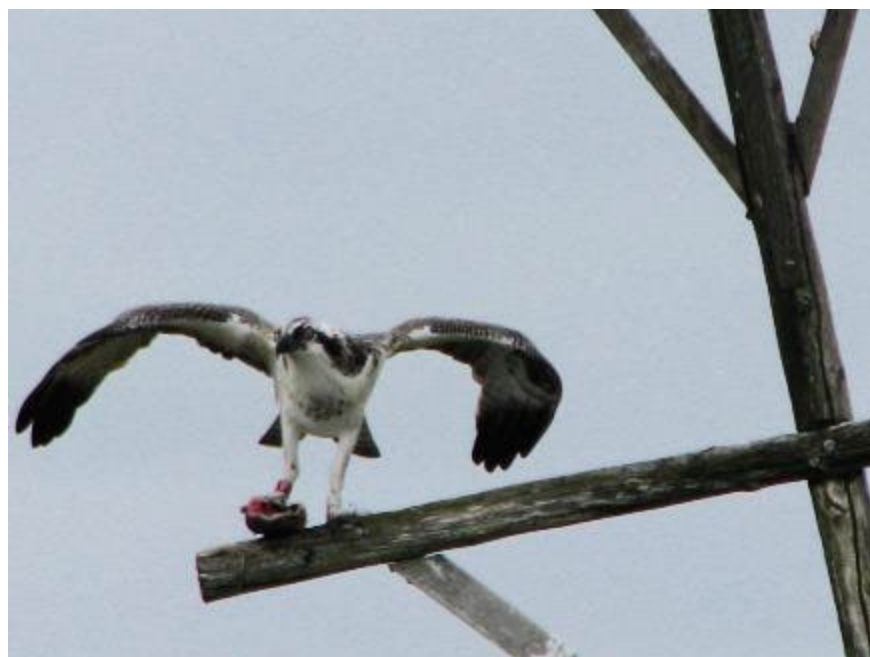
Figure 2.7: MLT Osprey Platform

An osprey platform was installed next to Mordecai Island in the 1990s. The structure decayed and was prone to predator invasion. In 2016 MLT replaced the osprey platform in the eastern cove area of Mordecai Island. (See Figure 2.7) In 2017 an unattached male was observed defending the platform and in 2018 a nesting pair with one chick was seen on the platform. The nesting pair returned and had successful breeding in 2019.

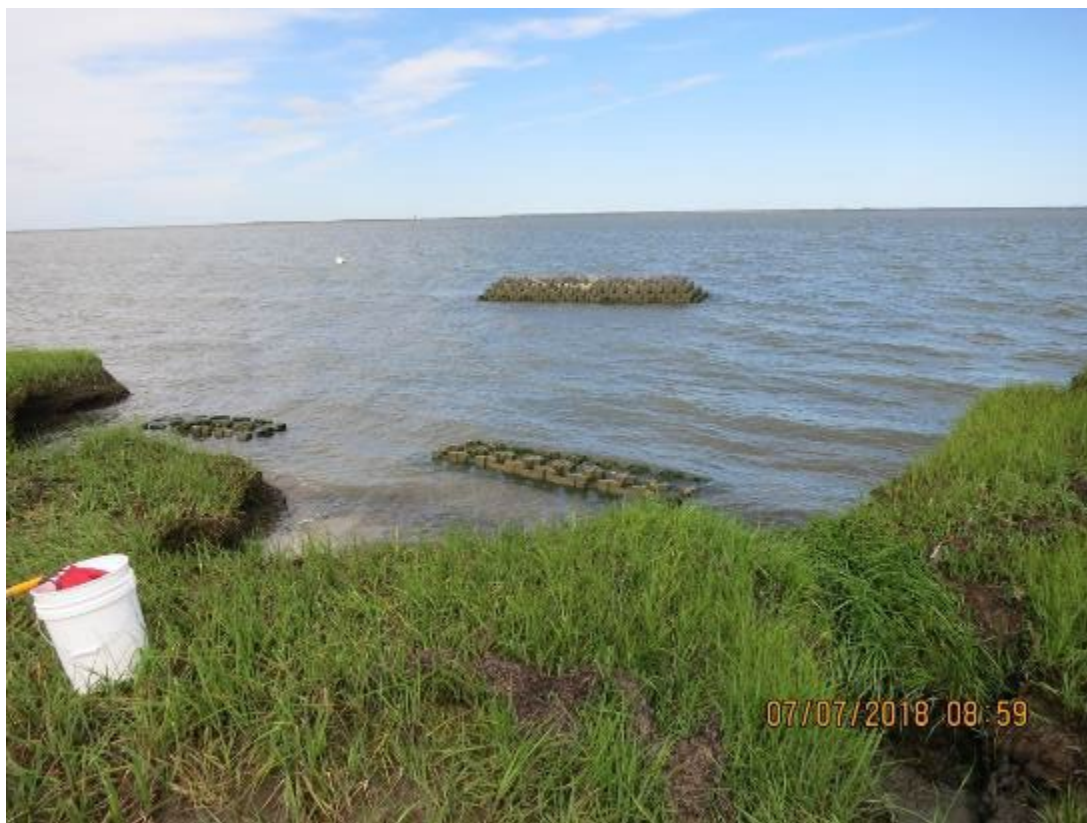
Figure 2.8: MLT Oyster Castle® Arrays

The third array is being observed for effectiveness of wave attenuation and the fourth array is being watched for habitat creation. In addition, the remaining Oyster Castles® were laid out near the island shoreline in an attempt to lessen erosion.

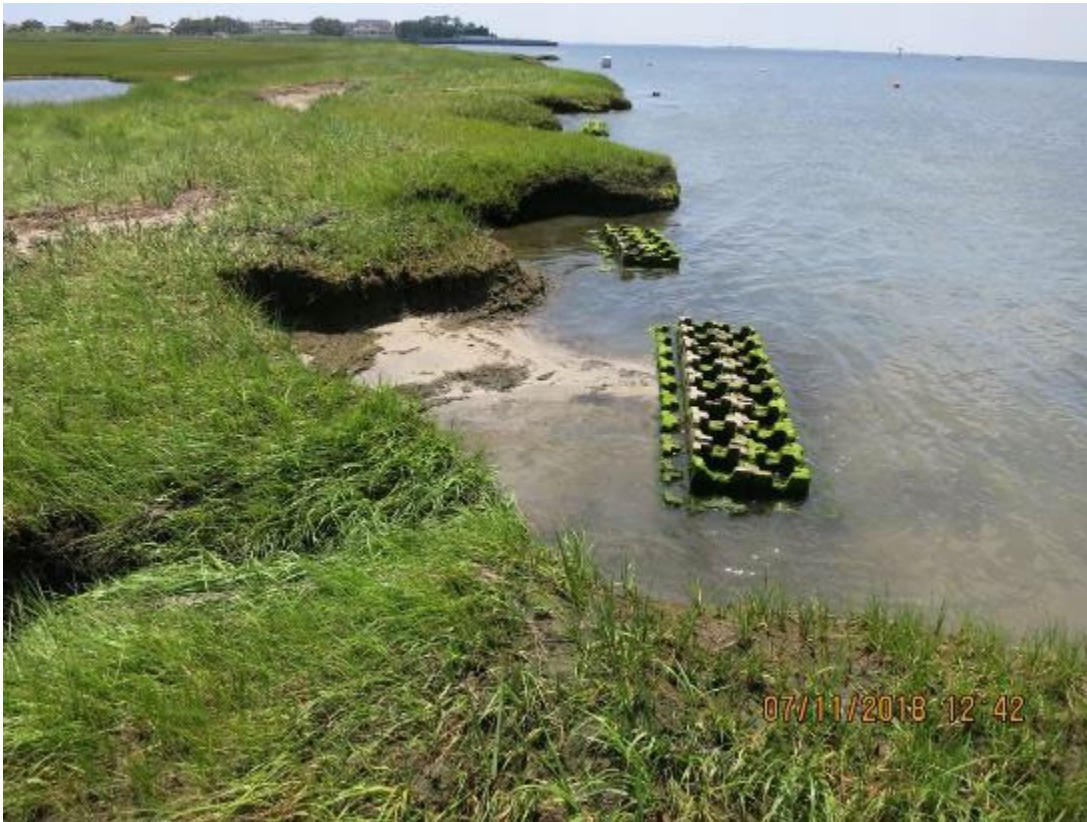
Figure 2.9: Tombolo Creation at Oyster Castle® Array on Mordecai Island

During a July 2018 visit to the castles, MLT members noted that spat on the 2017 castles had matured and submerged aquatic vegetation around the castles had grown significantly. It was also observed that the small near-shore sills from both 2017 and 2018 had tombolos of accreted material forming to join them to the island. (See Figure 2.9.)

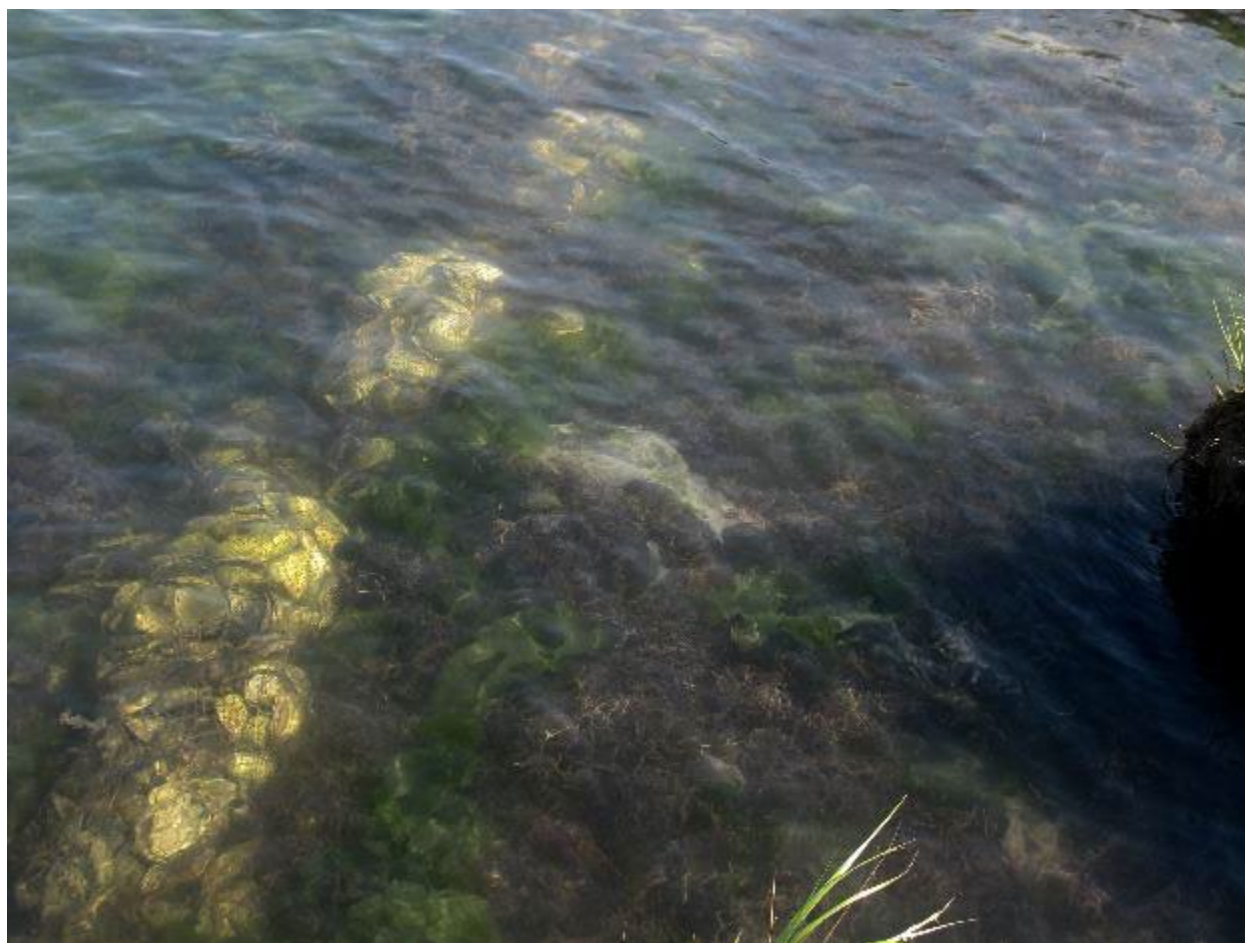
Figure 2.12: MLT Shell Bags at the Edge of Mordecai Island

As of July 2018, MLT and ReClam the Bay had installed over 200 shell bags in several locations along Mordecai Island. The bags contain clam shells that have oyster spat growing on them. The purpose of bag placement is to provide living protective structures. Bags have been placed on the Geotubes® to close off a hole, as well as near the Geotubes® to create a protective reef. MLT is looking into adding ribbed mussels to this protective effort. Shell bags have also been placed close to the edge of the marsh in an effort to slow erosion of the island. (See Figure 2.12.) In addition, shell bags were placed as a protective barrier along the western side of the Corps fill project location. This last placement has contributed to creation of tide pools and a mud flat. In September 2018 *Spartina* was observed growing through the shell bags.

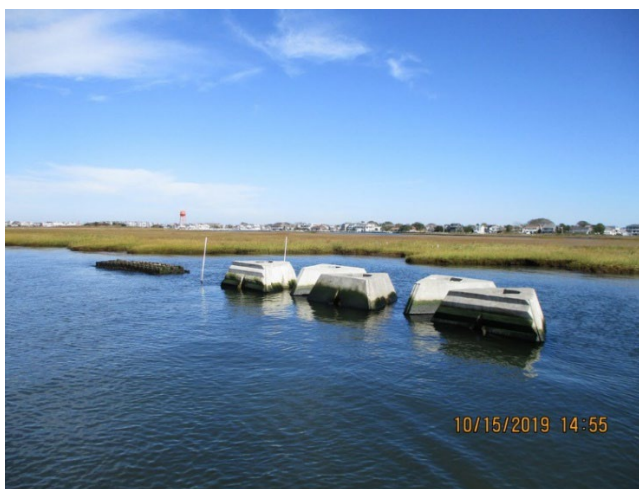
Figure 2.13: MLT Wave Attenuation Devices

As Phase 3 of their demonstration projects (see Figure 2.16), on September 17, 2019 Mordecai Land Trust installed five of Living Shoreline Solution, Inc.'s Wave Attenuation Devices, also known as WADs®. (See Figure 2.13.) WADs® are hollow poured concrete pyramids that are designed to site conditions. (See Figure 2.14.) The purpose of the WADs® is to break wave energy, while also promoting growth of biota. MLT's WAD® array is laid out in a staggered arrangement along the western shore of the island, in a northeast to southwest direction. Each of the WADs® is 60 inches high, with a base of 113 inches. MLT installed both corrugated and smooth surfaced WADs® to compare performance and biological growth patterns. Two different hand probes were used to consider firmness of the bay bottom. It was determined that no geotextile or geocomposite base was needed for the WADs®. Therefore, they were set directly onto the bay bottom.

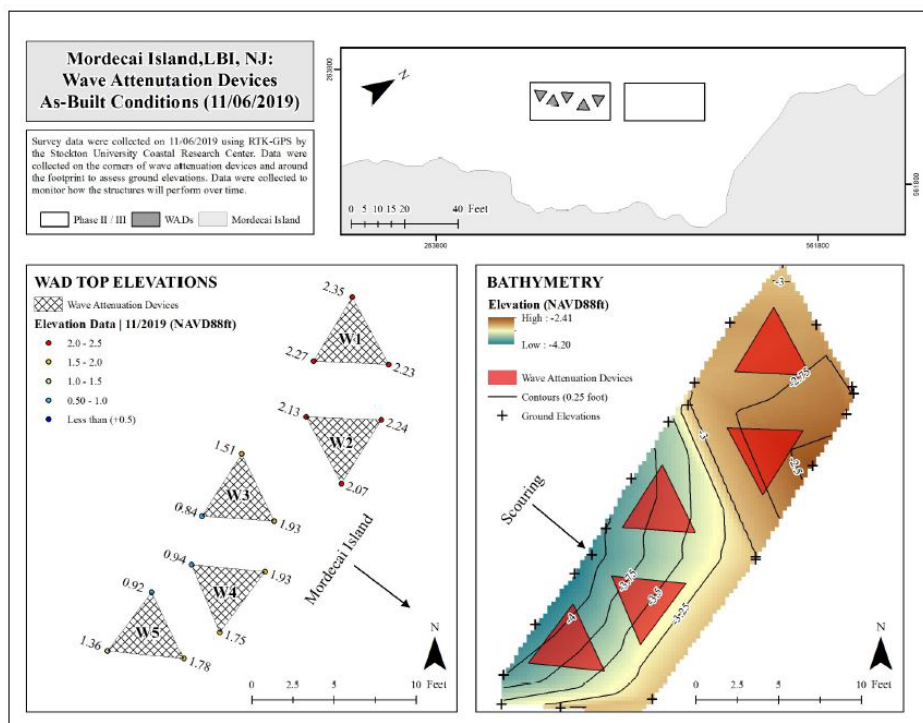
Figure 2.15: November 6, 2019 Elevation Conditions of MLT WADs®

On November 6, 2019 Stockton University Coastal Research Center conducted a survey to determine as-built elevations of the WADs®. (See Figure 2.15.) Ground elevations around the array were between -2.5 and -4.0 NAVD88, with all of the deeper areas (>-3.0 NAVD88) occurring around the western edge of the three southernmost WADs®, WADs® 3 through 5). Corner surface elevations at WAD® 1 and WAD® 2 were consistent with variations in elevations of 0.12 ft. and 0.17 ft., respectively. Corner surface elevations at WADs® 3 through 5 were consistently lower along the western edges. Data indicates that the western edges of the southern three WADs® are being scoured, causing uneven settlement of the WADs®.

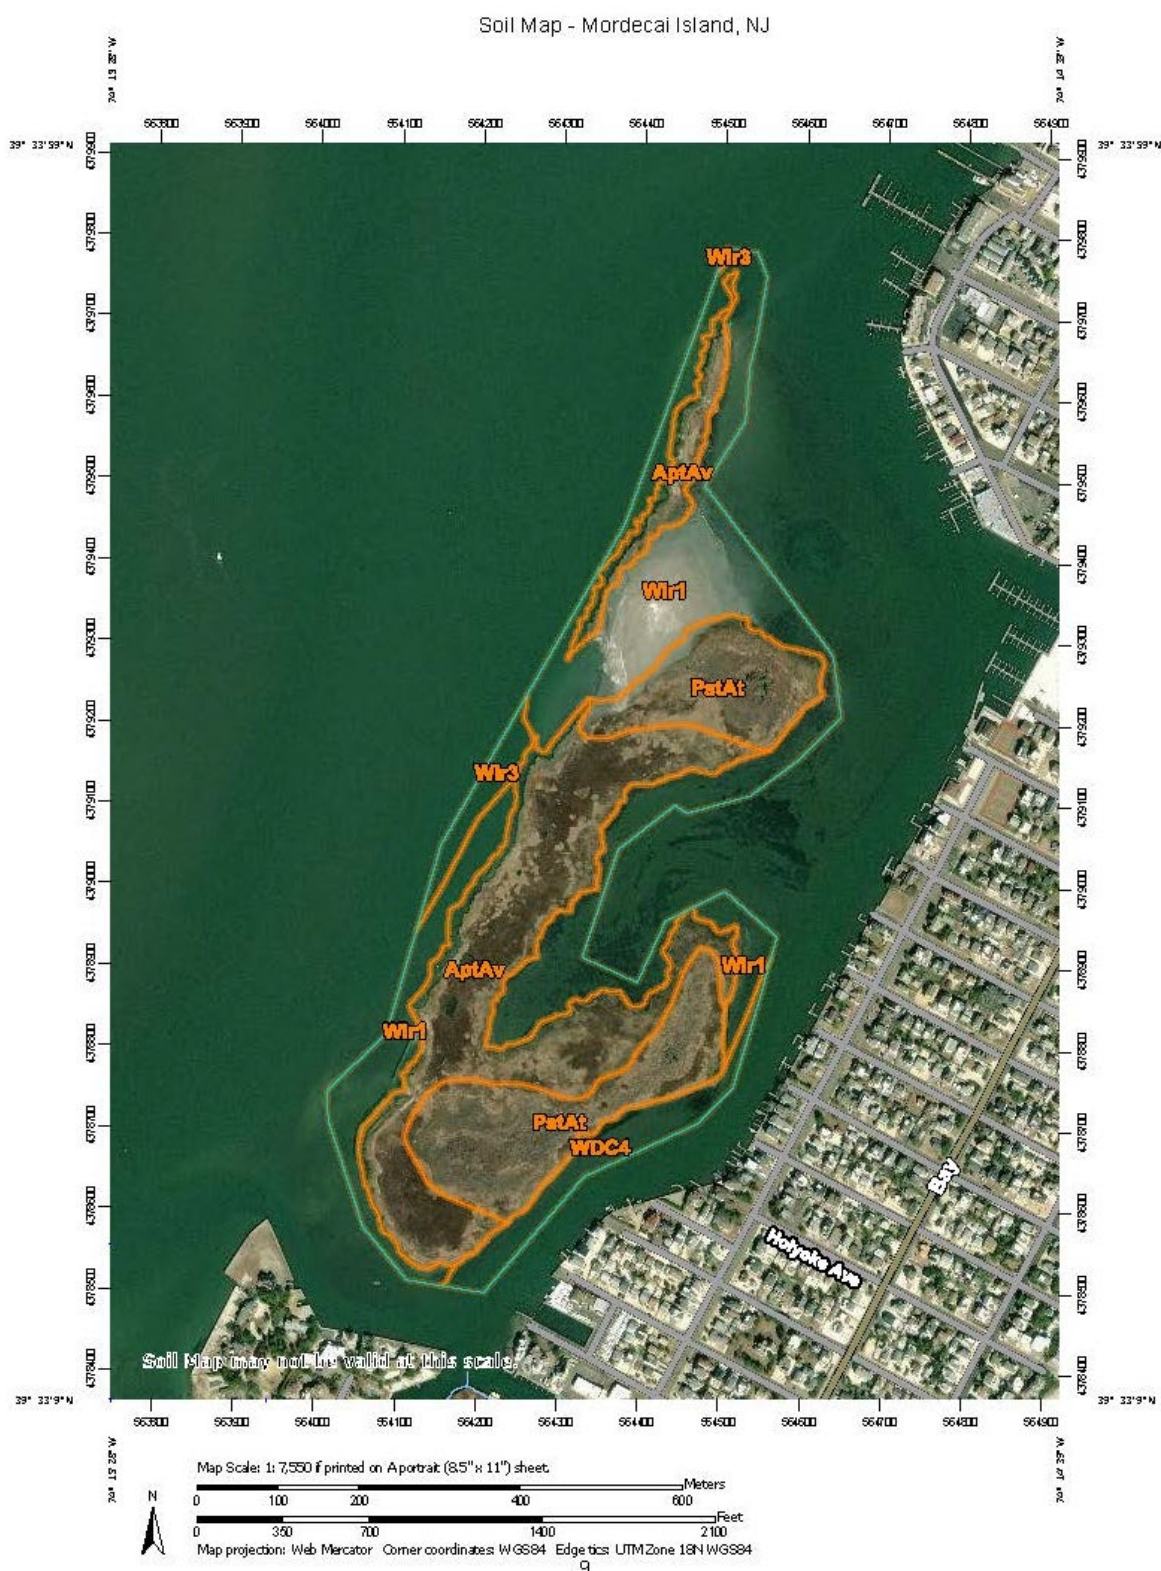
Figure 3.2: Mordecai Island Soils Map 5455

Based on the soil survey of Ocean County (NRCS Web Soil Survey: “Custom Soil Resource Report for Ocean County, New Jersey,” United States Department of Agriculture and Natural Resources Conservation Service, dated May 20, 2019), the typical soils found within the approximate project limits consist of Appoquinimink-Transquaking-Mispillion complex (AptAv), Psammaquents, sulfidic substratum, (PstAt), Dredge Channel (WDC4A), Indian River sand flat (WIr1) and Indian River sand tidal inlet (WIr3). (See Figure 3.2 and Table 3.2.)

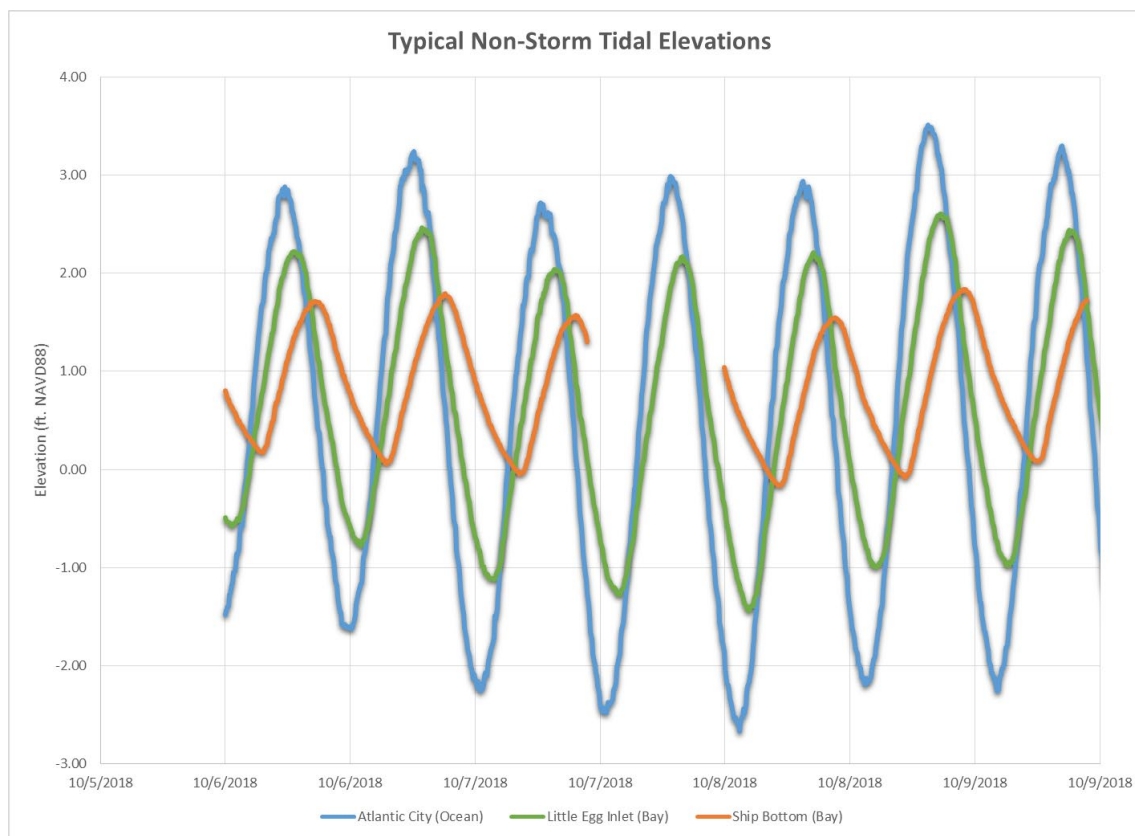
Figure 3.6: Typical Non-Storm Tidal Elevations in Vicinity of Mordecai Island

The USGS operates several tidal stations in Barnegat Bay. The two closest stations to Mordecai Island are USGS Station 01409335, Little Egg Inlet near Tuckerton, NJ and USGS Station 01409146, East Thorofare at Ship Bottom, NJ. These stations are located five miles south and seven miles north of Mordecai Island respectively. Figure 3.6 shows tides during typical non-storm conditions (Oct. 6-9, 2018) for NOAA’s Atlantic City open coast station and for the two USGS tidal stations in the vicinity of Mordecai Island.

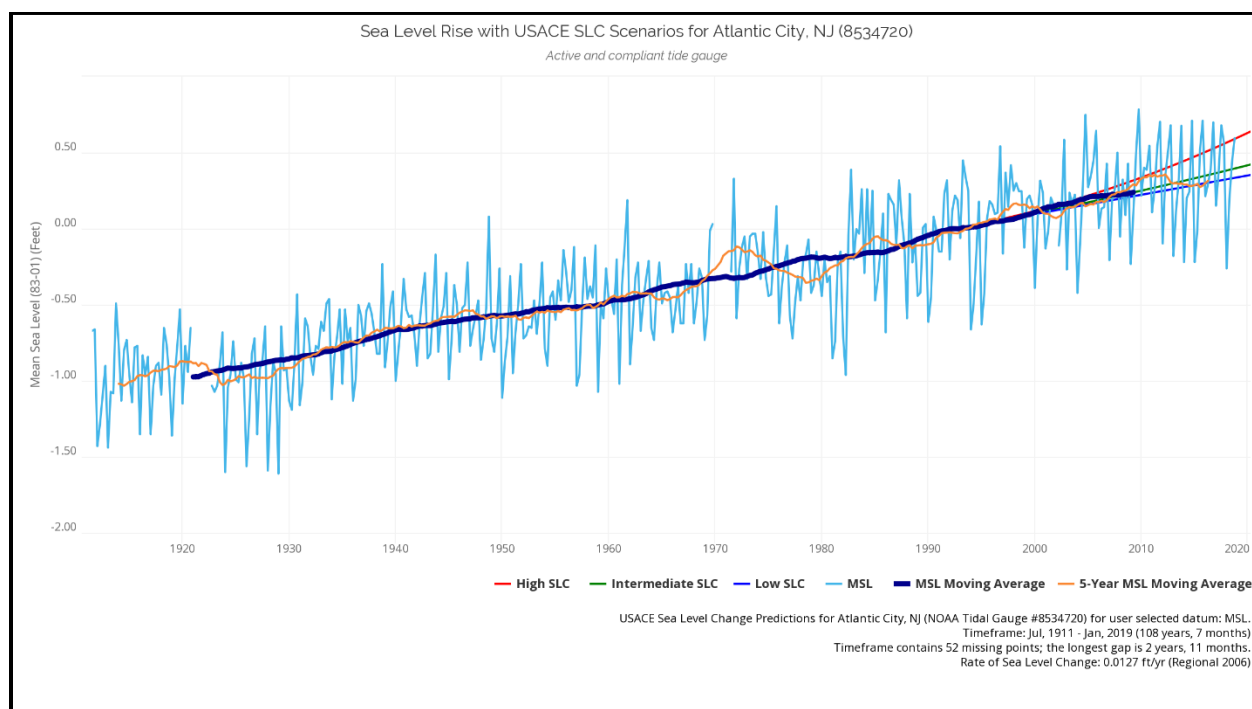
Figure 3.7: Historic Relative Sea Level Change at Atlantic City, NJ

Historical SLC adopted for Mordecai Island (4.07 mm/yr) is based on NOAA tidal records at Atlantic City, NJ. Figure 3.7 shows historical SLC at Atlantic City from 1992 to 2019. Several metrics for sea level are presented, the monthly mean sea level (light blue), 5-year moving average (orange), and 19-year moving average (dark blue). It is apparent that over longtime scales (19 years) mean sea level is steadily increasing. However, over shorter time scales mean sea level may increase or decrease.

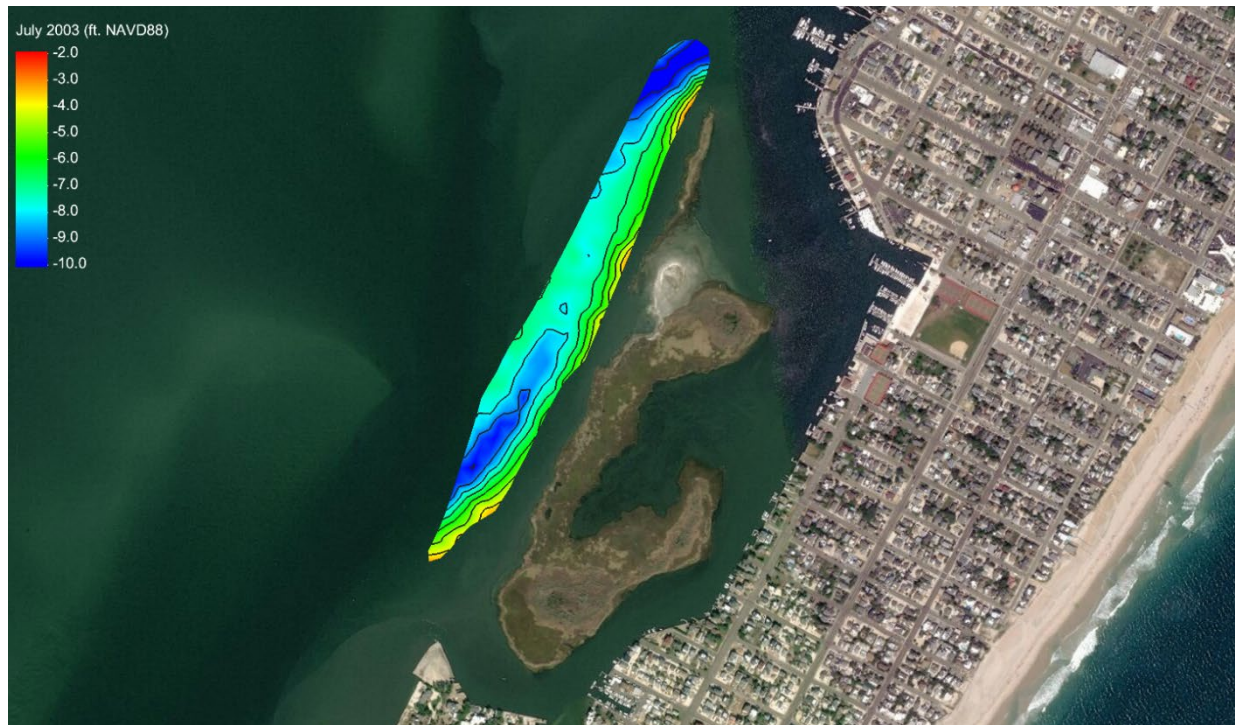
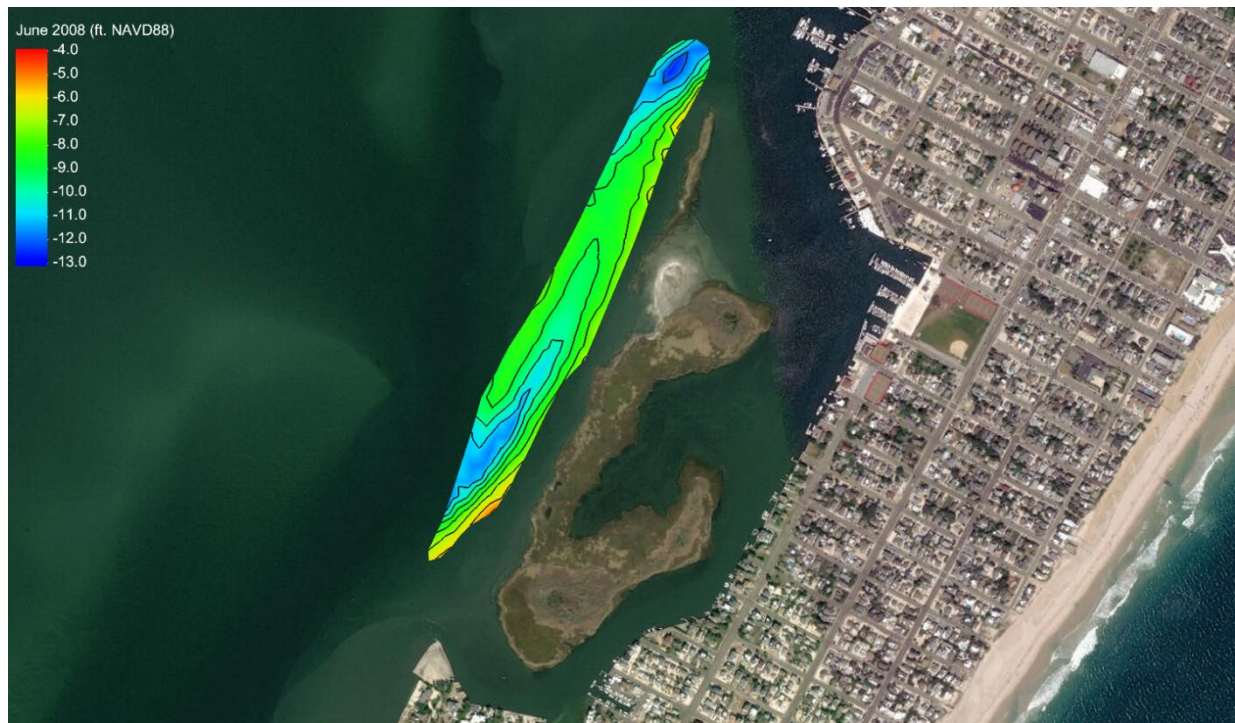
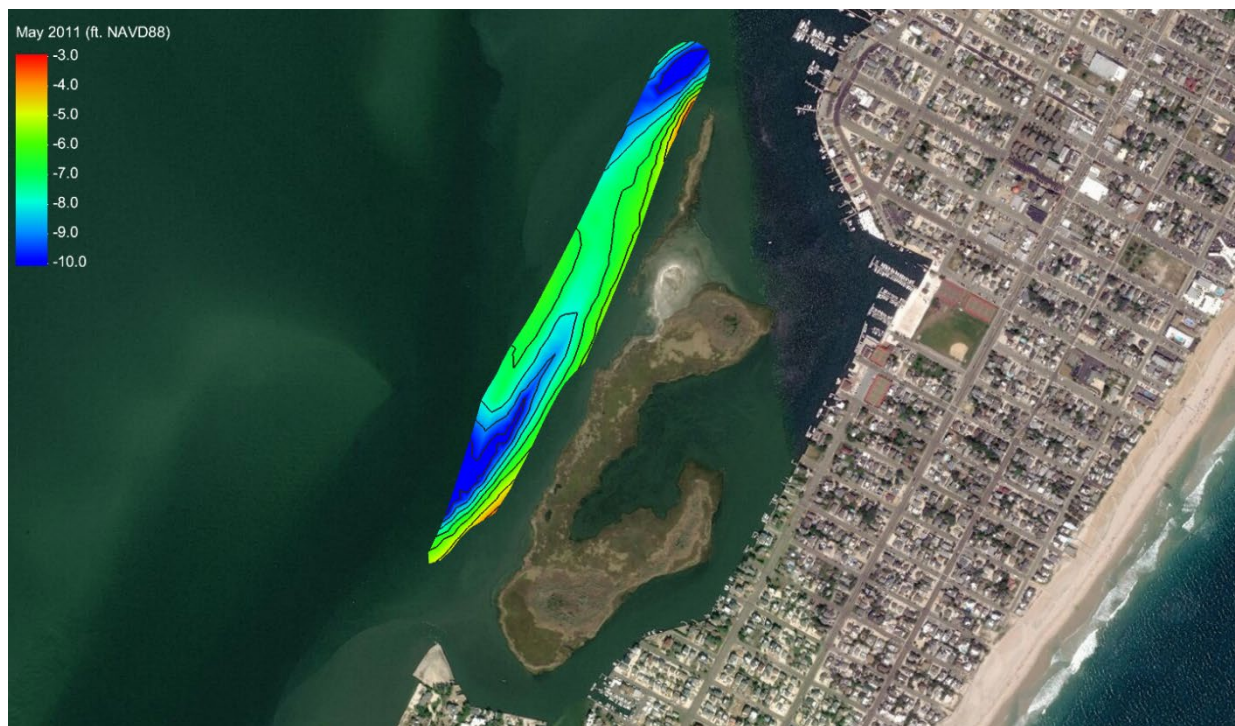
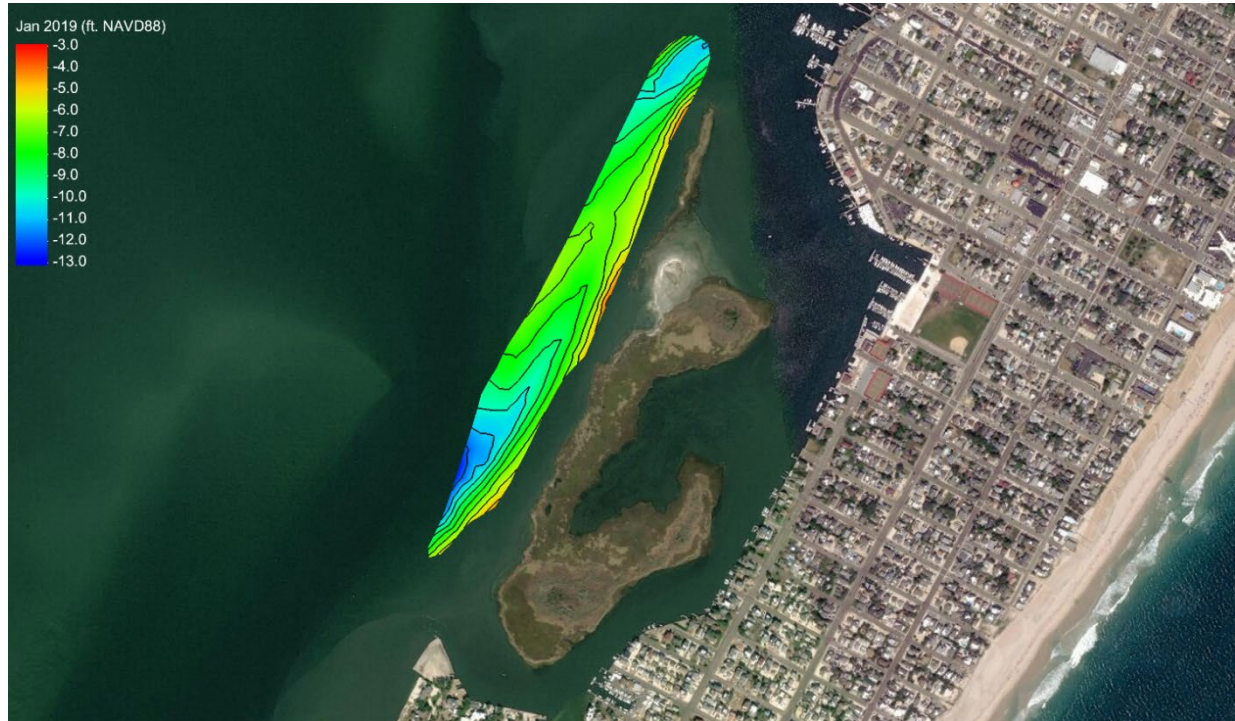
An offshore bathymetric change analysis was conducted off the western coastline of Mordecai Island to see if there has been any significant natural scouring or deposition in the nearshore from Mordecai Island erosion itself or from other sources. Bathymetric survey data collected in 2003, 2008, 2011, and 2019 was used in the analysis and the extent of the analysis was limited to the offshore area where coverage from all five survey dates overlapped. Digital elevation models were created from each survey as shown in the contour plots of Figure 3.9 to Figure 3.12.

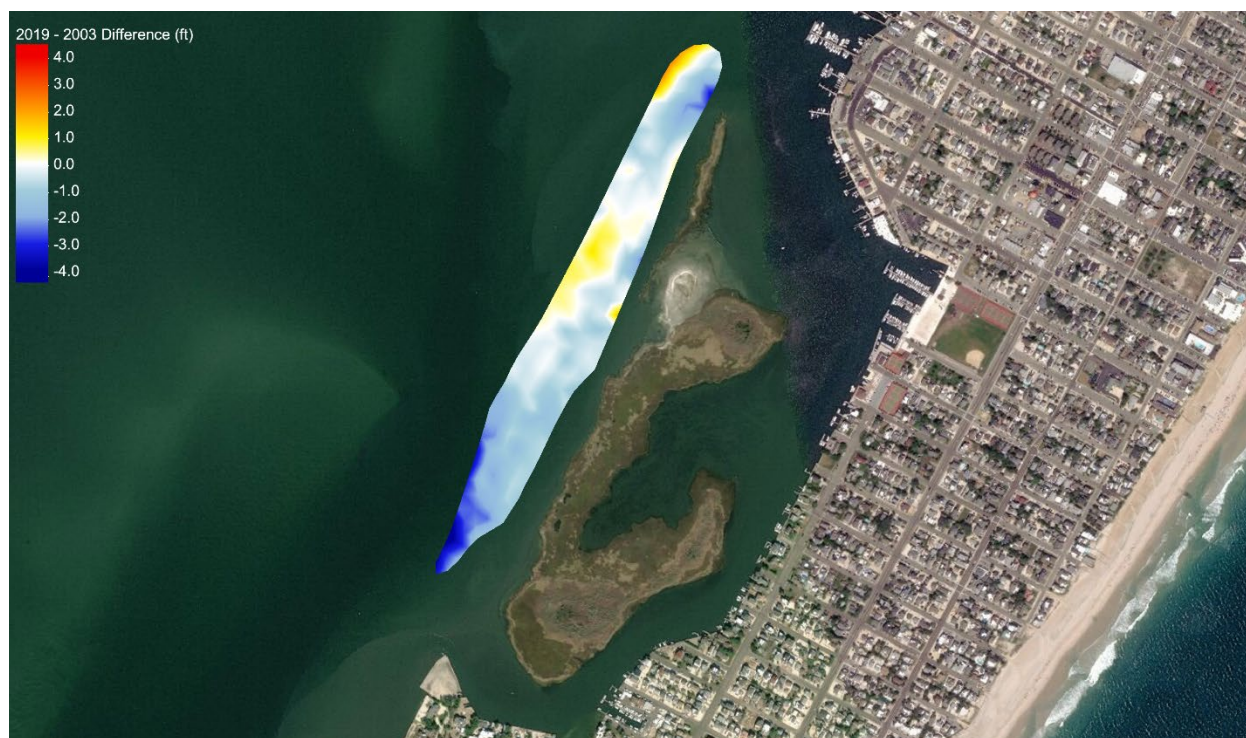
Figure 3.13: Changes in Offshore Bathymetry 2003 - 2019

Visualization of the difference between 2003 and 2019 was done by subtracting the bathymetric surface DEM from the Jan. 2019 survey from the July 2003 bathymetric surface DEM as shown in Figure 3.13. The figure shows where offshore are areas of deposition (positive) and areas of scour (negative).

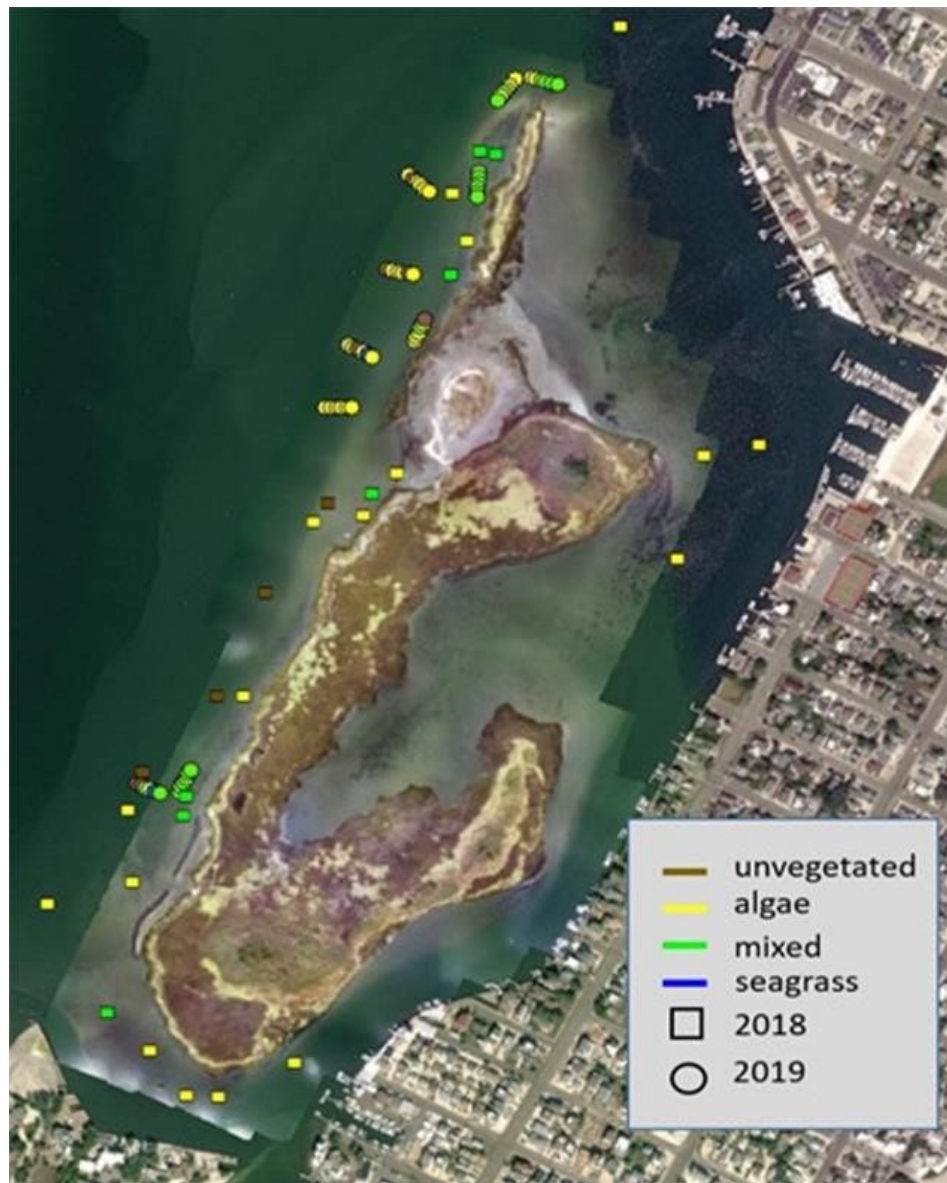
Figure 3.15: 2018 and 2019 NOAA-NCCOS Subtidal Vegetation Survey Results (NOAA-NCCOS pers. comm.)

In 2019, NOAA-NCCOS modified their methods and use a towed, sled-mounted camera at randomly selected locations and “concentrated their efforts in the nearshore waters on the west side of the island.” These results indicate that, “macroalgae was generally more abundant than SAV. Total percent cover of both algae and SAV dropped off dramatically with distance from shore.” (Davis pers. comm.).

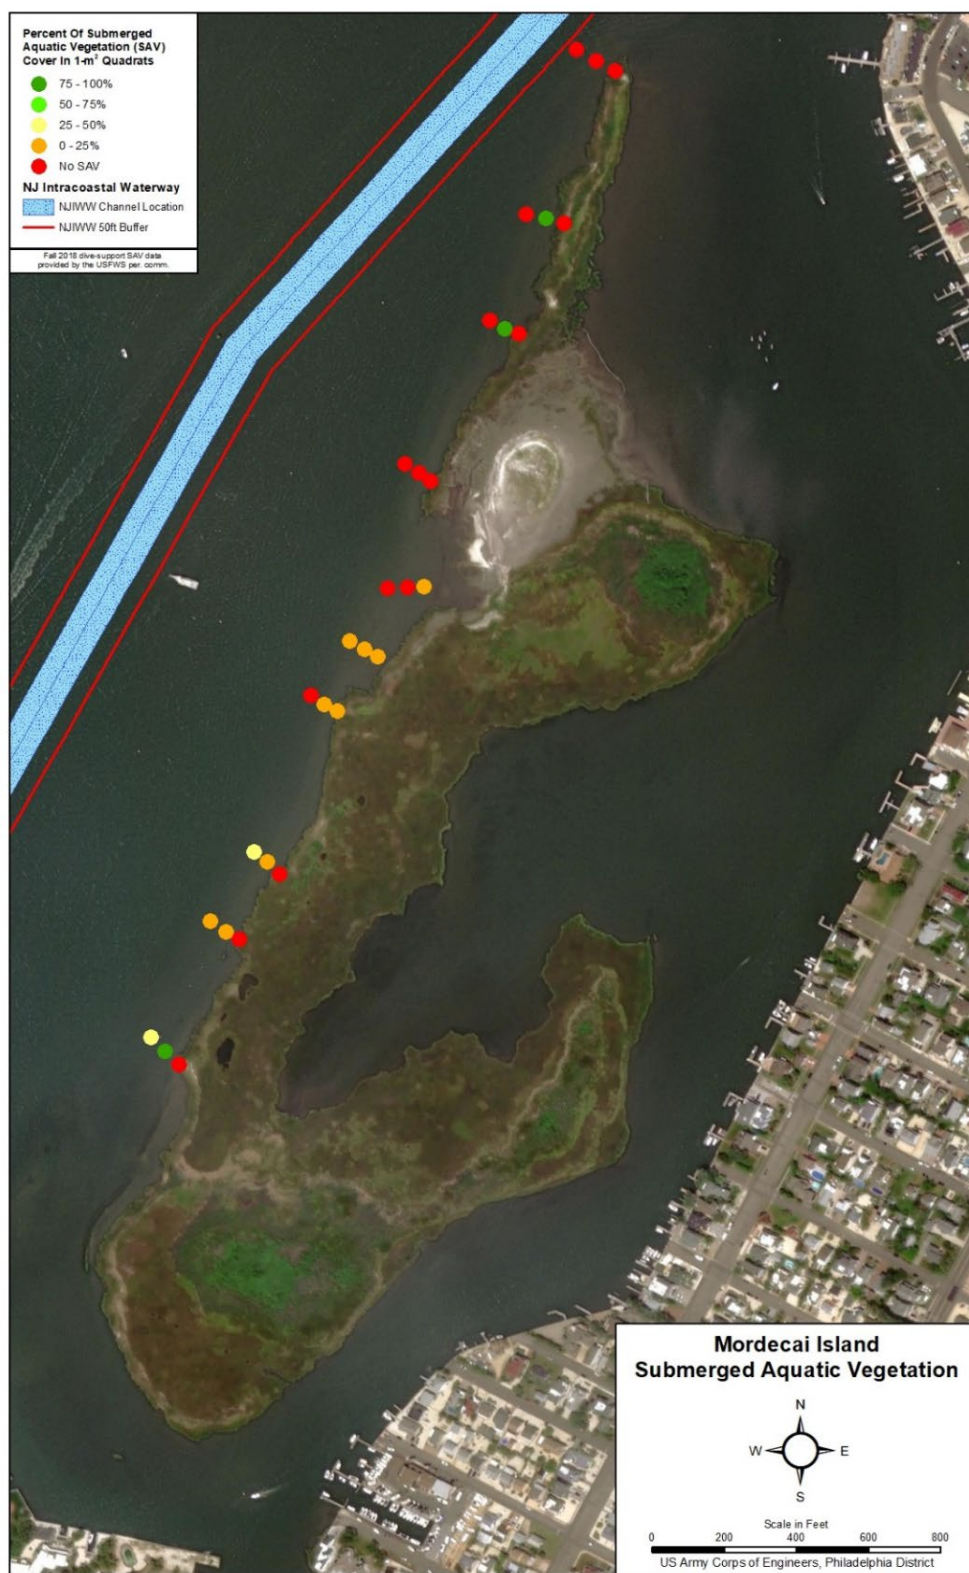
Figure 3.16: 2018 USFWS and MLT SAV Survey Results

Additionally, USFWS and MLT conducted a SAV survey via snorkeling in 2018. During the survey, the team collected depth and percent cover of SAV, macroalgae, and sediment in 1-square meter quadrats along 10 transects. The results of this survey are presented in Figure 3.16. Incidental observations conducted after the survey found the densest SAV beds near the oyster castles (Mcculloch, pers. comm.).
