**Mordecai Island
Beach Haven, New Jersey
Project Modification for
Ecosystem Restoration (Section 1135)
Feasibility Study and Integrated
Environmental Assessment**

**February 7, 2022
DRAFT FEASIBILITY REPORT**

**U.S. Army Corps of
Engineers
Philadelphia District**

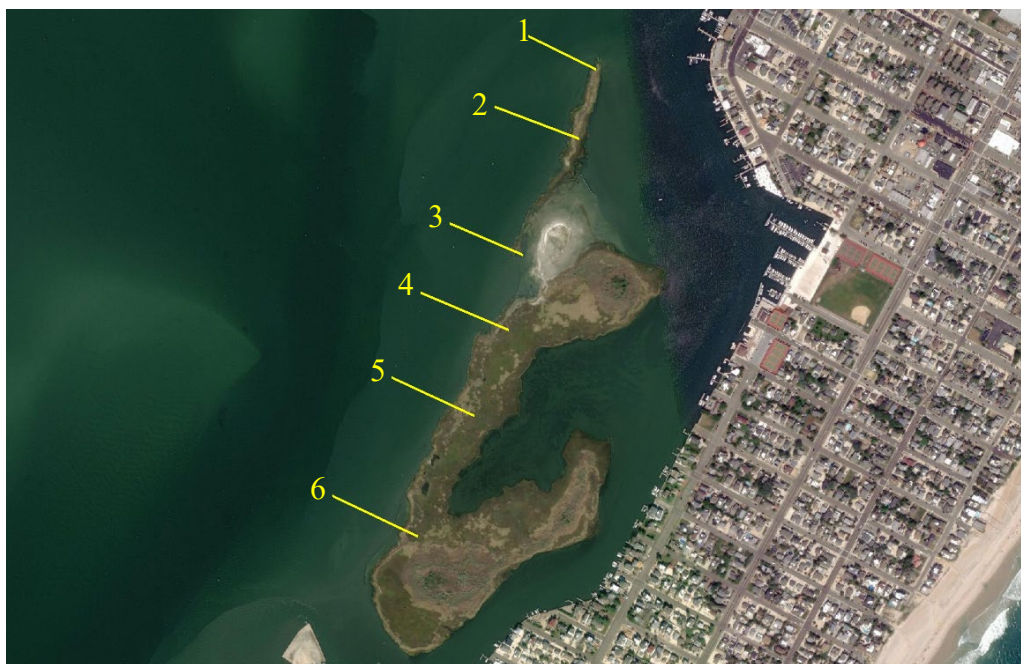
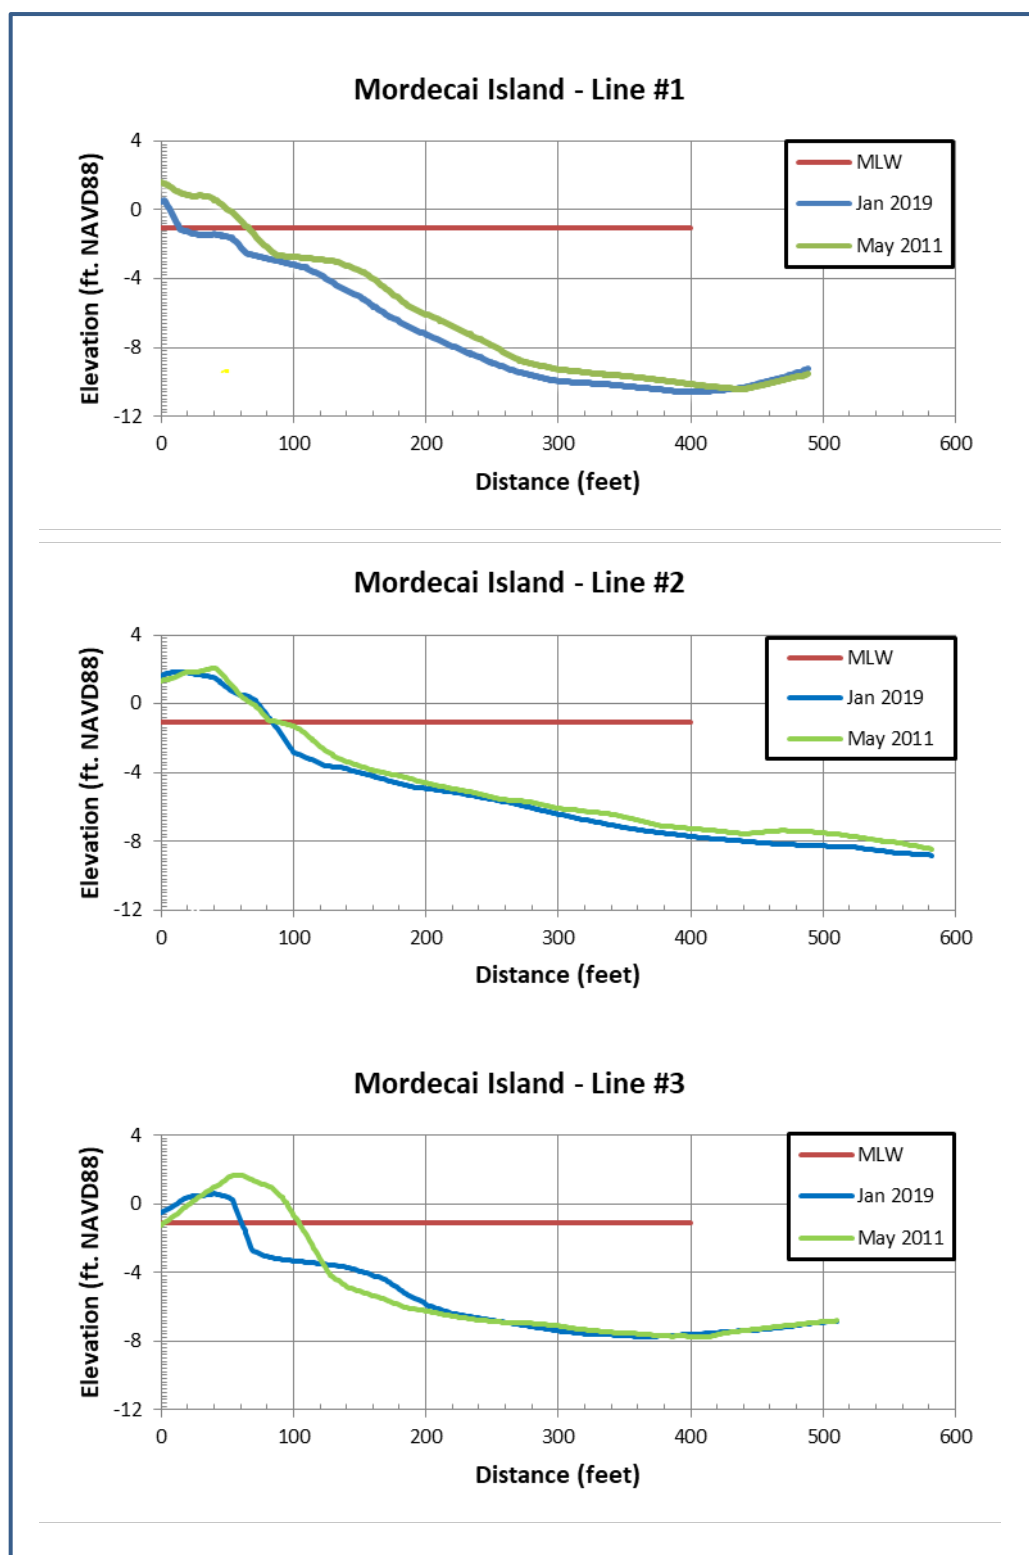
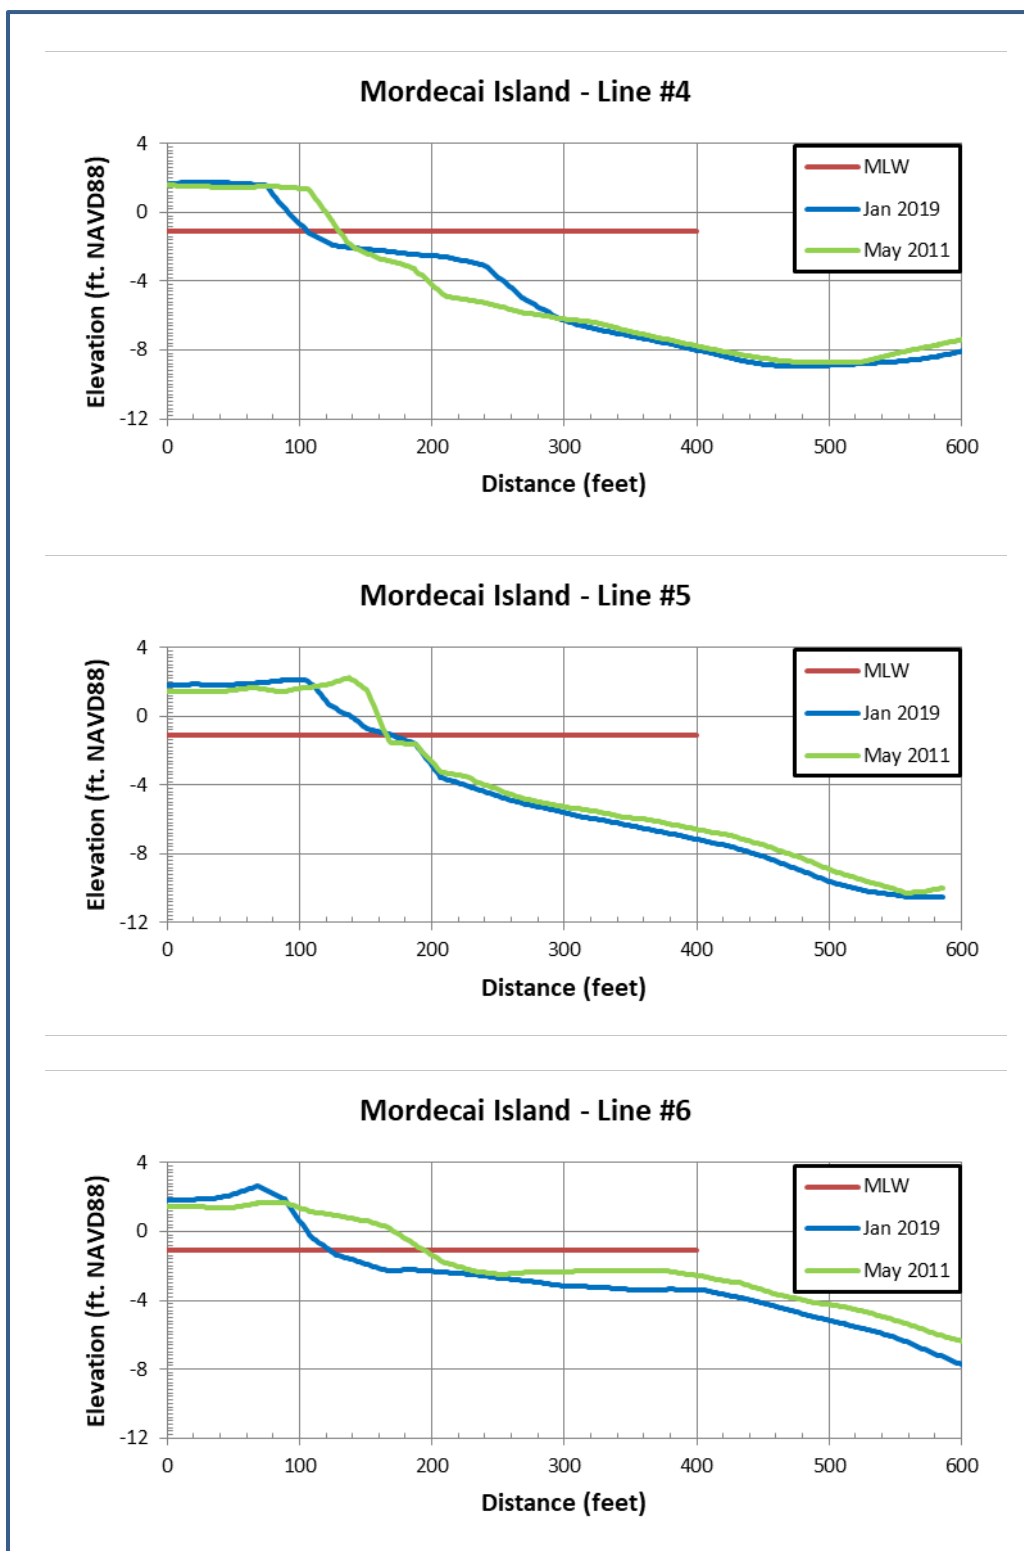
Cross-Section Method: DEMs were developed for the May 2011 and January 2019 topographic and bathymetric surveys and six cross-sections were cut (Figure 4.1) perpendicular to the western shoreline in order to track and visualize topographic and bathymetric changes in the nearshore during that eight year period as shown in Figure 4.2 and Figure 4.3.

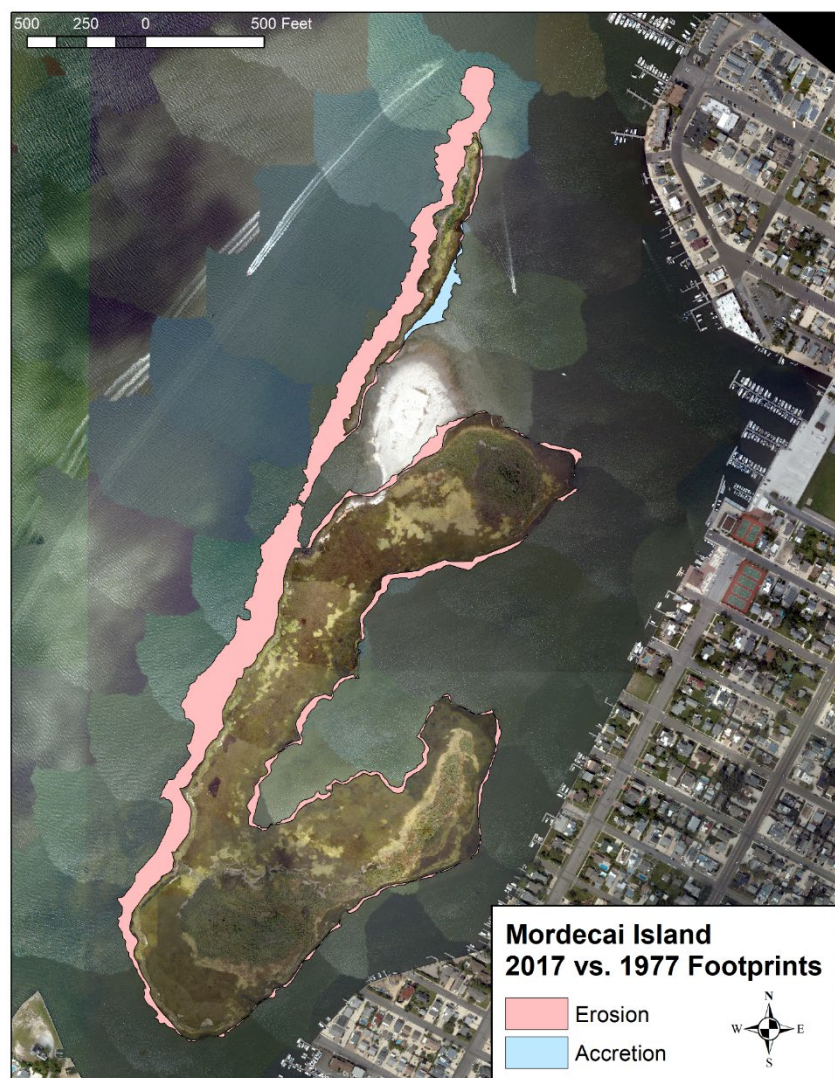
Footprint Method: Geo-referenced aerial photography of Mordecai Island from the years of 1977, 1995, 2002, 2007, 2012, 2015, and 2017 was obtained from various sources and digitized in order to quantify historical erosion rates on a footprint basis. The island footprint was digitized in ArcGIS for each aerial date and they were plotted against each other as shown in Figure 4.4. Also, a map was prepared that shows erosion and accretion areas around the perimeter of the island from the 1977 and 2017 aerials, as shown in Figure 4.5. It should be noted that the digitized shorelines representing the island footprint for each aerial photograph should not be considered necessarily as either the MHW or MLW line. They are just representations of the land/water interface and their locations are subject to the resolution and quality of the aerial photograph.

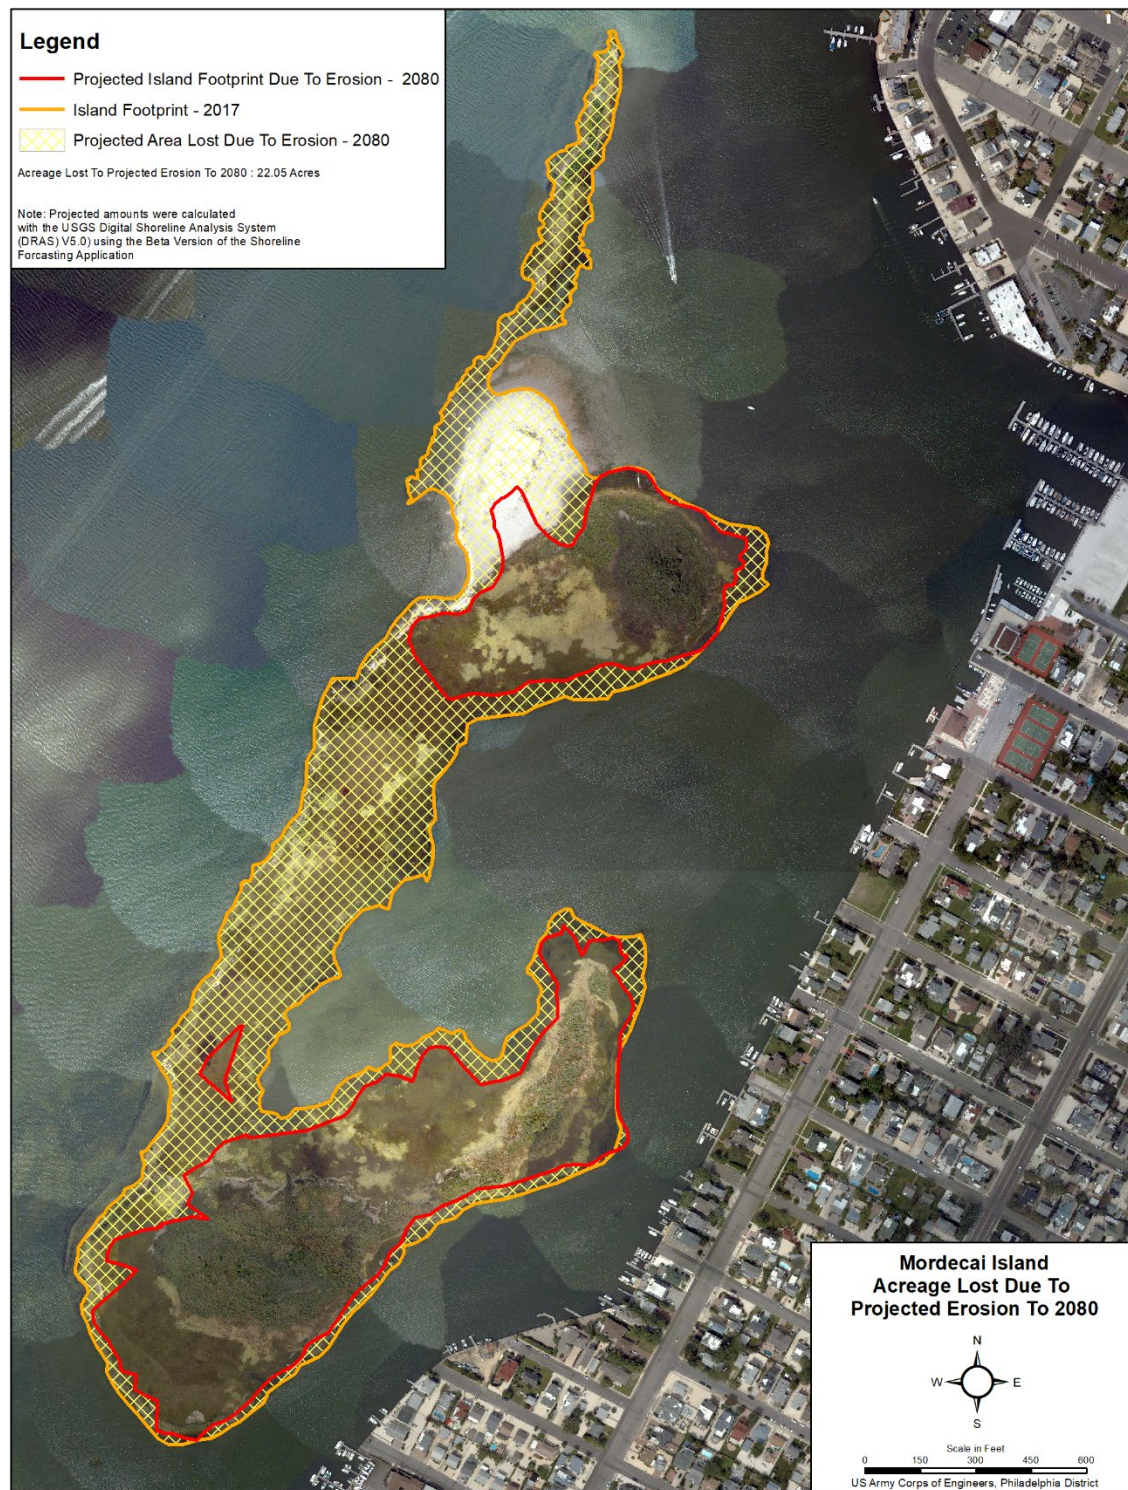
Figure 4.7: Future Without Project Condition - Projected Acreage Lost to Erosion by 2080

In the future, approximately 22 acres of Mordecai Island could be eroded by the year 2080, as shown in Figure 4.7. Separate analyses were conducted that projected a future Mordecai Island footprint in the year 2080 based upon historical erosion rates, future accelerated sea level change, and a combination of both. The historical annual erosion rates developed using the transect method described in Section 4.2 were the basis to determine what the size and shape of Mordecai Island could look like in the year 2080. At the onset of the analysis it was determined that having transects spaced every 200 ft. was not dense enough to adequately determine the size and shape of the island. The ArcGIS tool called “Digital Shoreline Analysis System” (DSAS) published by the USGS was used to take the rates developed every 200 ft. and refine them to a much closer spacing. The DSAS tool automates the process of taking multiple shoreline positions and calculating erosional changes out into the future.

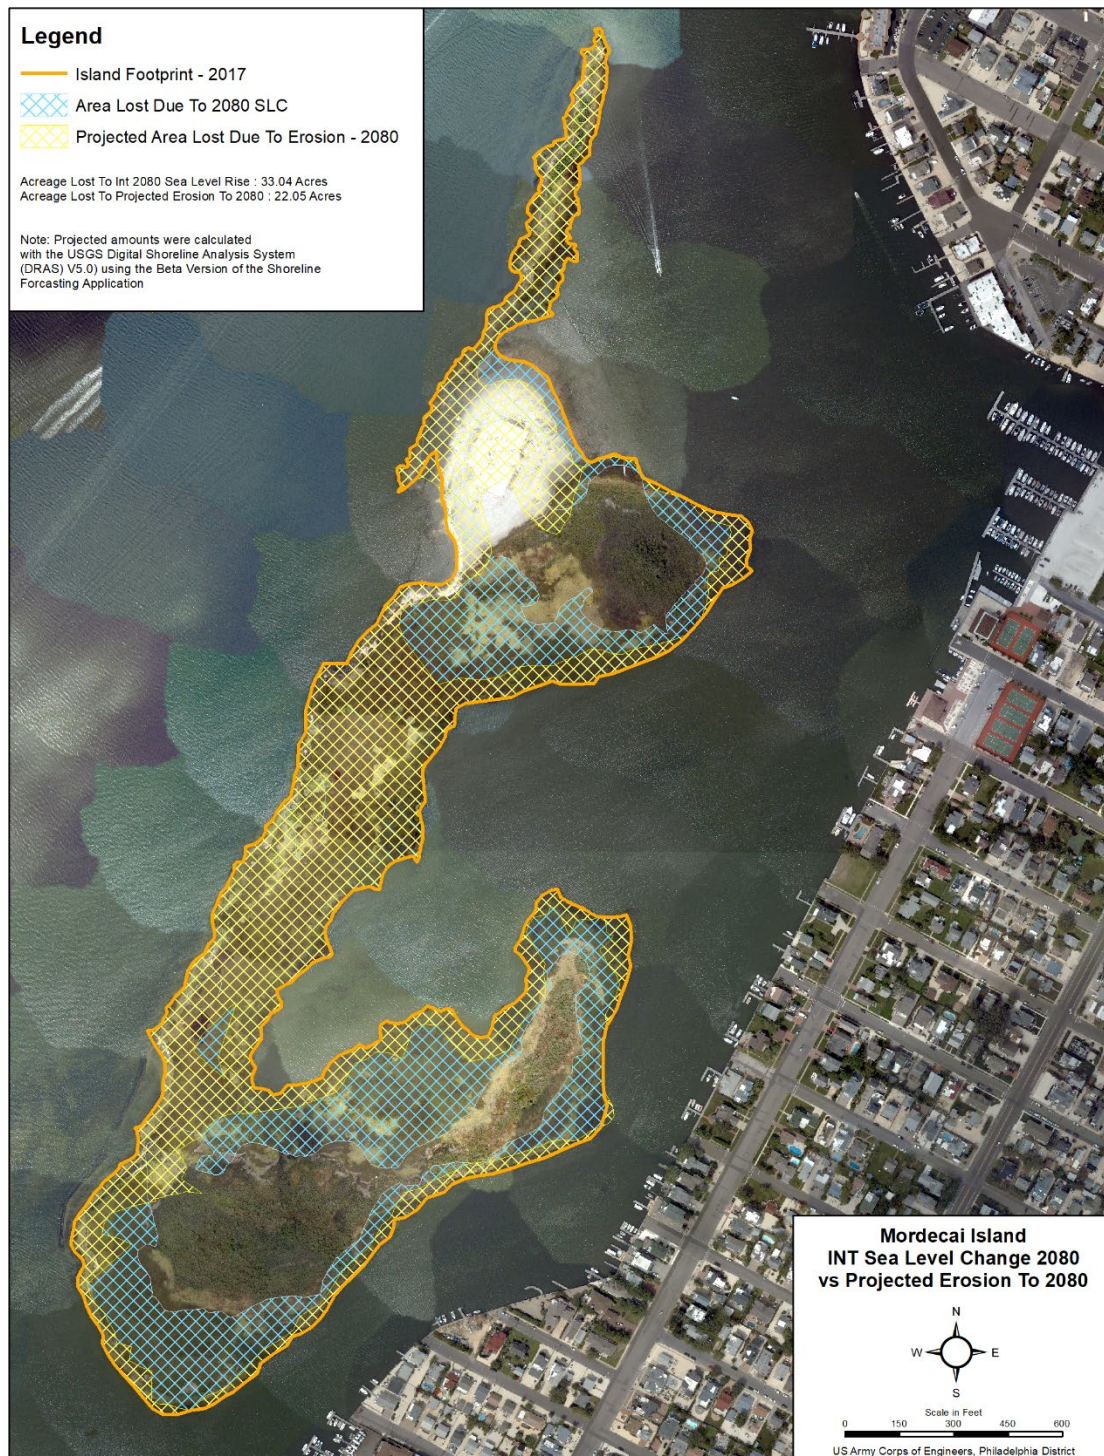
Figure 4.8: Future Without Project Condition - Combined Projected Acreage Lost to Erosion and Sea Level Rise by 2080

The results of both the future erosion and sea level change footprints were superimposed to derive a worse-case scenario of what the island's size and shape could be in year 2080, as shown in Figure 4.8 without and with topographic elevations from the recent 2018/19 island surveys.

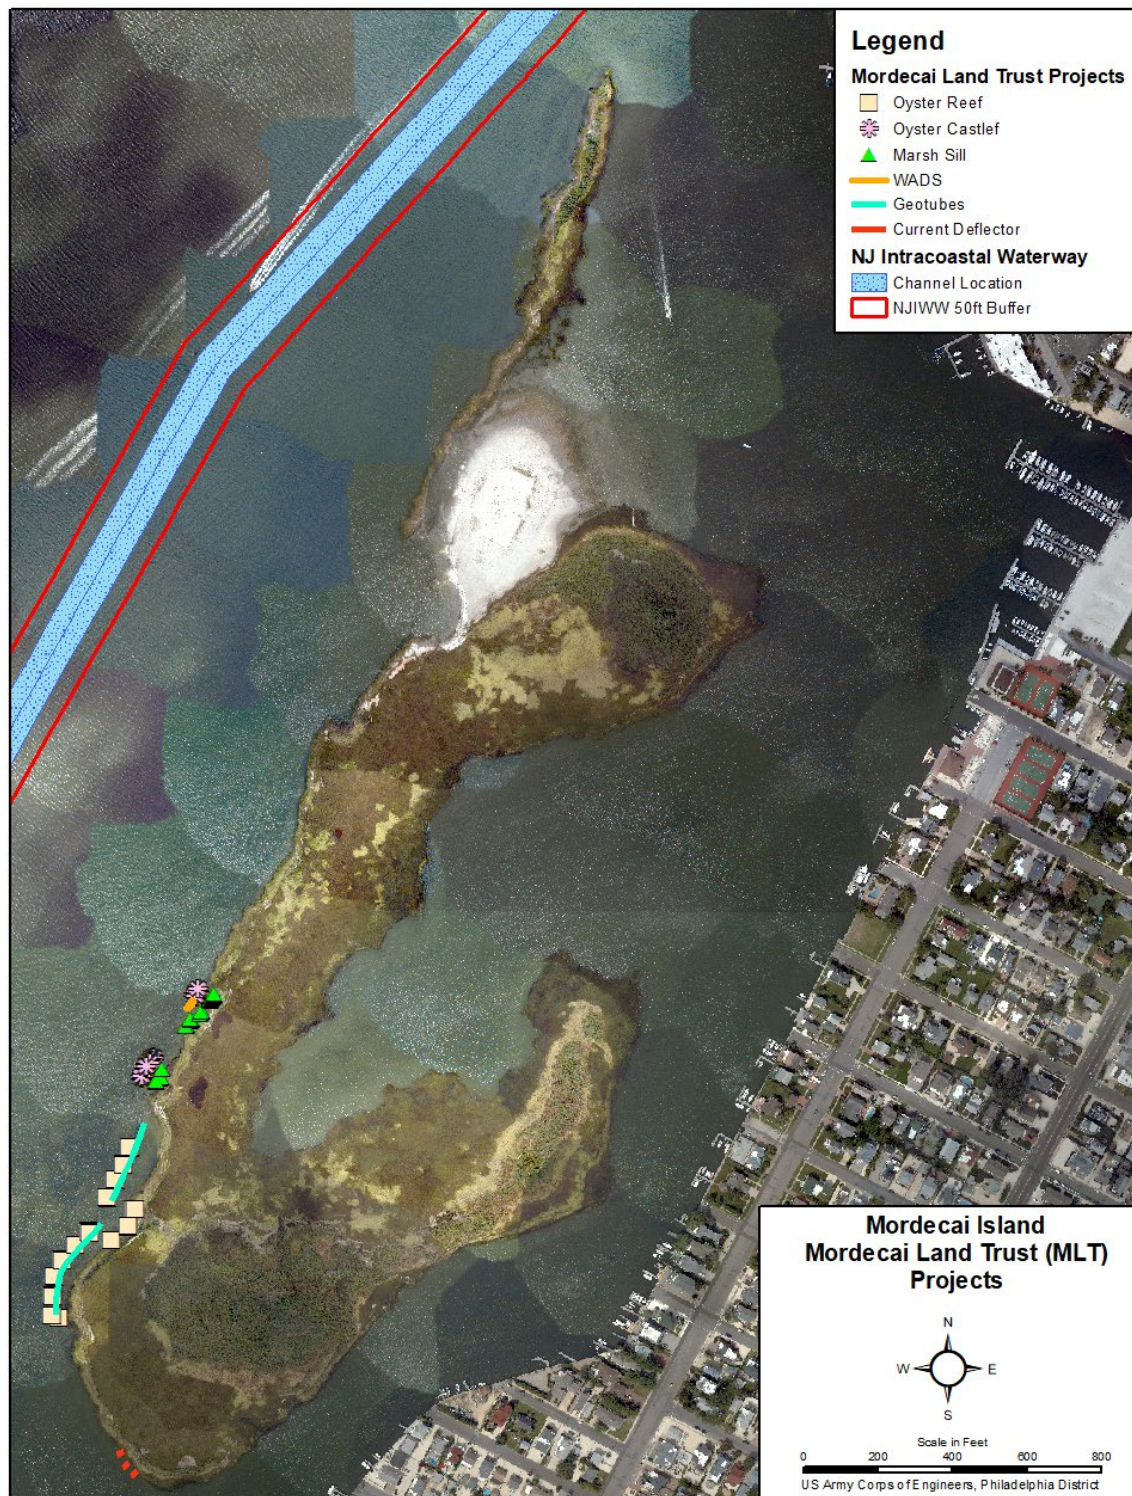
Figure 5.2: MLT Erosion Control Features

- 1) Ongoing local erosion control efforts need to be taken into consideration. See Figure 5.2.
- 2) Tidelands are all lands that are currently and formerly flowed by the mean high tide of a natural waterway. A project can be implemented within the boundary of the 1977 tidelands line. NJDEP Division of Land Use Regulation can more easily issue permits within the 1977 tidelands line. See Figure 5.1.

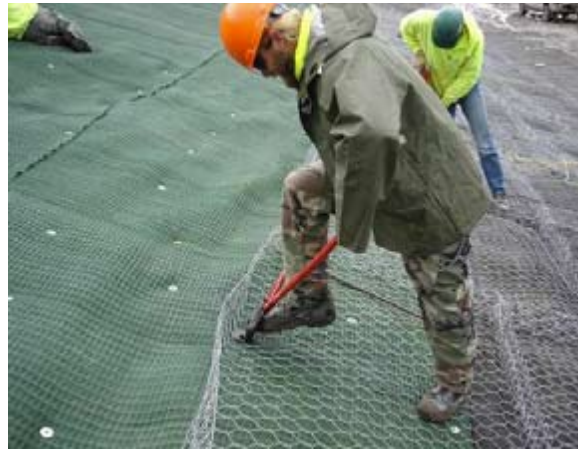
Figure 5.3: Installation of Turf Reinforcement Mat

Turf reinforcement mats (see Figures 5.3 and 5.4) can be biodegradable or non-biodegradable. Based on the following information from ERDC 2014, only non-biodegradable material was considered as a potential erosion control measure for Mordecai Island.

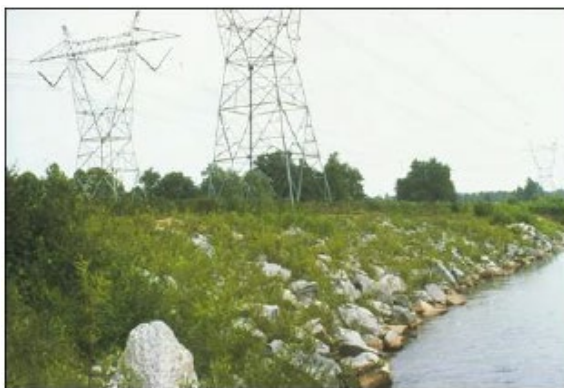
Figure 5.5: Stone Revetment with Planting

With planting, this measure is also known as a joint planted revetment (see Figure 5.5). Per Stevens Institute of Technology 2016, “Revetments are shore-attached structures built along the shoreline to prevent erosion of the bank. Revetments are typically constructed from rock or concrete armor units, although alternative materials such as gabion baskets, rubble/debris, and even felled trees can also be used. Revetments are designed to armor the existing bank and to dissipate the incident wave energy on their sloping face. Revetments can be used at both open coastal locations and on lower energy sheltered coasts. Revetments differ from rip-rap covered slopes in that revetments are typically designed more rigorously and have more clearly defined layers and stone sizes. As part of a living shorelines strategy, the interstitial spaces in a traditional revetment can be planted. Incorporating vegetation within the revetment can provide valuable ecological benefits and help to stabilize the soil under the revetment.”

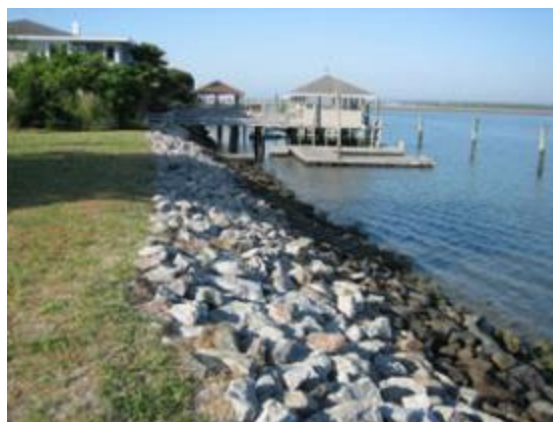
Figure 5.6: Stone Revetments

“Revetments are typically constructed on a 1Vertical: 2Horizontal slope. Riprap/Stone can move during storms or wave action and as such the stone used needs to be heavy enough to remain in place. Revetments are very long lasting, durable structures which usually do not need any maintenance after construction. Revetments, when designed to, can withstand a wide range of wave energies from very little to large wave action. Although revetments cause a loss of soft bottom habitat, it causes less habitat destruction and loss than bulkheads and also creates fisheries habitat.” (See Figure 5.6.)

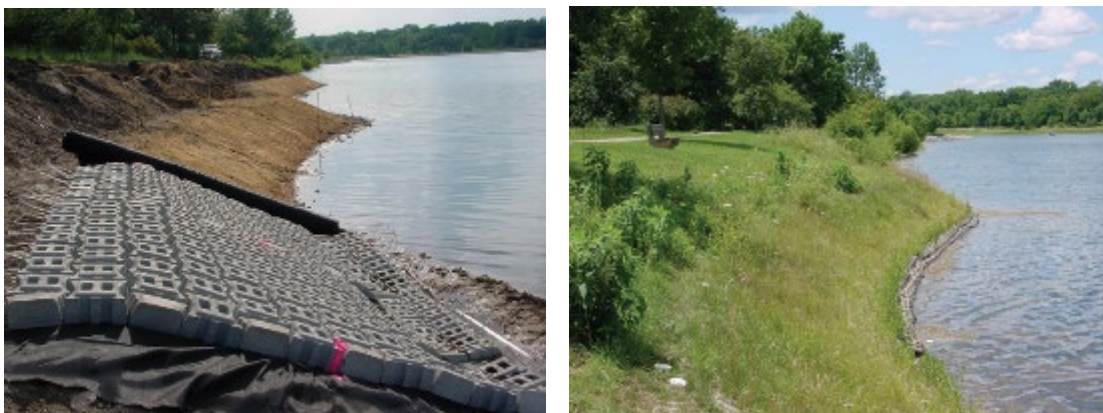
Figure 5.7: Articulated Concrete Mat Installation and Planted

Articulated concrete mats consist of a flexible, interlocking matrix of cellular concrete blocks of uniform size, shape, and weight used for hard armor erosion control. (See Figure 5.7.) The concrete blocks can be solid or have openings in them. For Mordecai Island, open celled blocks were considered in order to support growth of marsh vegetation.

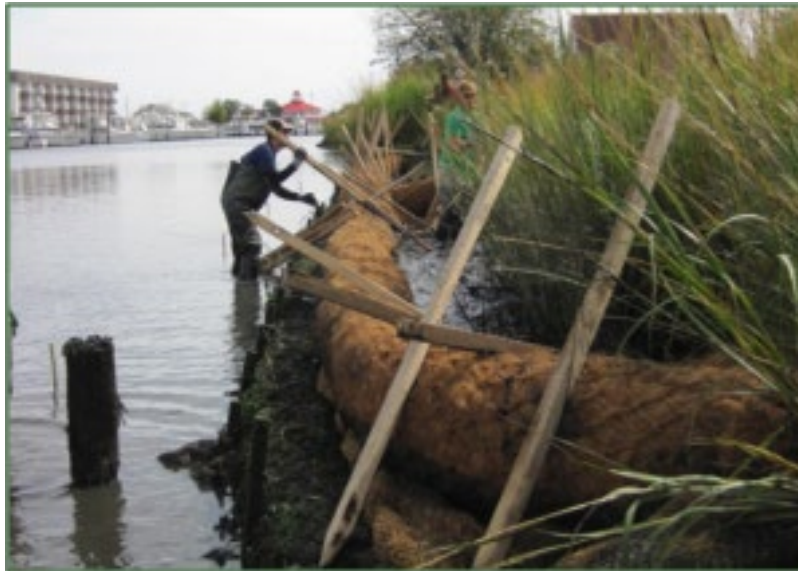
Figure 5.8: Installation of Biologs

Biologs are tubes typically made with polyethylene or coir twine material on the outside and packed coconut fiber on the inside. According to Austin, Texas, Watershed Protection Department, “Coir is anchored in areas with loose soils that need stabilization including stream banks, wetlands and construction sites. The advantage of using coir logs for erosion control (rather than rocks or bulkheads) is that the coir allows vegetation to grow within it as it slowly biodegrades becoming part of the matrix of the soil. When the coir has finally biodegraded (years later), the roots of the vegetation then provide the long-term stability of the soil which provides natural and beneficial integrity to the land and water.” (See Figures 5.8 and 5.9.)

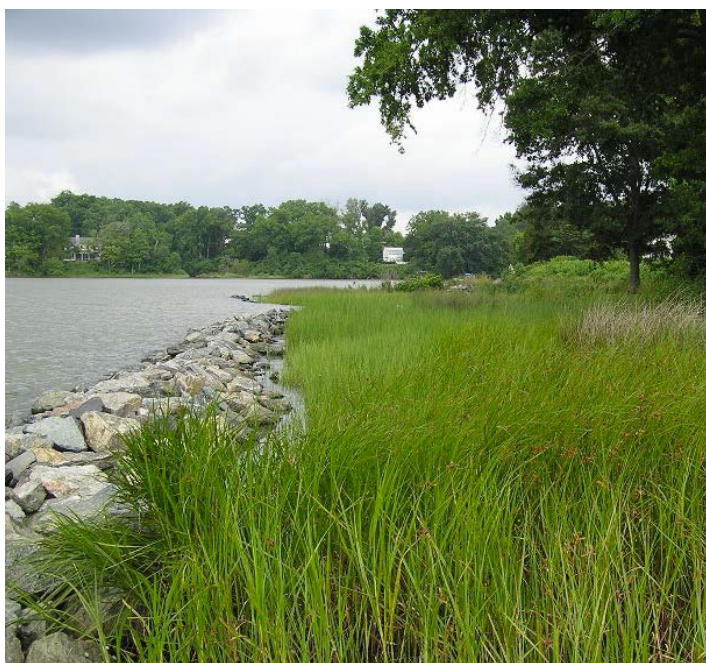
Figure 5.11: Nearshore Stone Sill

“Sills are low-elevation, typically stone structures that are constructed in the water parallel to the existing shoreline. Sills are often used as armoring for fringe marshes or wetlands that require a higher degree of protection. Sills dissipate wave energy and reduce bank erosion, causing waves to break on the offshore structure, rather than upon the natural, more fragile shore. The quiescent area of water that is created by the sill often allows sand and sediment to accumulate between the structure and the shoreline. With time this process can eventually raise the elevation of the bottom and create a perched beach. This unique effect not only serves to further stabilize the shoreline or marsh behind the sill but replaces lost and eroded land. Often the area between the sill and the shoreline is filled during construction to accelerate the development of the perched beach. Marsh plantings are often added to further stabilize the reclaimed land.”³ (See Figure 5.11.)

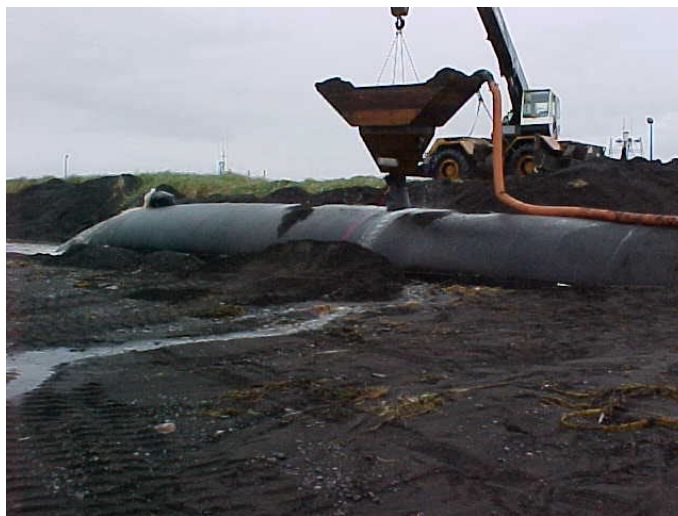
Figure 5.13: Corps Installation of Geotubes® at Nelson Lagoon, Alaska

Geotubes® are sediment-filled permeable, but soil-tight, sleeves of geotextile fabric. When used for erosion control they are usually large, often with a circumference of 15 – 60 or more ft. and lengths of 50 – 200 or more ft. (See Figure 5.13.)

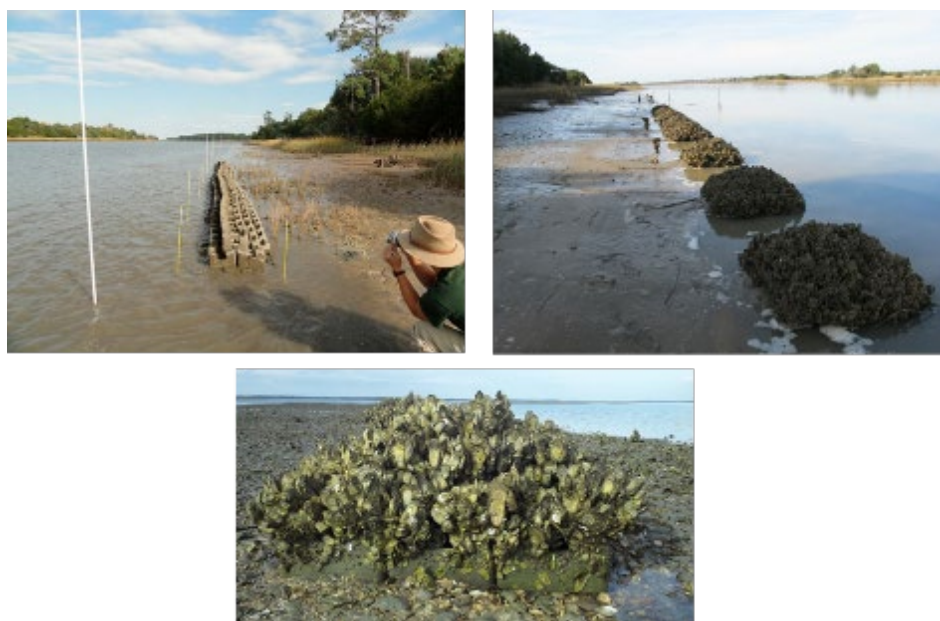
Figure 5.14: Oyster Castles®

"Oyster Castles® are prefabricated concrete blocks specifically designed to attract and foster oyster settlement and are manufactured by Allied Concrete Company in Charlottesville, Virginia. Each Oyster Castle® is 1 foot by 1 foot, 8 inches high, and 2 to 3 inches thick... The structures are hollow on the inside with a notch cut into each side to allow the blocks to lock together."⁴ (See Figure 5.14.)

Oyster Castles® are designed to be connected into arrays of various sizes. Shoreline remediation and salt marsh preservation are by-products of the effort geared toward oyster restoration.

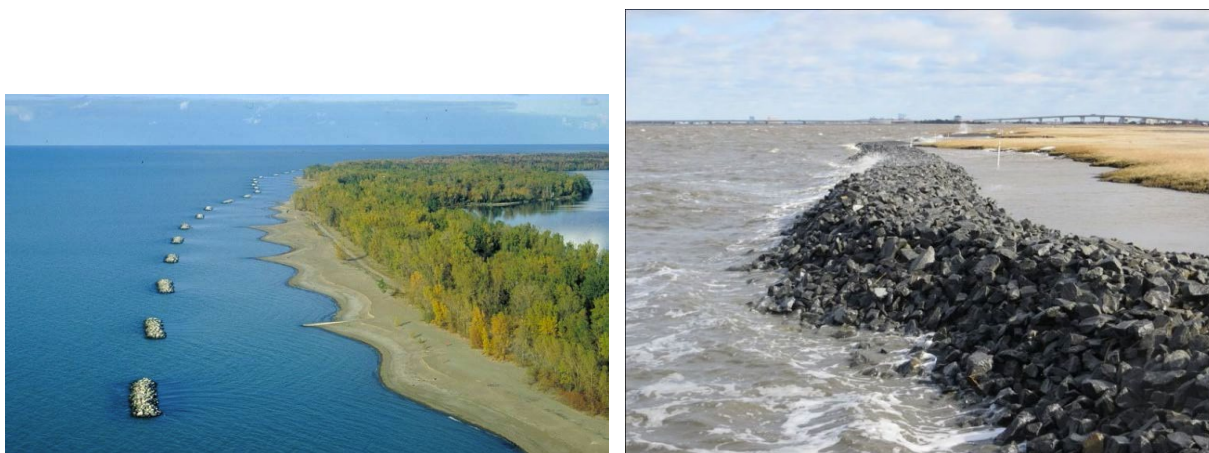
Figure 5.15: Stone Breakwaters

(See also, **Geotubes® with armor layer** and **Precast concrete structures**) Per Stevens Institute of Technology (2016), “Breakwaters are coastal engineering structures typically constructed parallel to the shoreline that are designed to reduce the amount of wave energy experienced by the area directly behind them. Breakwaters are frequently used in marinas and harbors as well as along open coasts. When utilized as a part of a living shorelines project, breakwaters are designed to reduce the wave energy to acceptable levels to allow the establishment of a beach or vegetated (typically marsh) shoreline in its lee. Breakwaters are distinguished from sills in that they are typically constructed in deeper water, further from shore, in more energetic wave climates, and tend to be slightly larger.”

Breakwaters can be continuous or have breakwater gaps as seen on the right and left, respectively in Figure 5.15. Breakwater gaps help promote sediment accretion behind the structure in sediment rich environments. In some areas, where there is not enough sediment in the system to naturally accrete, a continuous breakwater may be more advantageous. A continuous breakwater has a greater potential to protect material placed behind the structure. Instead of breakwater gaps, sill vents can be designed into a continuous breakwater by reducing the crest height in some areas of the structure to promote intertidal flushing while still protecting the habitat behind the structure. (See Figure 5.16.)

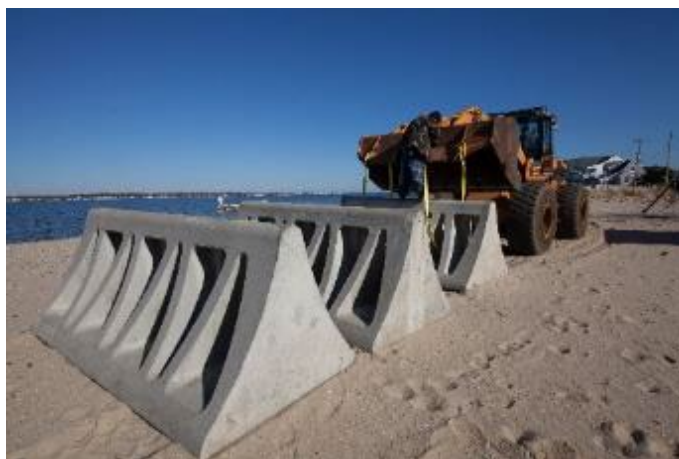
Figure 5.17: Beach Prisms™ Prior to Installation

Easi-Set® Worldwide's Beach Prisms™ are triangular pre-cast concrete structures that are designed to limit shoreline erosion in riverine and bay environments (see Figure 5.17). The structures have slots in them to allow water through while breaking wave energy. Each section is 3-4' in height and 10' in length, making them most appropriate to a near shore shallow environment. The size limit appears to limit opportunities for adaptation to sea level rise. Beach Prisms™ have been used in the Toms River off of Barnegat Bay, north of Mordecai Island.

Beach Prisms™ (weighing about 10,000 pounds each) before installation roughly 50 ft. away from the beach in the Toms River in Ocean Gate, NJ. (Photo by: FEMA/Rosanna Arias, <https://www.fema.gov/media-library/assets/images/85964> (accessed May 1, 2019))

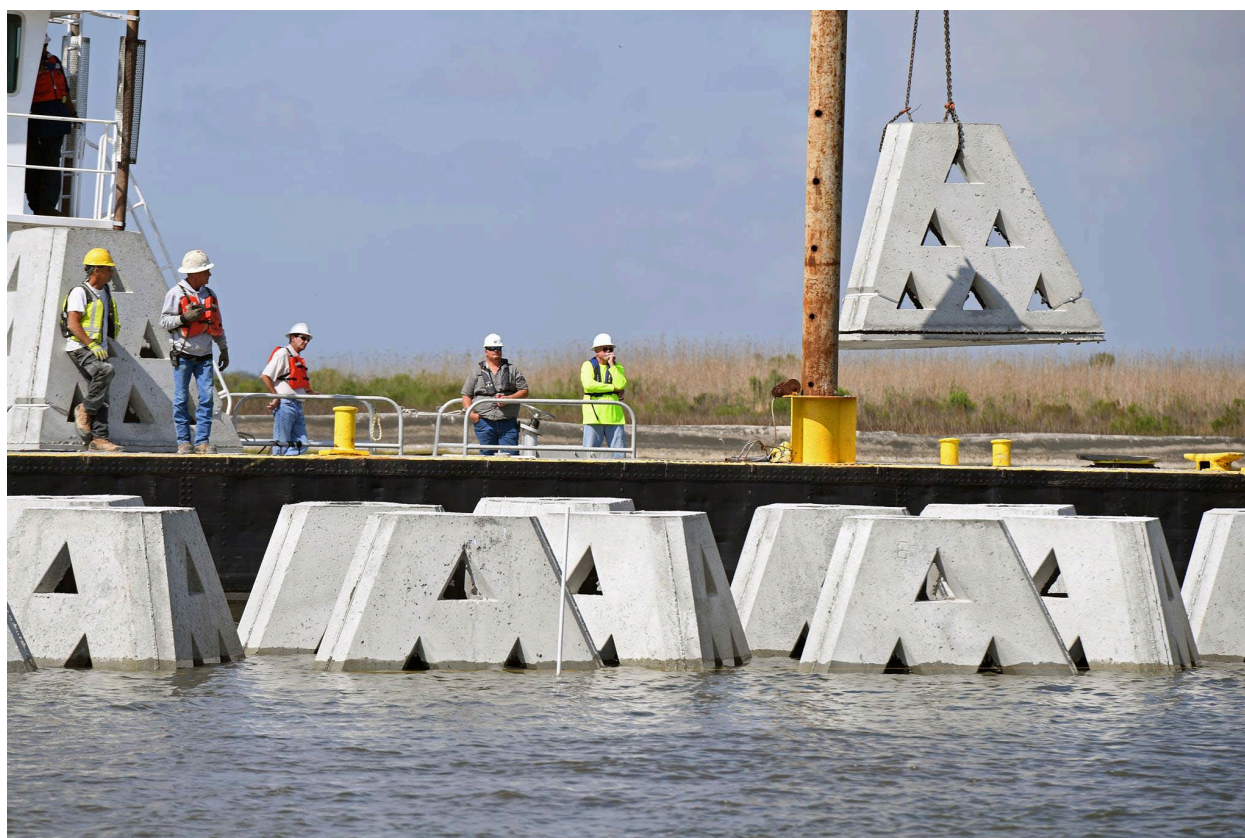
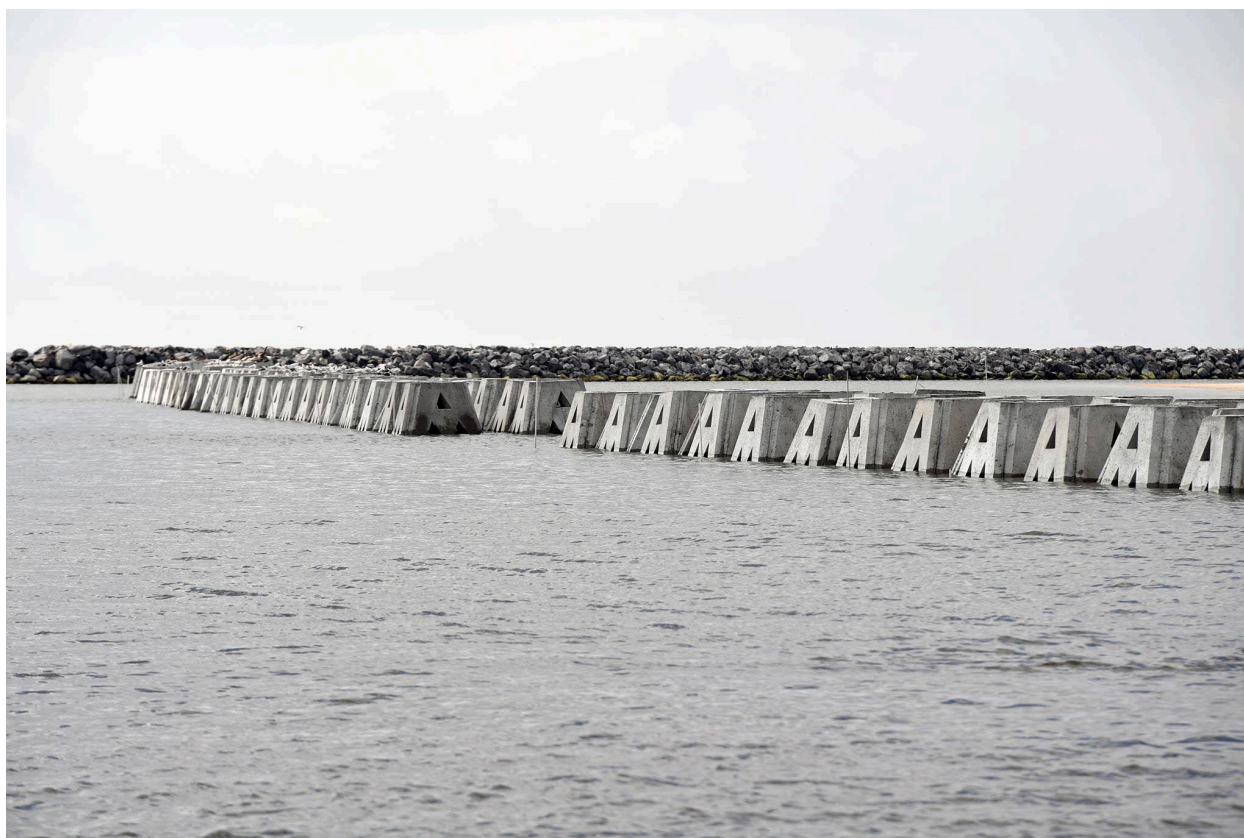
Figure 5.18: WADs® Placement at Bayou Caddy in Biloxi, MS

As previously described in Section 2.2.8 of this report, Living Shoreline Solutions, Inc.'s WADs® are poured concrete pyramids of varying heights that are designed to site conditions. The structures are hollow to allow water and biota to pass through, while reducing wave energy. They are often placed in overlapping rows. The system is not anchored to the bottom and is therefore portable in the event of needed modification. Rising water levels can be addressed by sliding another WAD® unit on top of an existing one, or by adding a higher row of WADs®. As shown in the Figures 5.18 and 5.19, the Corps has placed WADs® for a living shoreline project at Bayou Caddy in Biloxi, Mississippi.

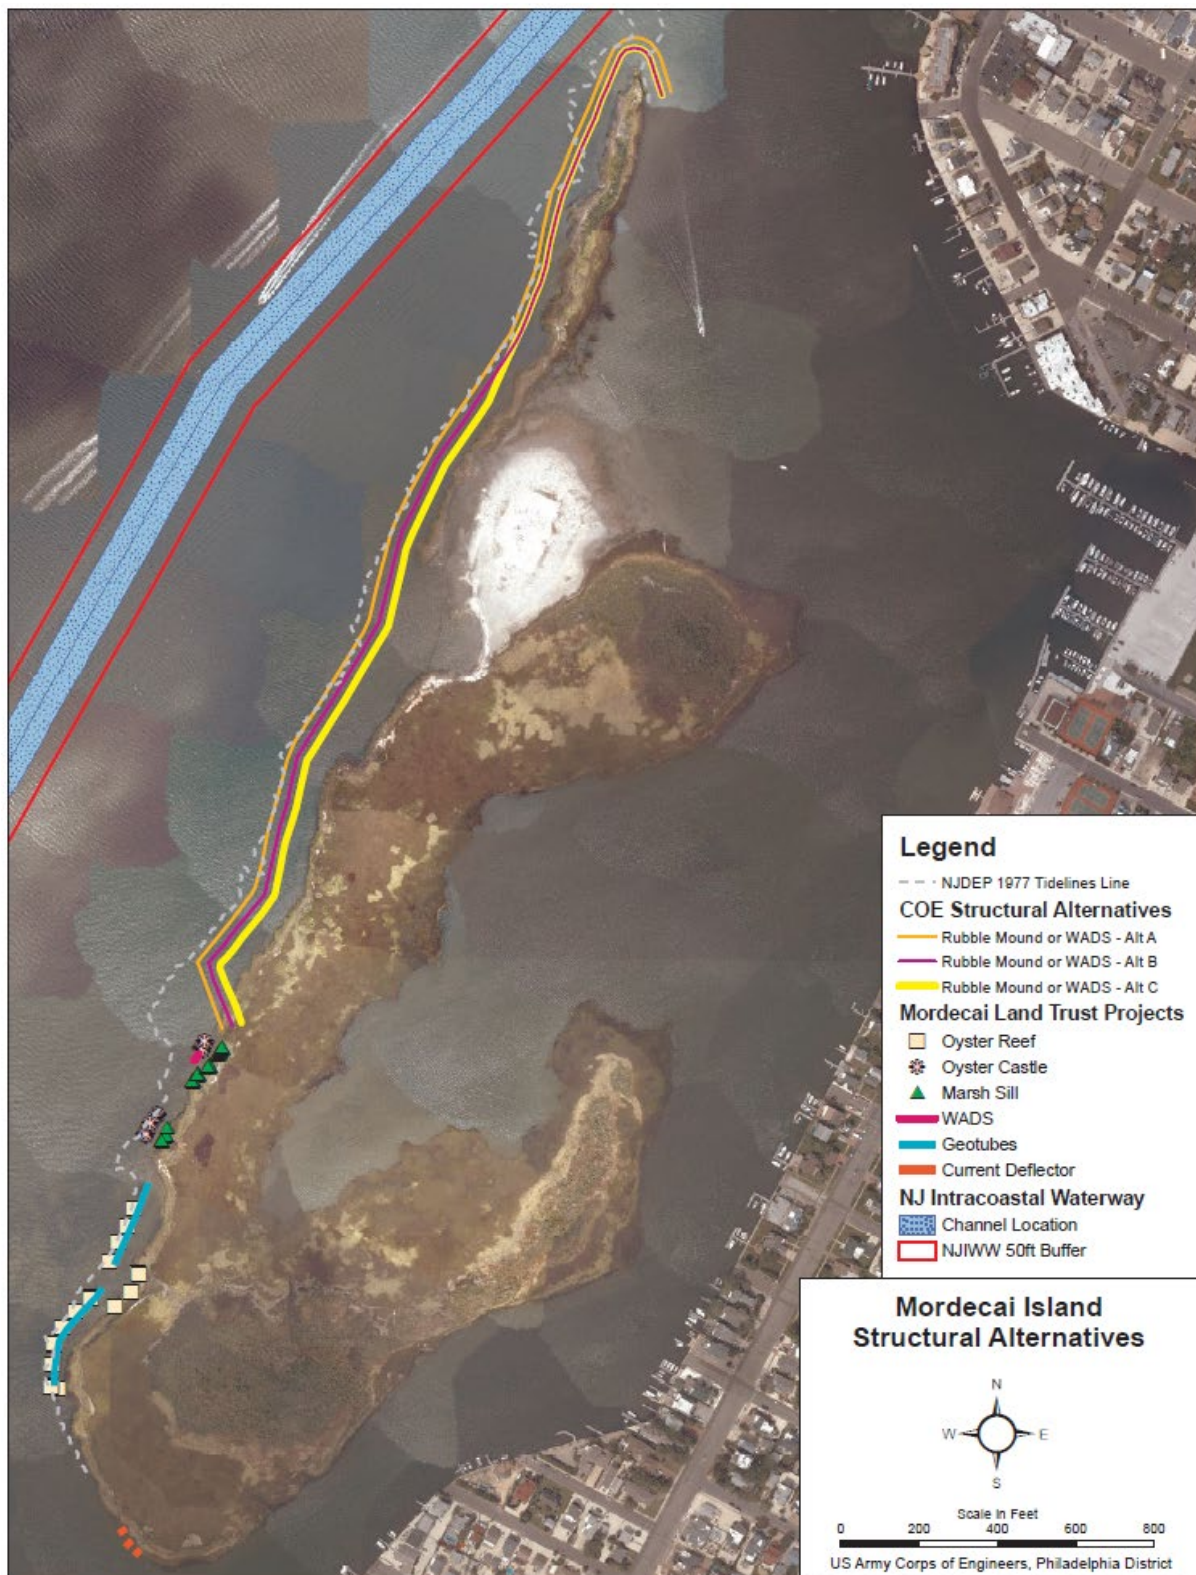
Figure 5.20: Plan View of Structural Alternatives

Both wave attenuation structures (e.g., WAD®) and rubble mound breakwaters, with and without fill, were considered at three different depths providing similar levels of erosion protection, with the 1977 Tidelands line generally representing the greatest depth (Alignment A) and two other alternatives (Alignments B and C) approximately 25 ft. apart in successively shallower water toward the western shore of the island. (See Figure 5.20.)

Structural alignments A, B, and C can be found in Figure 5.20. Fill material without a structure can be found in 5.21. Sample typical cross sections can be found in Figure 5.22 through Figure 5.27. Cross sections are not shown with fill because the amount of fill will vary throughout the placement

Description of rubble mound breakwater design remained the same as in Section 5.2.4 of this report. Alignments remained the same as in Figure 5.20 and are shown again in Figure 5.28. Cross sections remained the same as in Figures 5.22, 5.24 and 5.26. Each of the alternatives includes a recommendation to move No Wake Zone markers closer to the channel, at no cost to the project.
