**Mordecai Island
Beach Haven, New Jersey
Project Modification for
Ecosystem Restoration (Section 1135)
Feasibility Study and Integrated
Environmental Assessment**

**February 7, 2022
DRAFT FEASIBILITY REPORT**

**U.S. Army Corps of
Engineers
Philadelphia District**

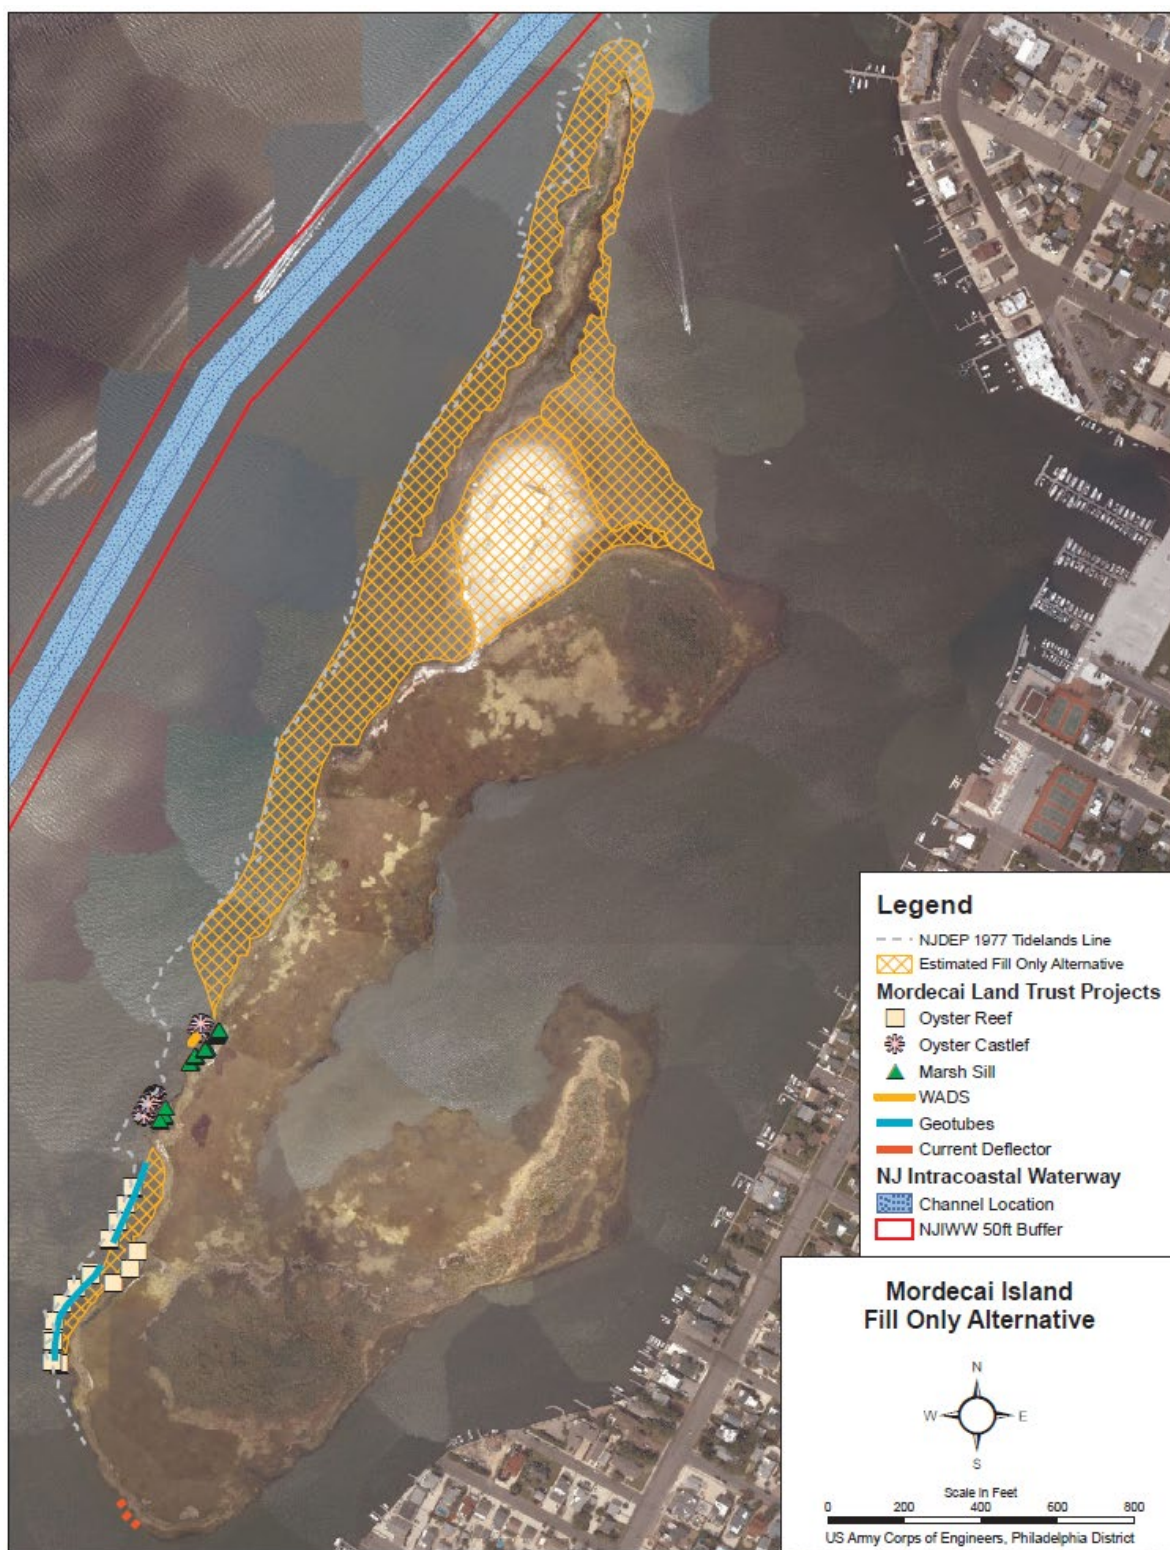
Figure 5.21: Plan View of Fill Only Alternative

Structural alignments A, B, and C can be found in Figure 5.20. Fill material without a structure can be found in 5.21. Sample typical cross sections can be found in Figure 5.22 through Figure 5.27. Cross sections are not shown with fill because the amount of fill will vary throughout the placement

area and throughout time. Depending upon the quantity of sand available from the maintenance dredging and the island conditions at the time of construction, it is estimated that between 1 and 1.5 feet of sand will be placed in the fill areas. Behind the breakwater and MLT structures, the sand will be graded in a natural slope that will eliminate the steep edges and mimic healthy intertidal habitat. Fill will not extend beyond the rubble mound structure.

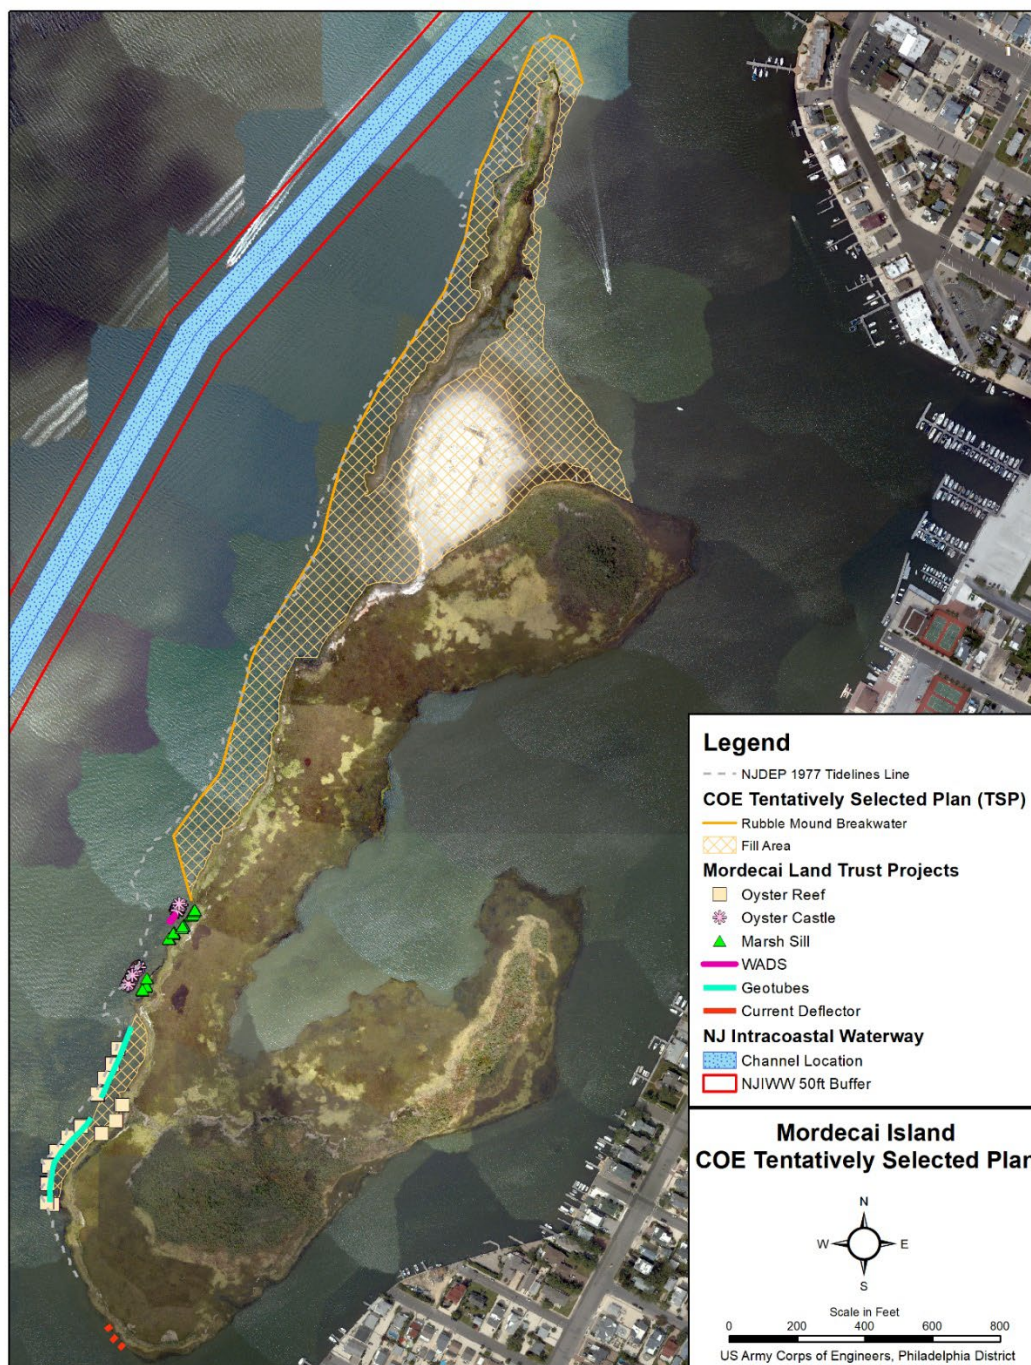
Figure 6.1: Tentatively Selected Plan

Alignment A1 generally follows the 1977 Tidelands line, approximately parallel to the west side of Mordecai Island in the nearshore area. (See Figure 6.1.) The rubble mound breakwater along Alignment A1 will extend for 3,000 linear ft. and have an average height of 7.6 ft. from the bay bottom. (See Figures 6.2 and 6.3.) The average height is the initial construction height of the structure and factors in one foot of over-build for potential settlement. Settlement will be further evaluated in more detail during the next phase of the study. To account for potential settlement of one foot, the initial construction is estimated to be +3.6 ft. NAVD88 (1 foot of overbuild). A geocomposite will be placed between the bottom of the structure and the existing ground (see Geotechnical Section of the Engineering Technical Appendix).

Following the installation of the rubble mound breakwater, sand obtained from maintenance dredging of the NJIWW will be placed behind the new breakwater and behind the existing MLT structures to restore lost wetland acreage. It is anticipated that approximately 30,000 cy of sand will be available every 10 years. Depending upon the island conditions and the available sand quantity at the time of construction, approximately 1 foot of sand will be added around the edge of the island (as depicted in Figure 6.1) to restore lost marsh habitat. It is anticipated that approximately 11.5 acres of wetland habitat will be restored as part of the restoration project. In addition to the wetland restoration, approximately 1.5 feet of sand will be added to the bird nesting area that currently exists in the previously filled breach area. Once the sand fill has been placed, wetland vegetation will be planted to help stabilize the shoreline. Figure 6.1 outlines the maximum potential extent of any sand fill for the project. An area larger than what is expected to be filled has been identified in order to allow for flexibility with sand placement based on available sand quantities and island conditions at the time of construction. This also allows for adaptive management of sand placement for future maintenance dredging cycles if needed.
