Clay Creek Mitigation Bank

Final Prospectus

Private Commercial Mitigation Bank for Stream and Wetland
Compensatory Mitigation Credits

Chester County, Pennsylvania
PA Water Plan Subbasin 3S,
Lower Delaware River Subbasin
8-Digit HUC #02040205

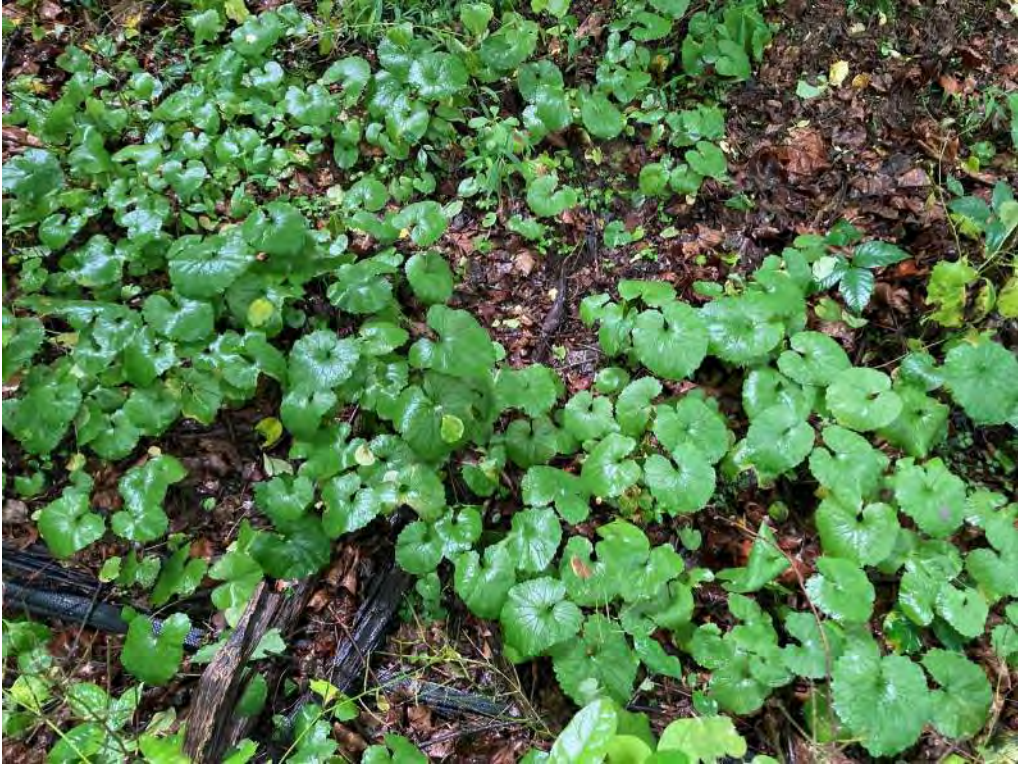
Photograph: 3	Date: 06/27/23

Feature ID: Existing Conditions		
Direction: N/A		
Description: Garlic mustard, co-dominant with oriental bittersweet, was abundant within steeply sloped woodlots dominated by black locust and tulip poplar in the canopy.

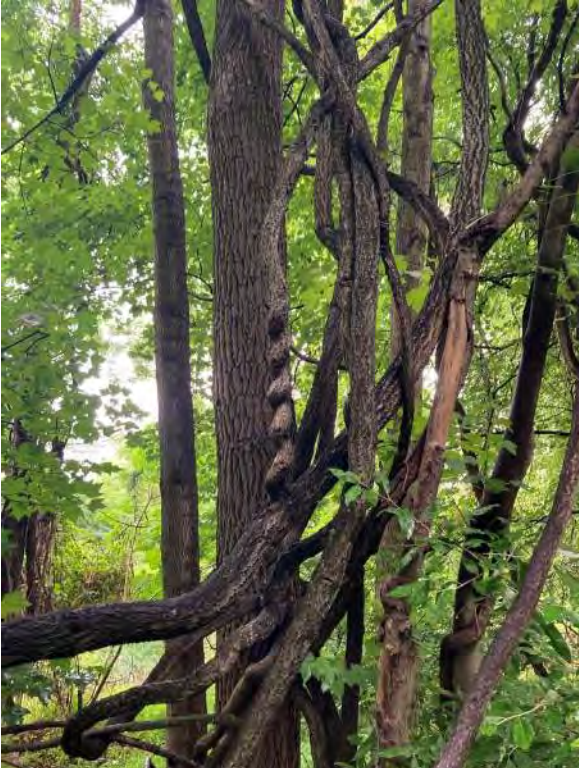
Photograph: 4	Date: 06/27/23

Feature ID: Existing Conditions		
Direction: East		
Description: Oriental bittersweet; dominant vine within wooded areas along steeper slopes.

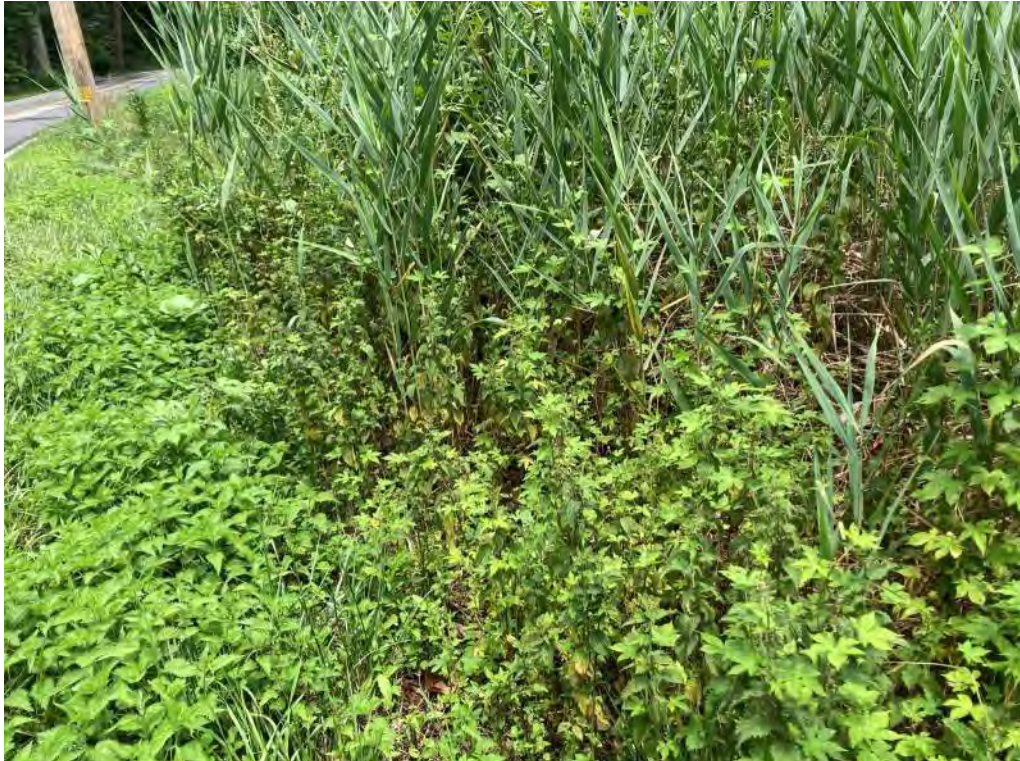
Photograph: 7	Date: 06/27/23

Feature ID: Existing Conditions		
Direction: Northwest		
Description: Japanese hops and Phragmites along Clay Creek Road.

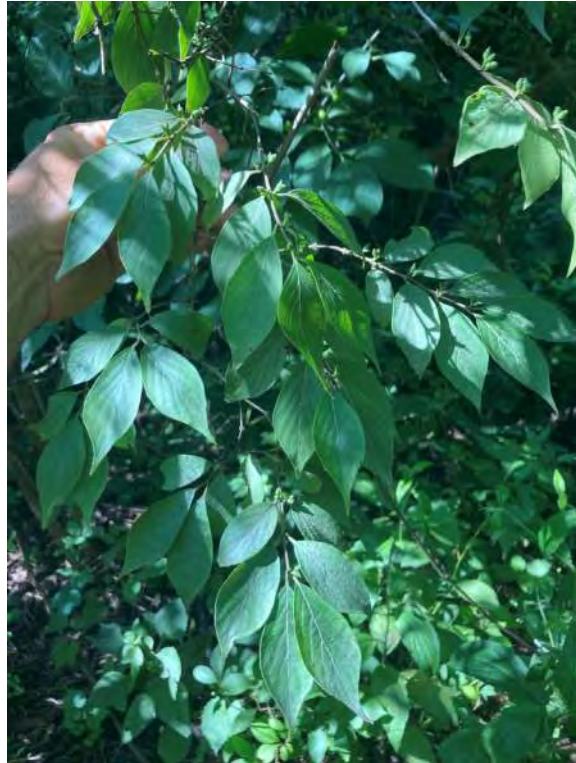
Photograph: 9	Date: 07/12/23

Feature ID: Existing Conditions		
Direction: N/A		
Description: Amur honeysuckle encountered in a few isolated areas within Study Area.

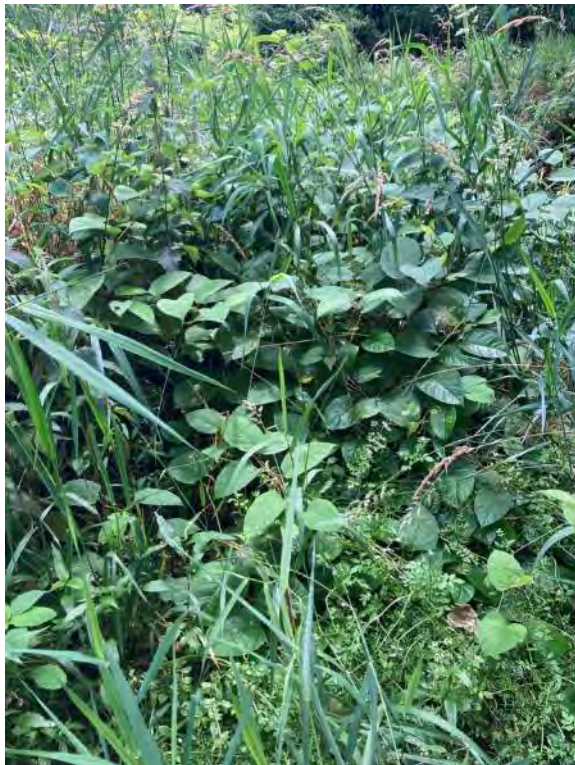
Photograph: 10	Date: 07/12/23

Feature ID: Existing Conditions		
Direction: East		
Description: Japanese knotweed encountered within isolated area along UNT to East Branch Clay Creek.

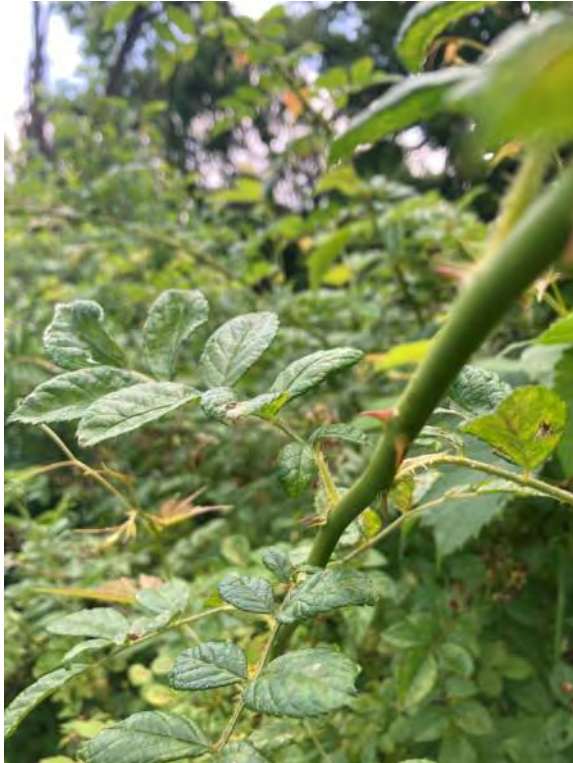
Photograph: 11	Date: 06/27/23

Feature ID: Existing Conditions		
Direction: N/A		
Description: Multiflora rose scattered throughout Study Area but not a dominant shrub species.

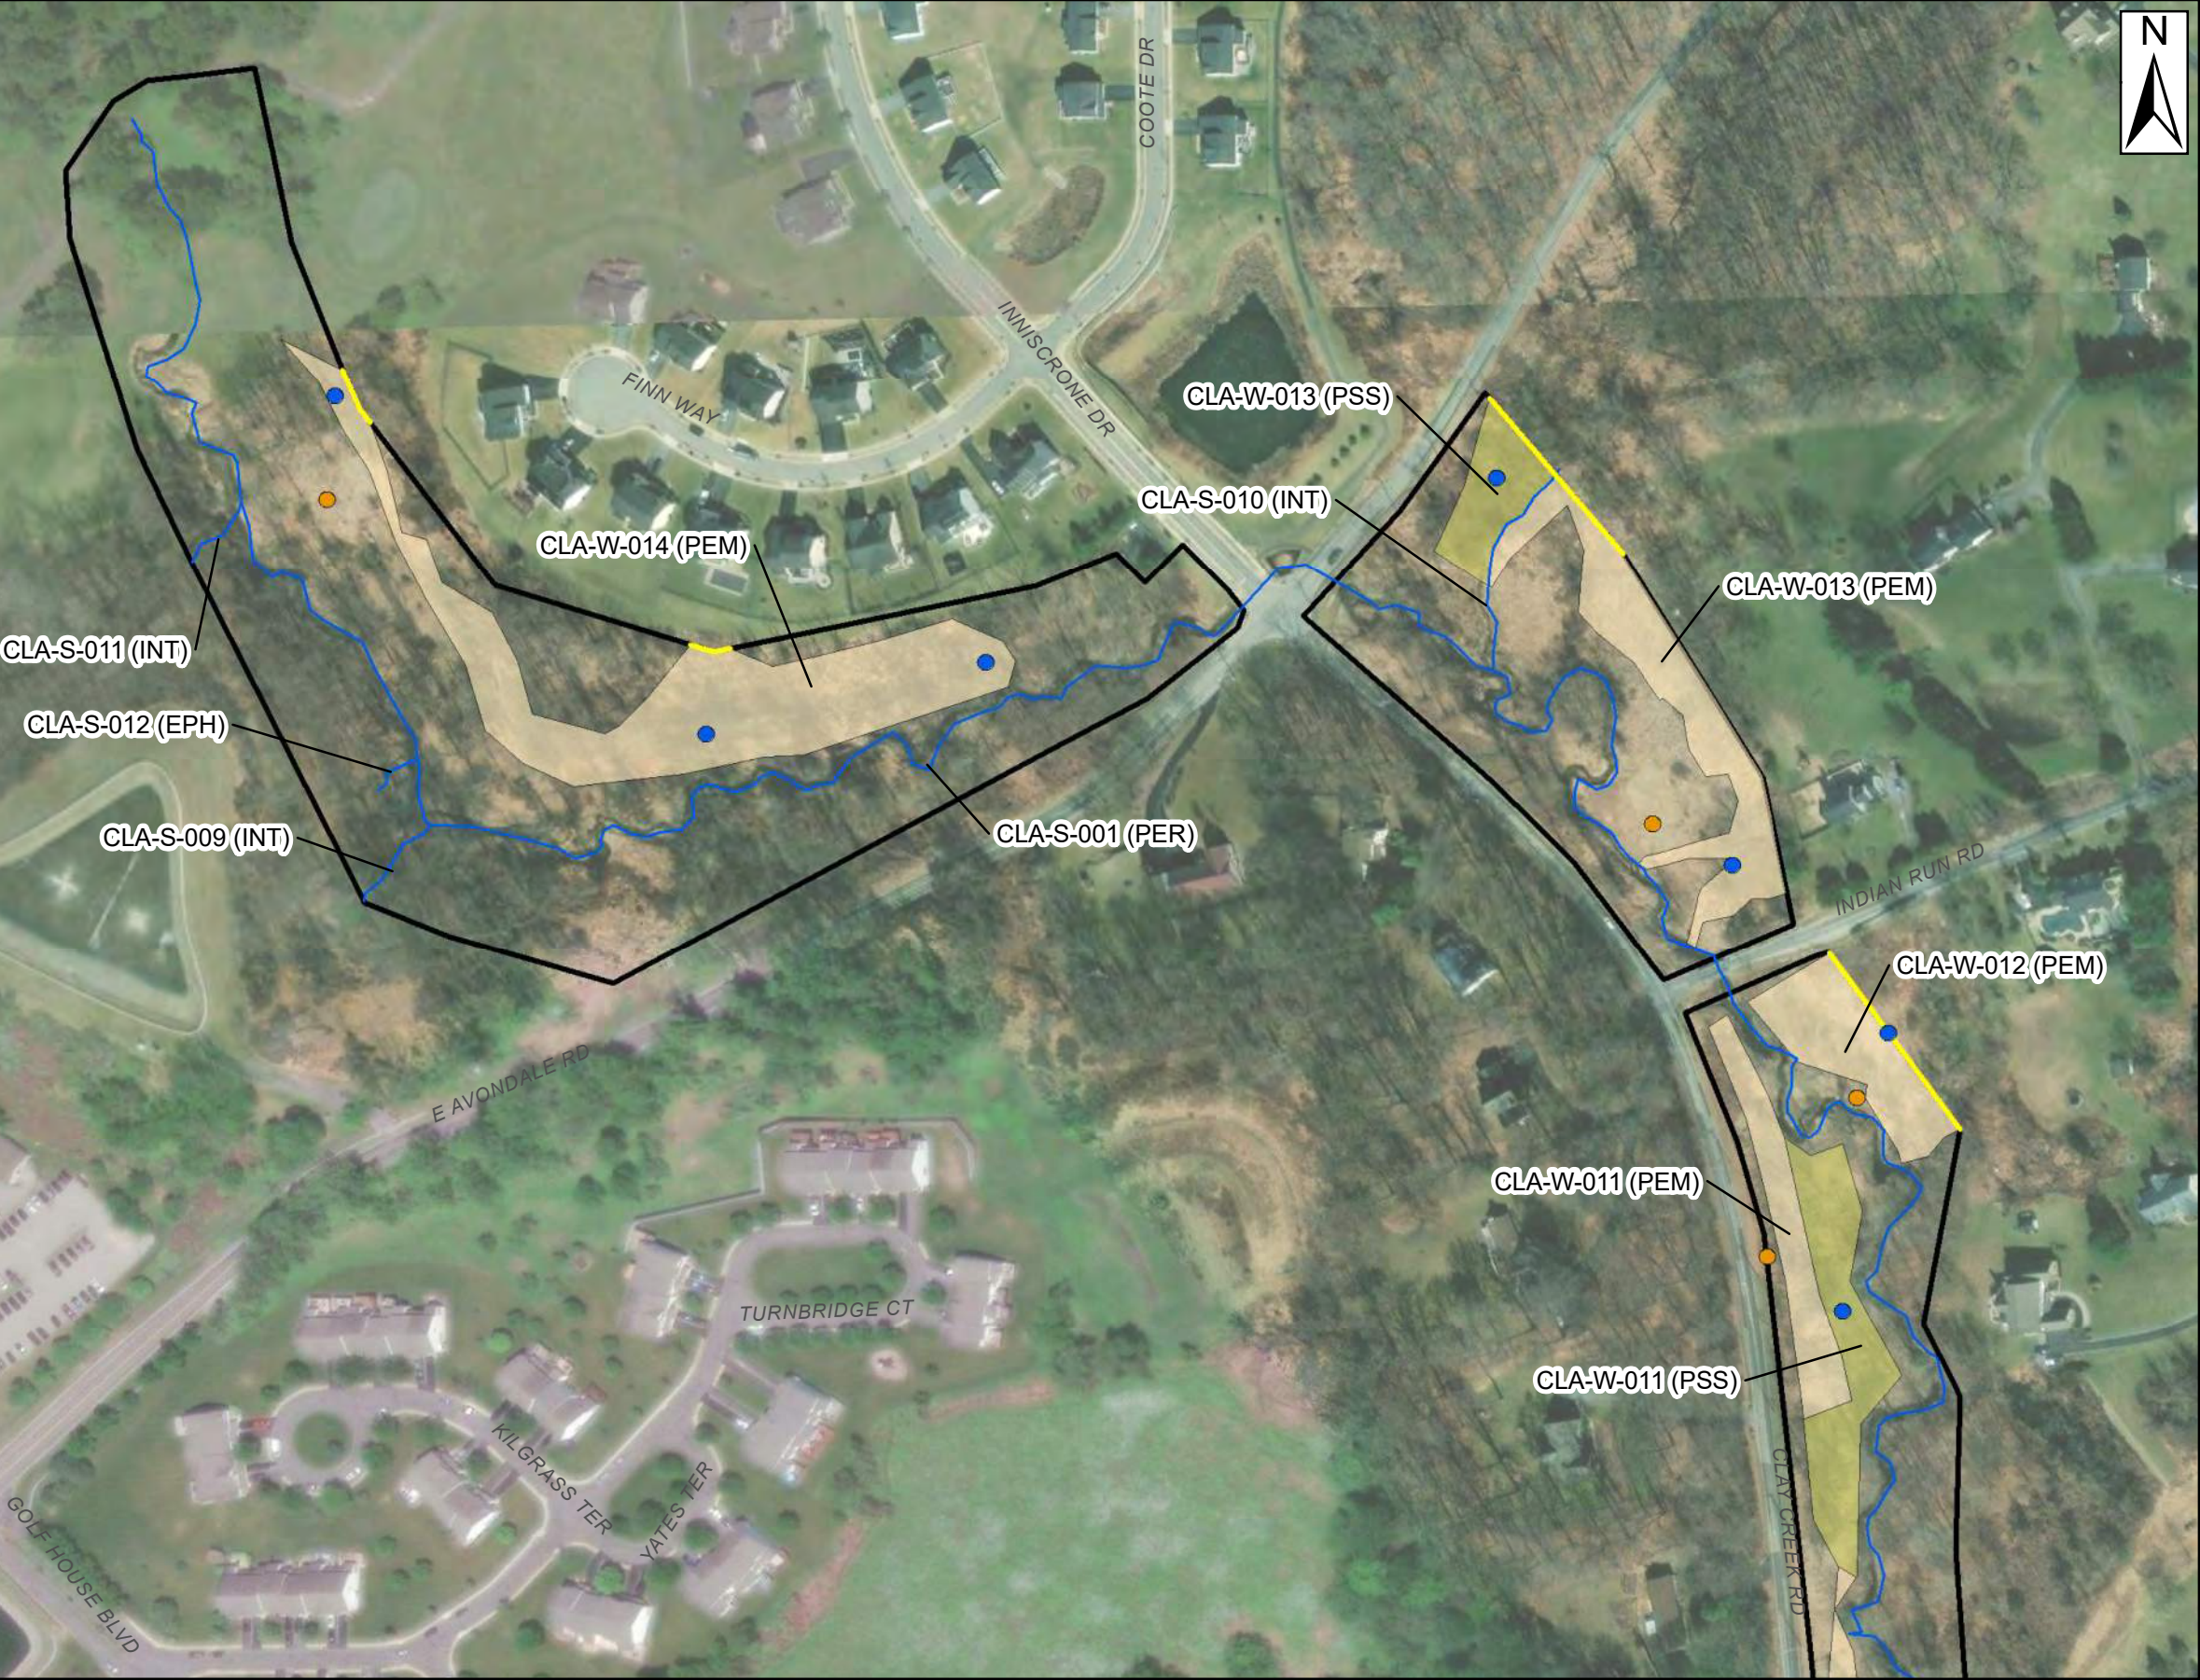
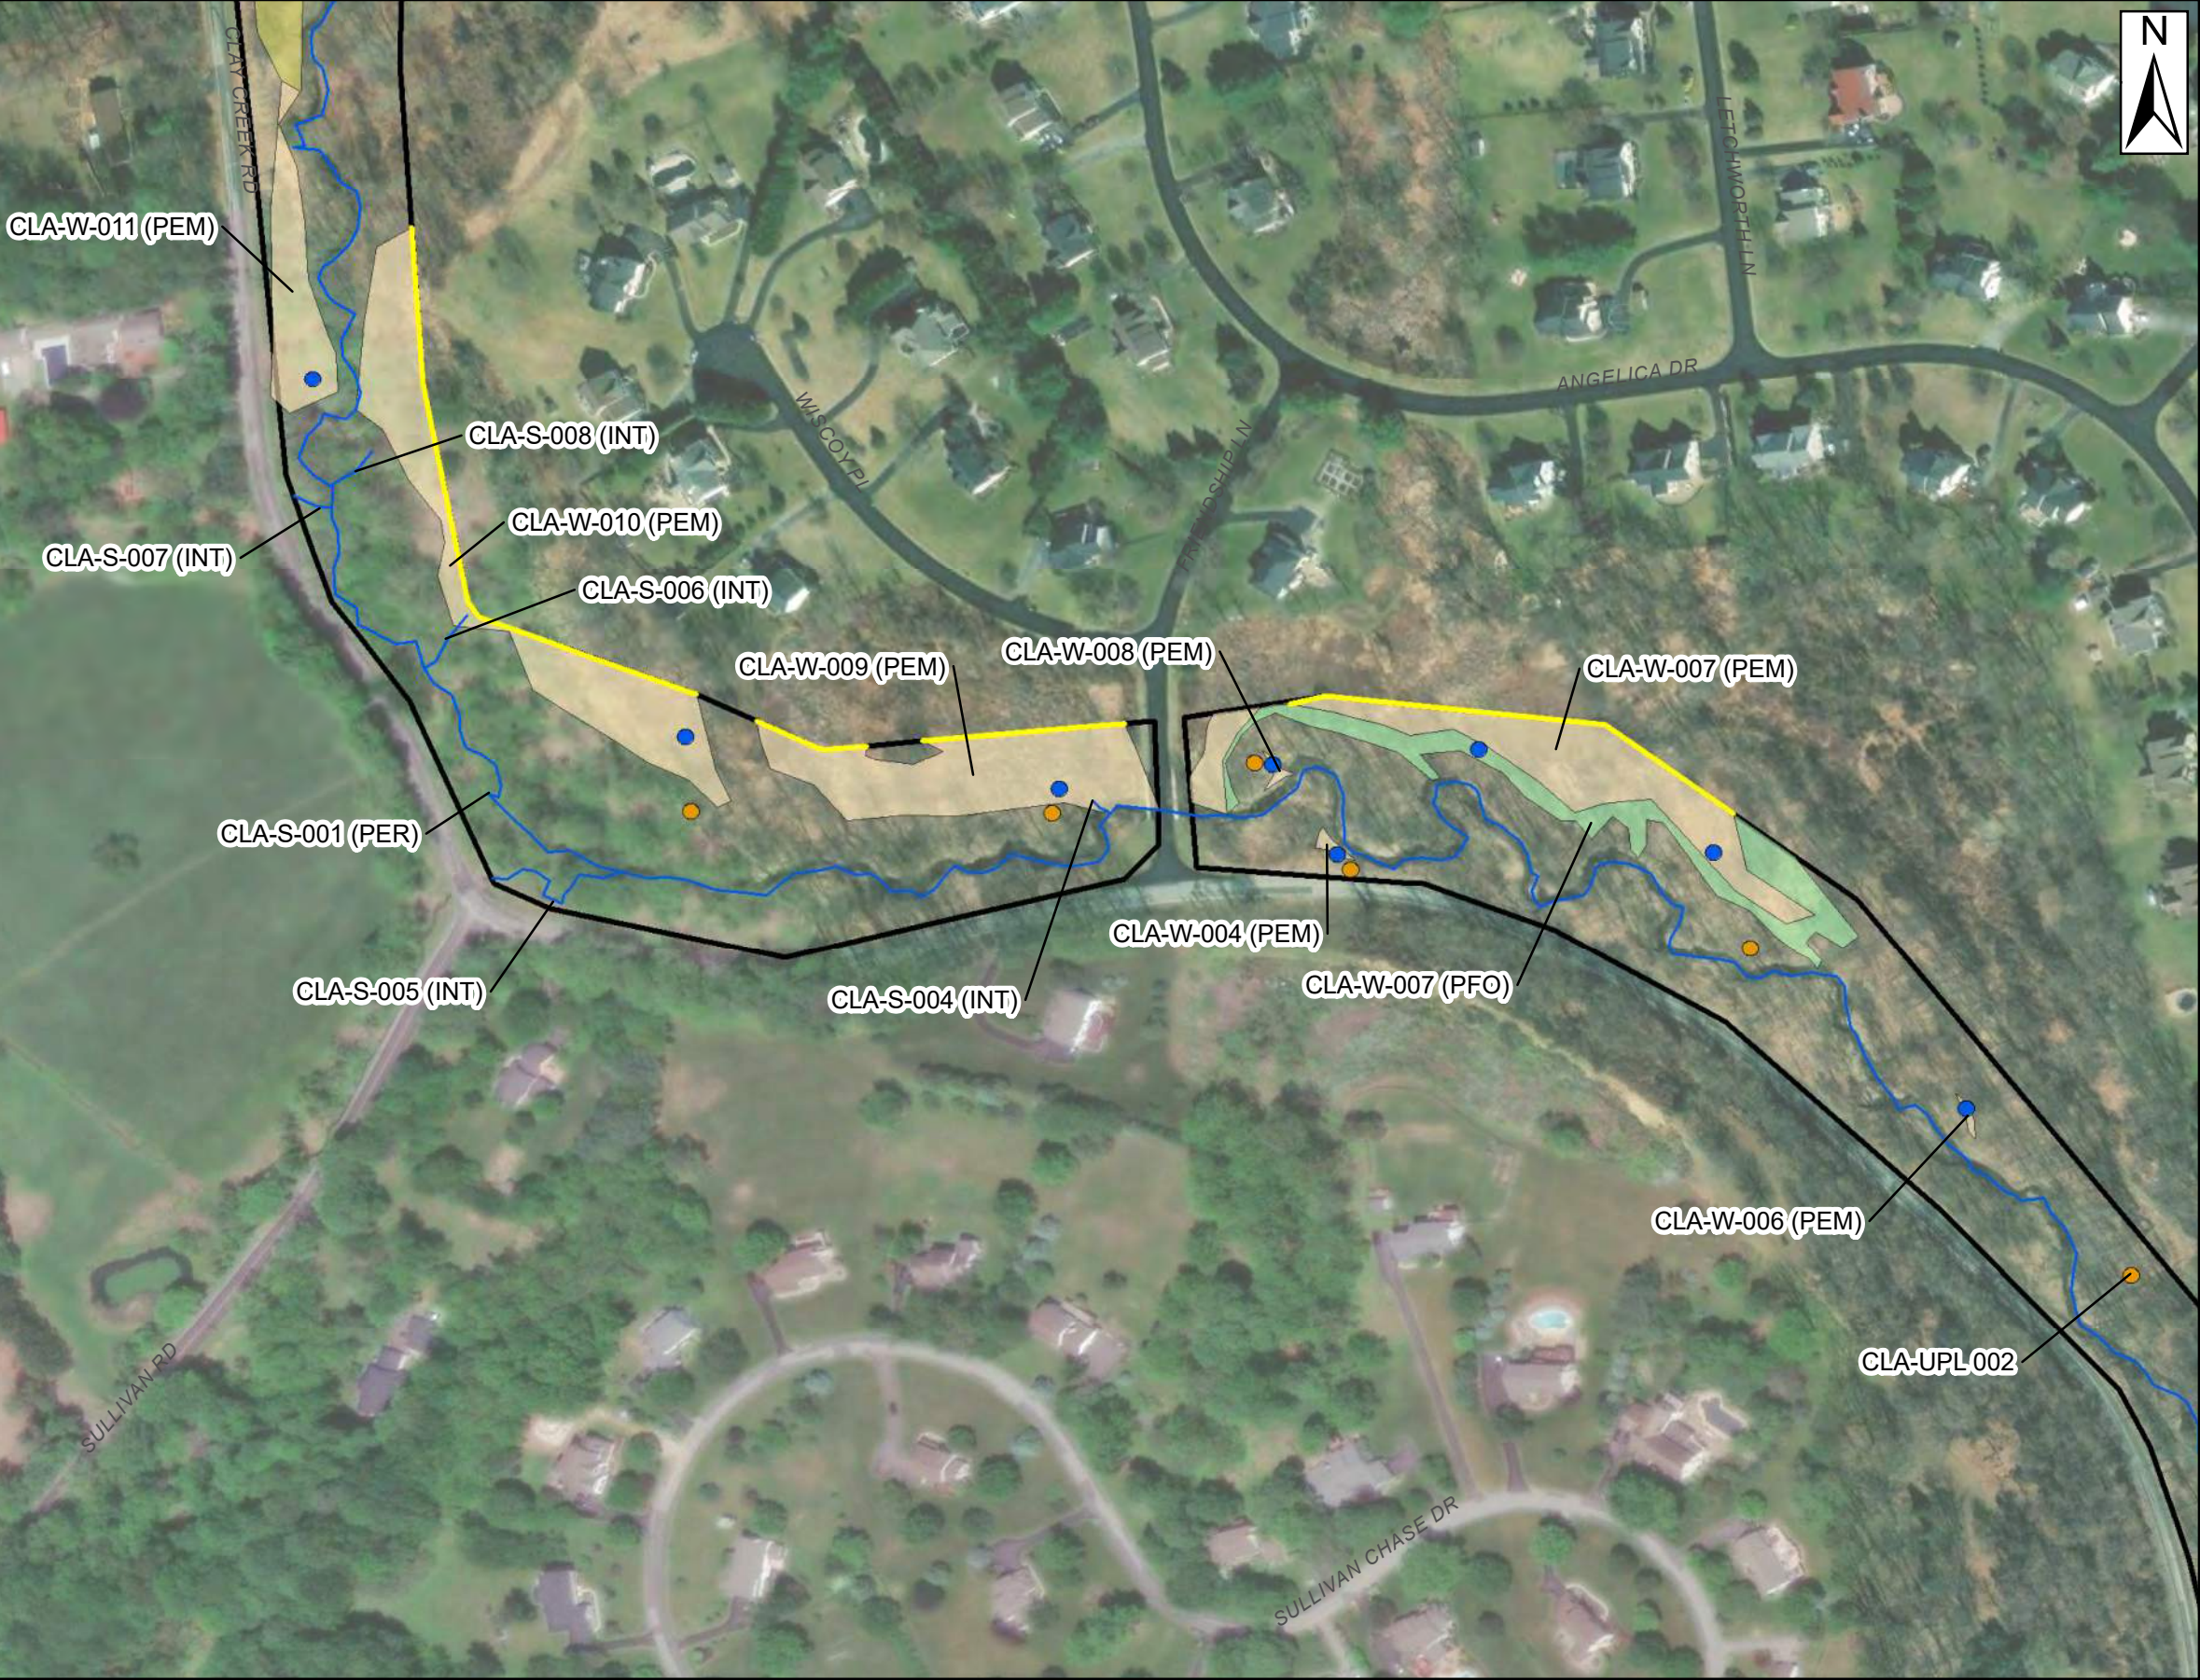
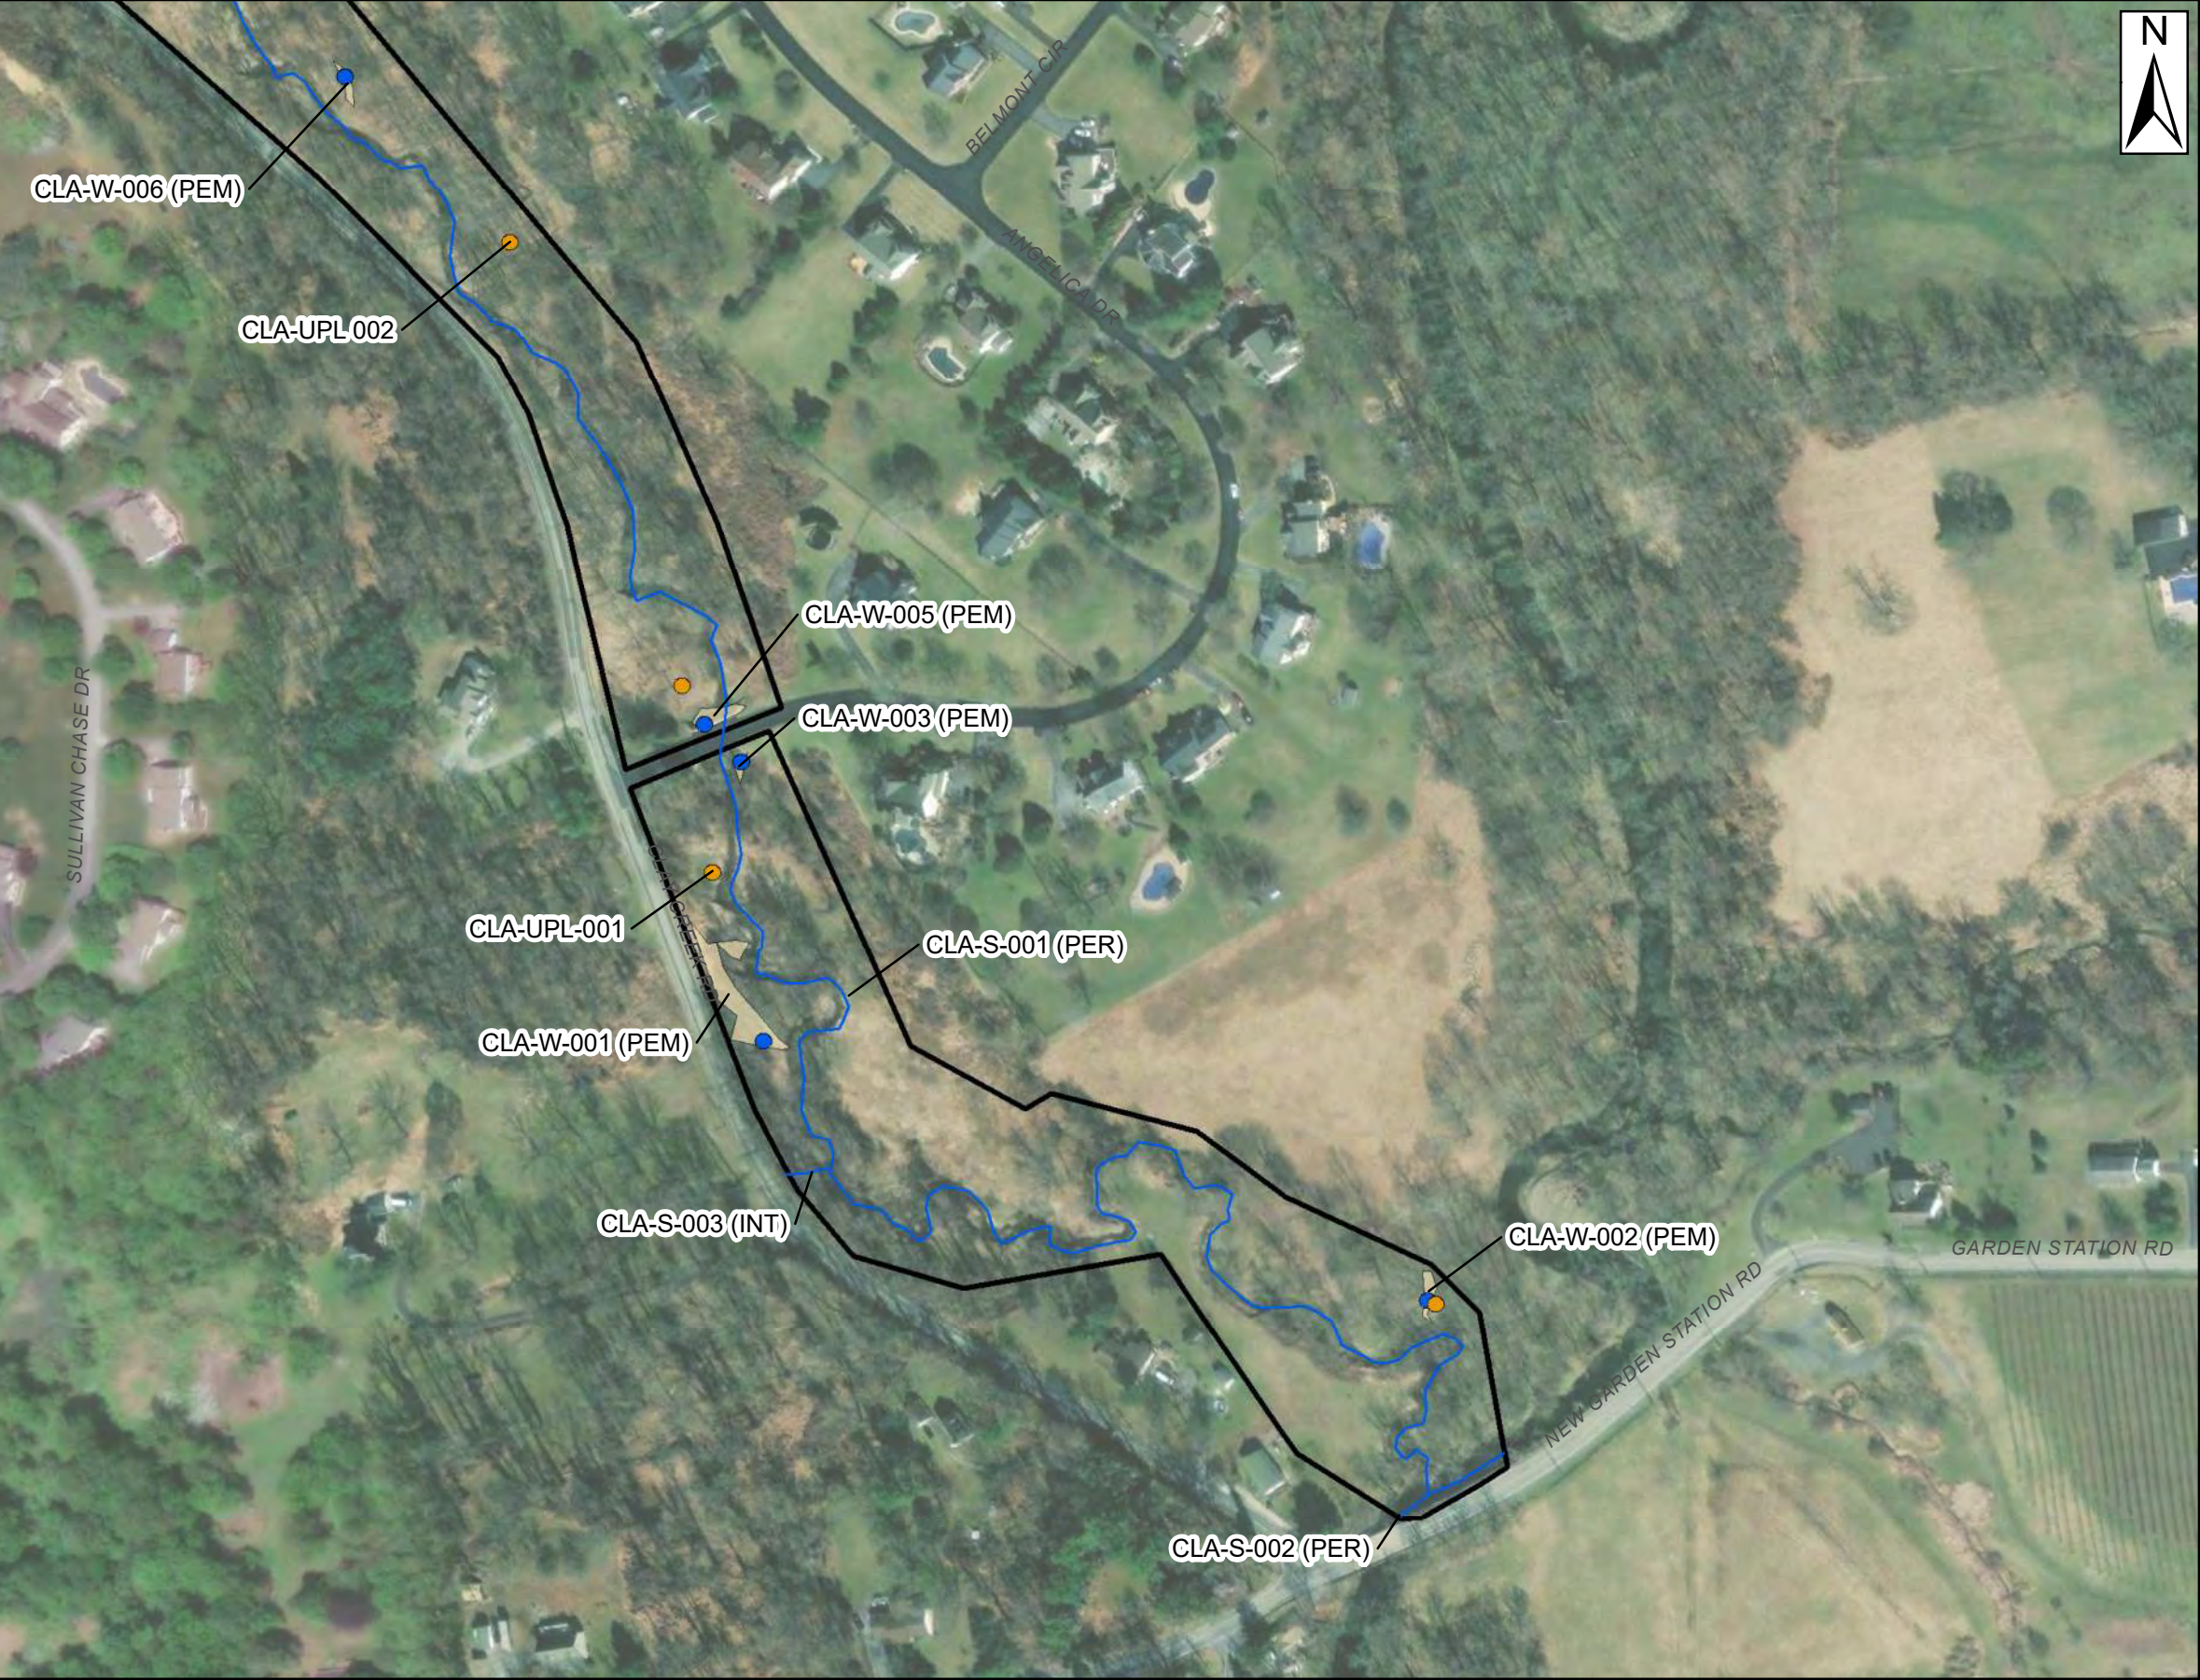
Figure 3: Delineated Aquatic Resources

- Upland Sample Point
- Wetland Sample Point
- Open End
- Delineated Watercourse

Wetland and stream delineations following the 1987 *Army Corps Wetland Delineation Manual* (USACE, 1987) and the *Eastern Mountains and Piedmont Regional Supplement Version 2* (USACE, 2012) were completed at the Bank in June 2023 by TES&P. Results from the environmental surveys are described briefly below. Detailed descriptions, data forms, photographs, and additional mapping are included in the Aquatic Resource Delineation Report provided in Appendix E: Existing Conditions Data – Part 2 – Aquatic Resource Delineation Report (Delineation Report). Delineated resources are shown in Appendix B: Figures, Figure 3: Existing Conditions Map.

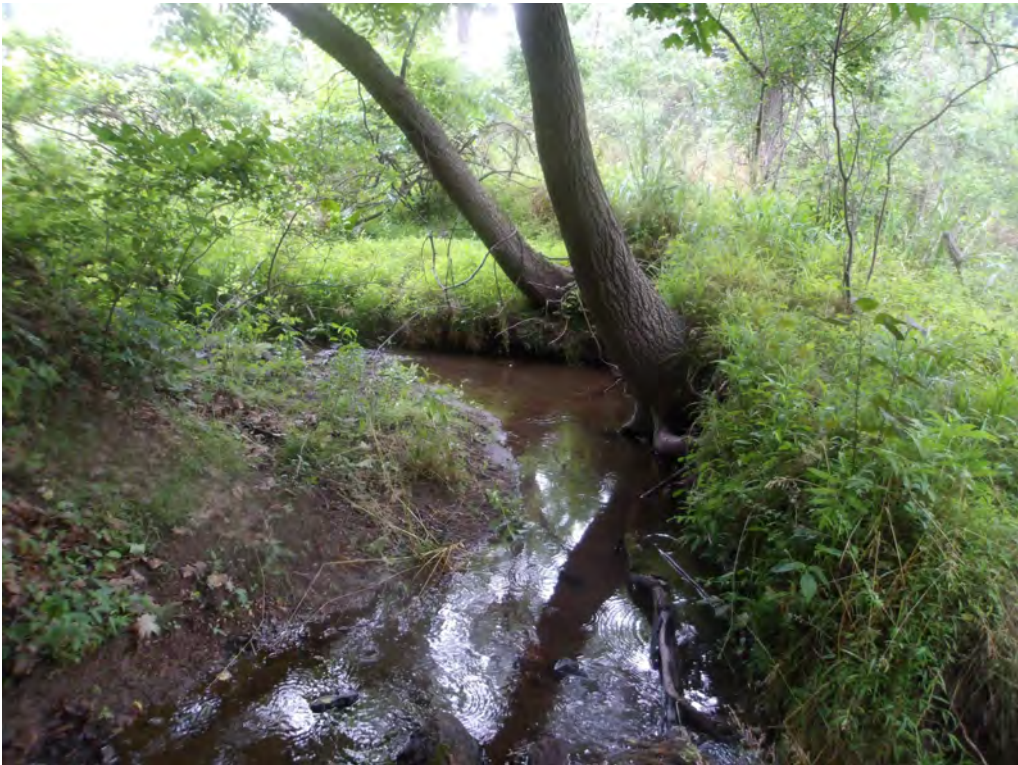
Photograph: 6	Date: 06/14/23
Feature ID: CLA-S-001 (PER)	
Direction: South	
Description: CLA-S-001 facing downstream near residential area.

Photograph: 7	Date: 06/14/23
Feature ID: CLA-S-001 (PER)	
Direction: Northwest	
Description: CLA-S-001 facing upstream within northern section of Project Study Area near golf course.

A photograph showing a narrow, shallow stream or ditch flowing through a lush, green environment. The water is dark brown and appears slightly murky. Both sides of the stream are heavily overgrown with tall, green grasses and various leafy plants. In the background, there is a dense forest of green trees and foliage. The scene is captured from a slightly elevated perspective, looking down the length of the stream.

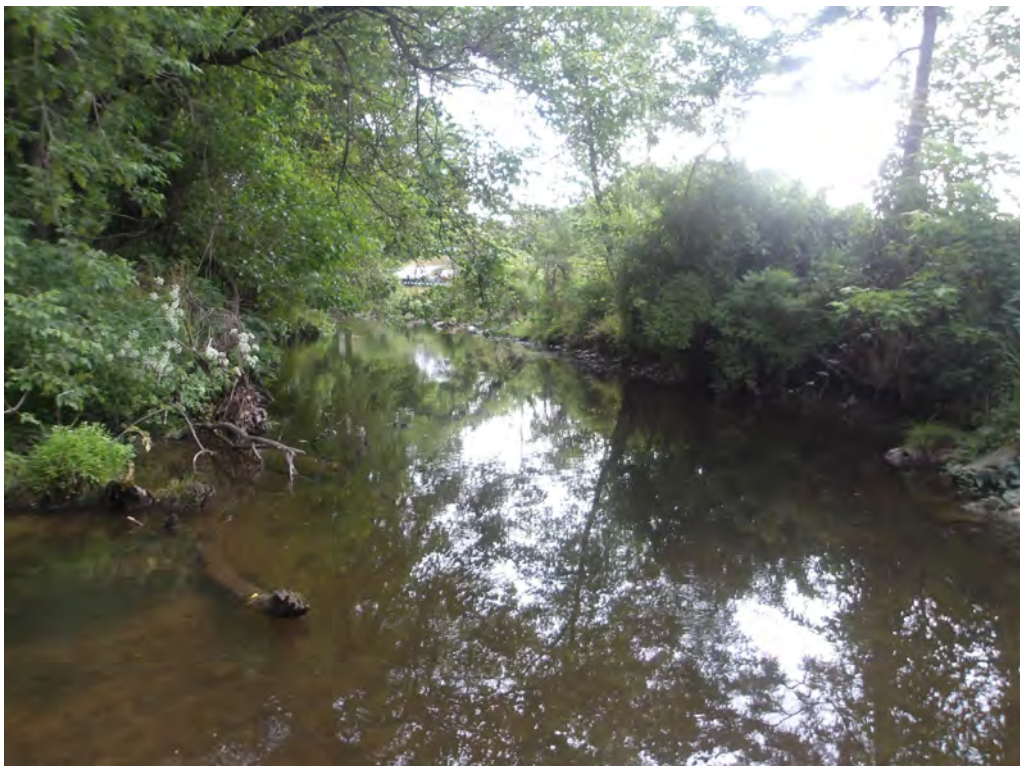
Photograph: 8	Date: 06/14/23
Feature ID: CLA-S-002 (PER)	
Direction: Northeast	
Description: Main stem of East Branch White Clay Creek at southern edge of Project Study Area, facing upstream along New Garden Station Road.

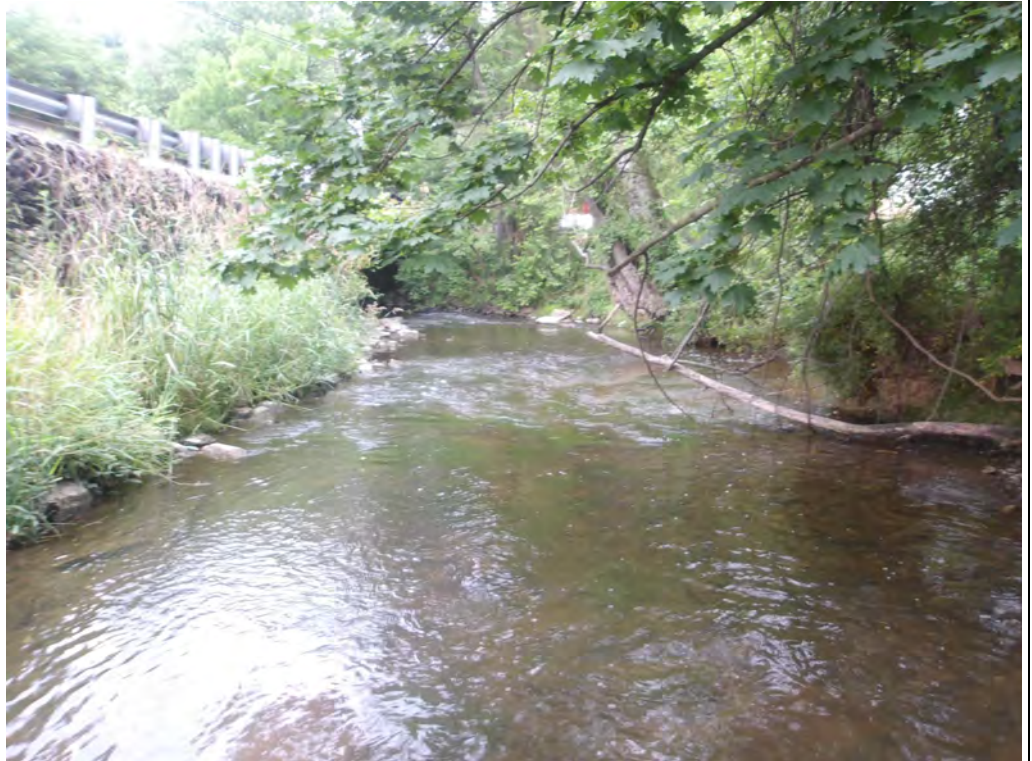
Photograph: 9	Date: 06/14/23

Feature ID: CLA-S-002 (PER)		
Direction: Southwest		
Description: Main stem of East Branch White Clay Creek at southern edge of Project Study Area, facing downstream at confluence with CLA-S-001 along New Garden Station Road.

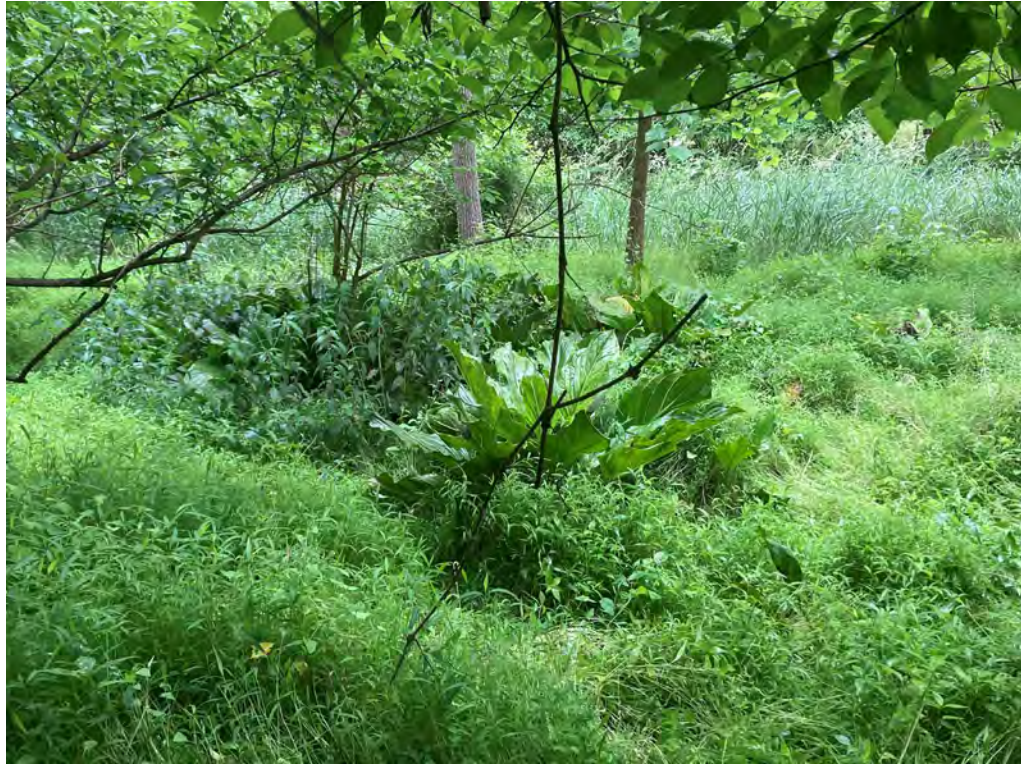
Photograph: 13	Date: 06/14/23

Feature ID: CLA-W-006 (PEM)		
Direction: Southeast		
Description: Wetland Plot associated with CLA-W-006 (PEM) along topographically defined drainage pattern.

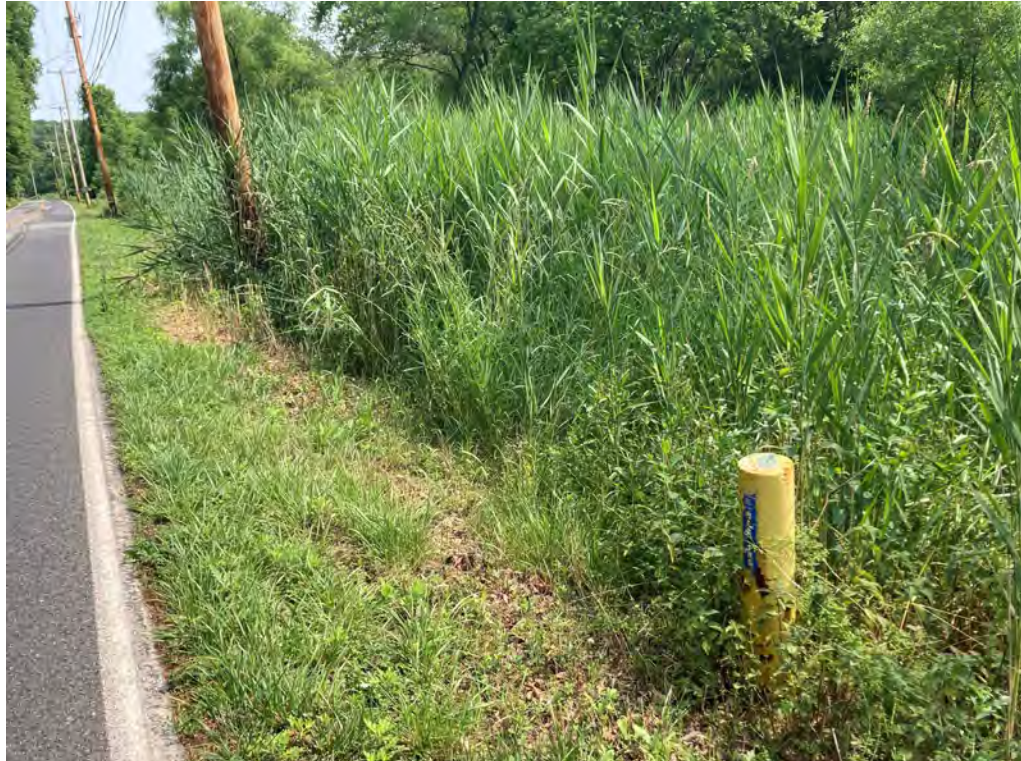
Photograph: 23	Date: 06/15/23
Feature ID: CLA-W-011 (PEM)	
Direction: North	
Description: CLA-W-011 (PEM) showing dominance of common reed (<i>Phragmites australis</i>) along Clay Creek Road.

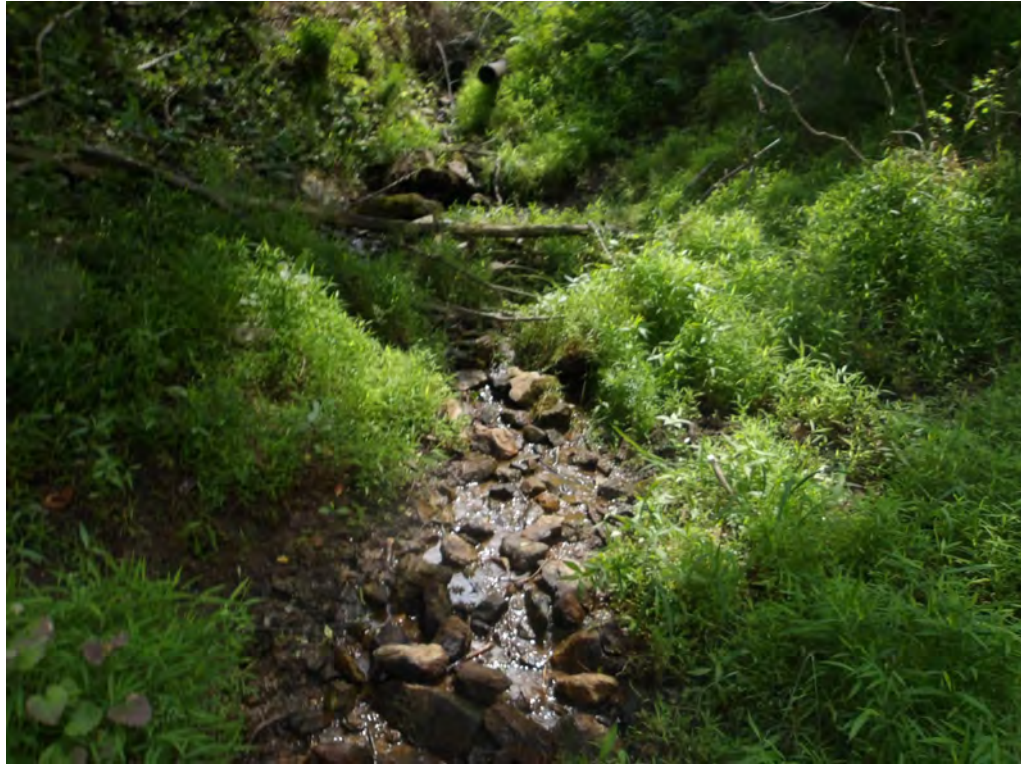
Photograph: 29	Date: 06/14/23

Feature ID: CLA-S-009 (INT)		
Direction: Southwest		
Description: CLA-S-009 facing upstream towards NPDES outfall of sewage treatment facility.

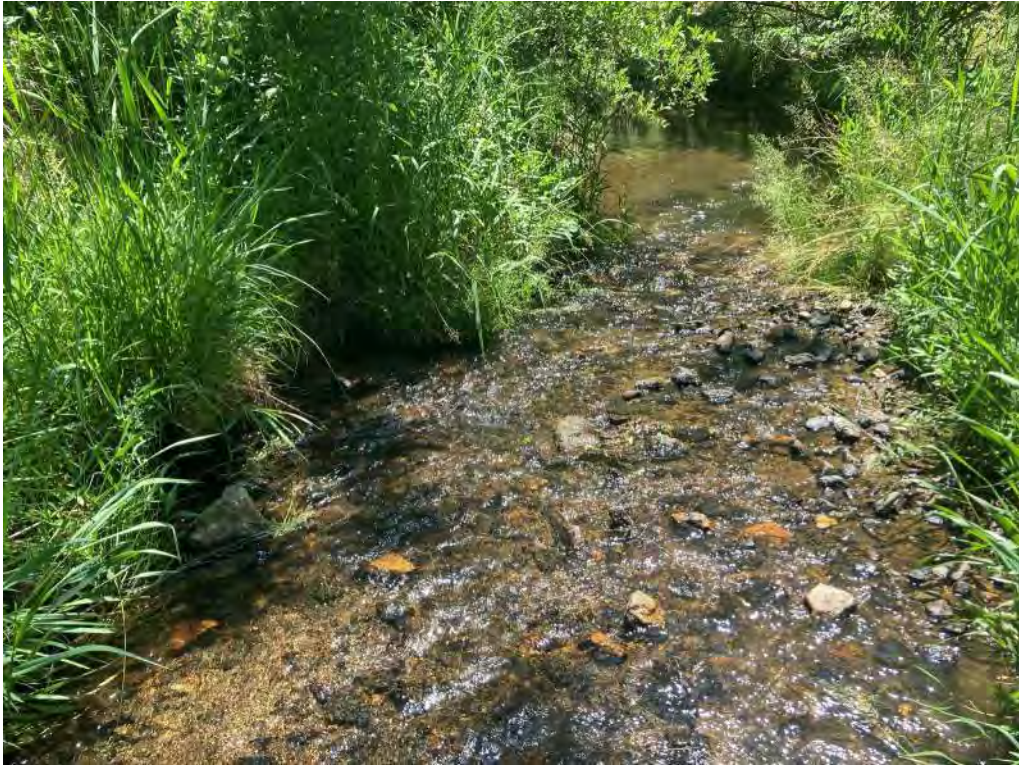
Photograph: 1	Date: 05/31/23

Feature ID: CC-B1		
Direction: North		
Description: Clay Creek Benthic Sampling Reach CC-B1 facing upstream at approximate mid-point.

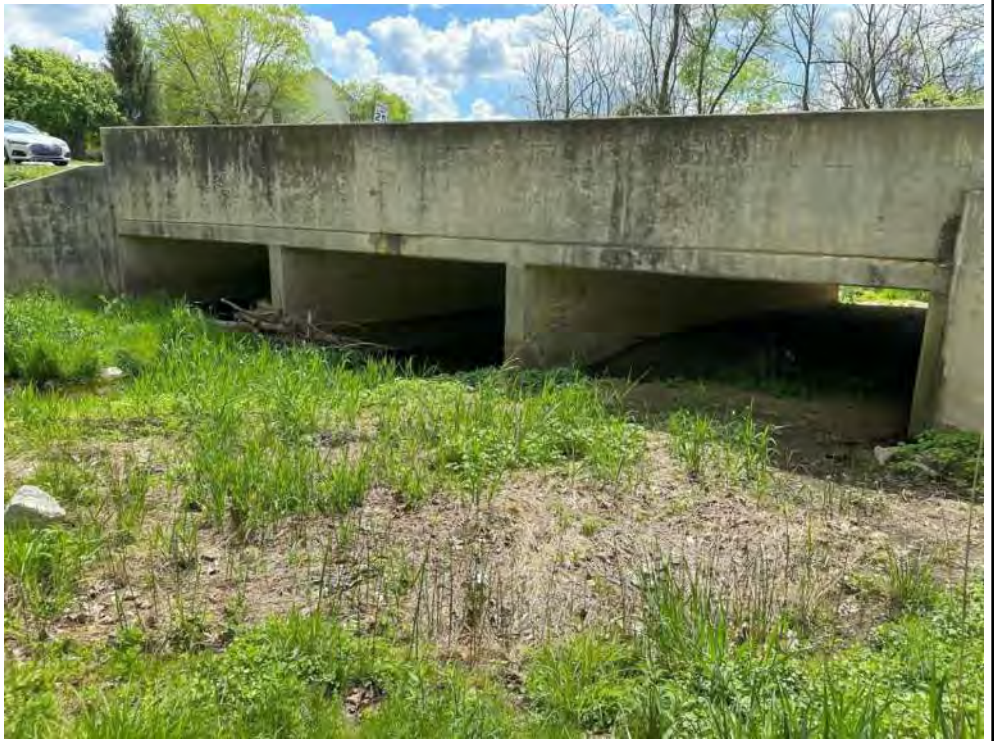
Photo Location: Clay Creek at Angelica Drive			
Direction: Southeast			
Survey Date: 5/8/2024			
Comments: Flood plain on north side of bridge.

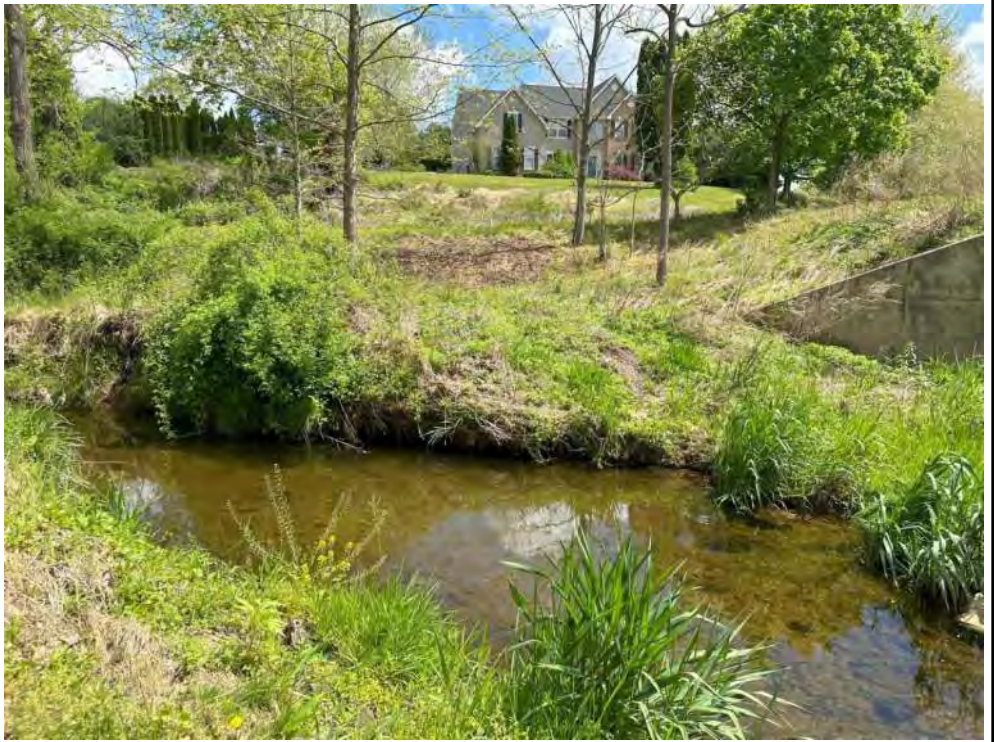
Photo Location: Clay Creek at Angelica Drive			
Direction: East			
Survey Date: 5/8/2024			
Comments: East bank of Clay Creek with residence in background.			
Photograph ID: 4
