Clay Creek Mitigation Bank

Final Prospectus

Private Commercial Mitigation Bank for Stream and Wetland
Compensatory Mitigation Credits

Chester County, Pennsylvania
PA Water Plan Subbasin 3S,
Lower Delaware River Subbasin
8-Digit HUC #02040205

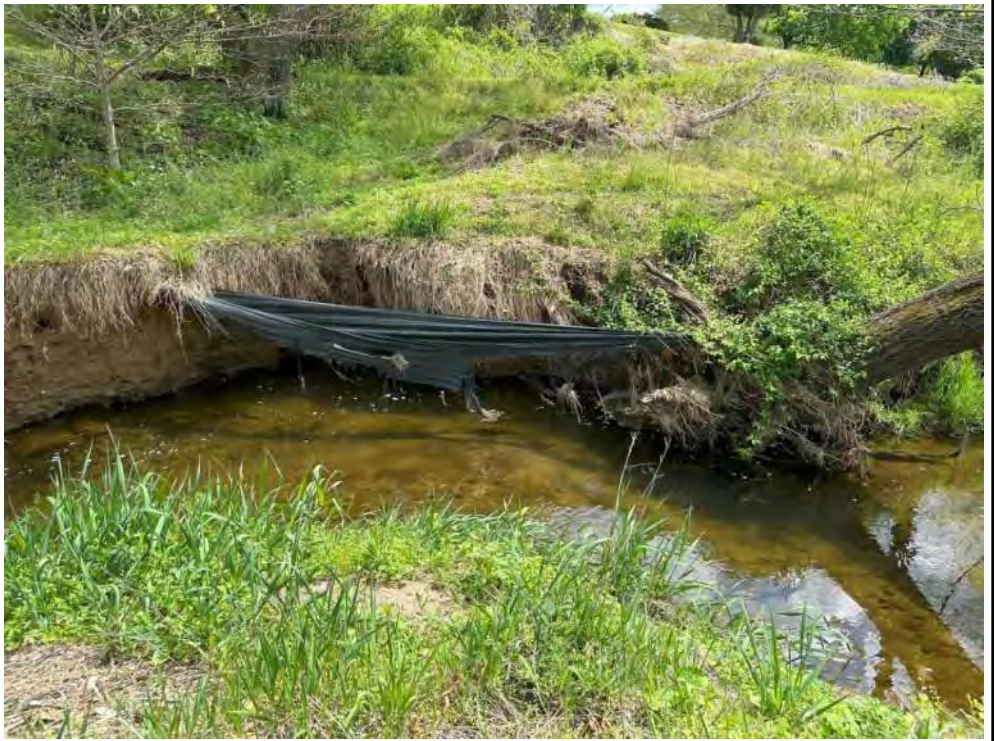
Photo Location: Clay Creek			
Direction: North			
Survey Date: 5/8/2024			
Comments: Remnant silt fence along bank of Clay Creek.

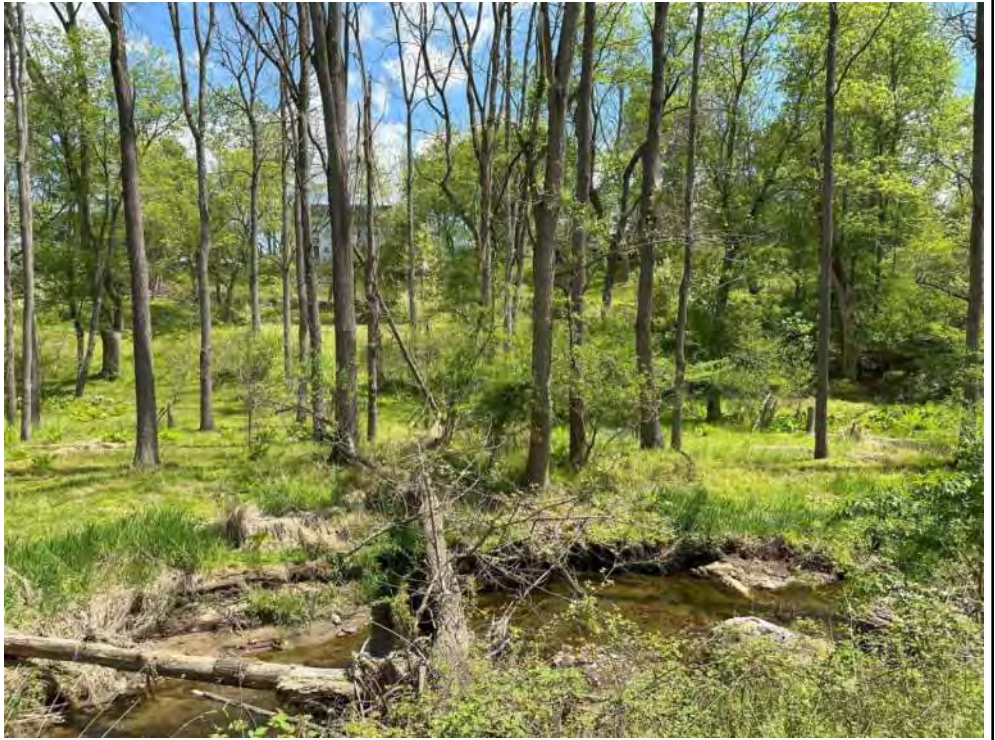
Photo Location: Clay Creek			
Direction: North			
Survey Date: 5/8/2024			
Comments: Woods along creek with residence in background.			
Photograph ID: 6

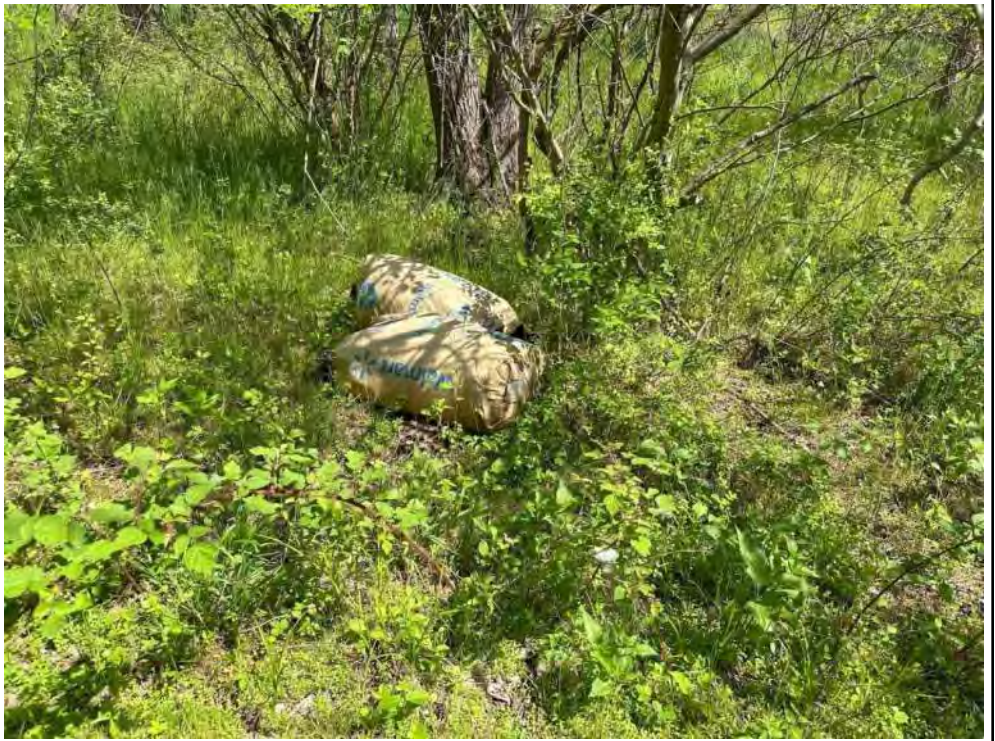
Photo Location: Clay Creek Road			
Direction: North			
Survey Date: 5/8/2024			
Comments: Abandoned yard waste near shoulder of Clay Creek Road

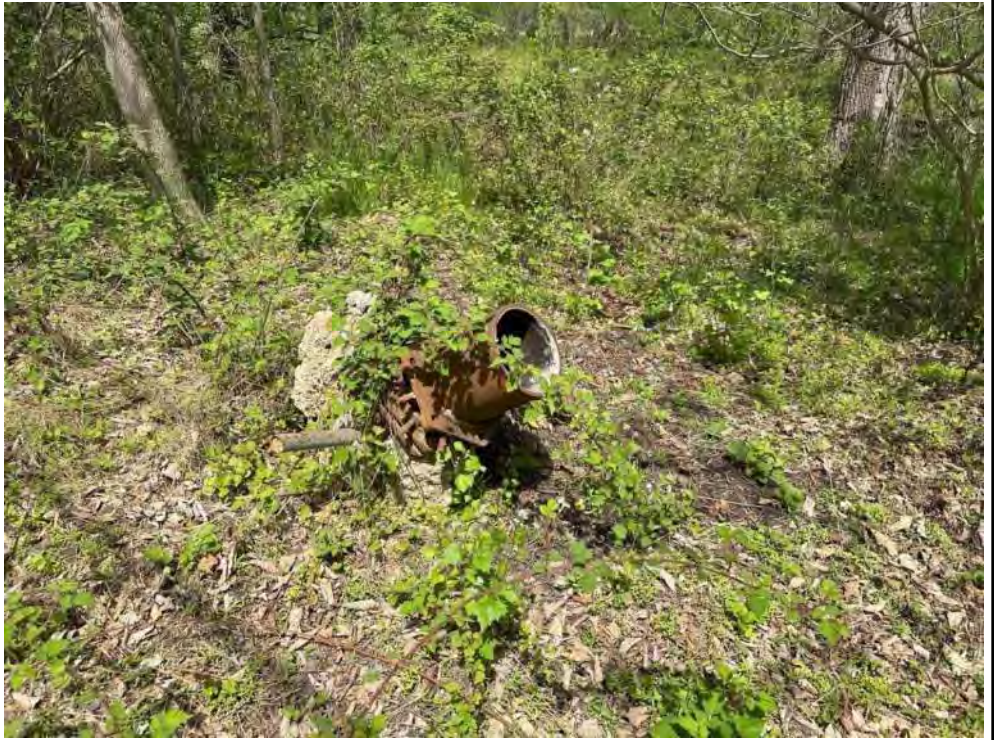
Photo Location: East of Clay Creek Road			
Direction: West			
Survey Date: 5/8/2024			
Comments: Concrete and steel pipe debris.			
Photograph ID: 10

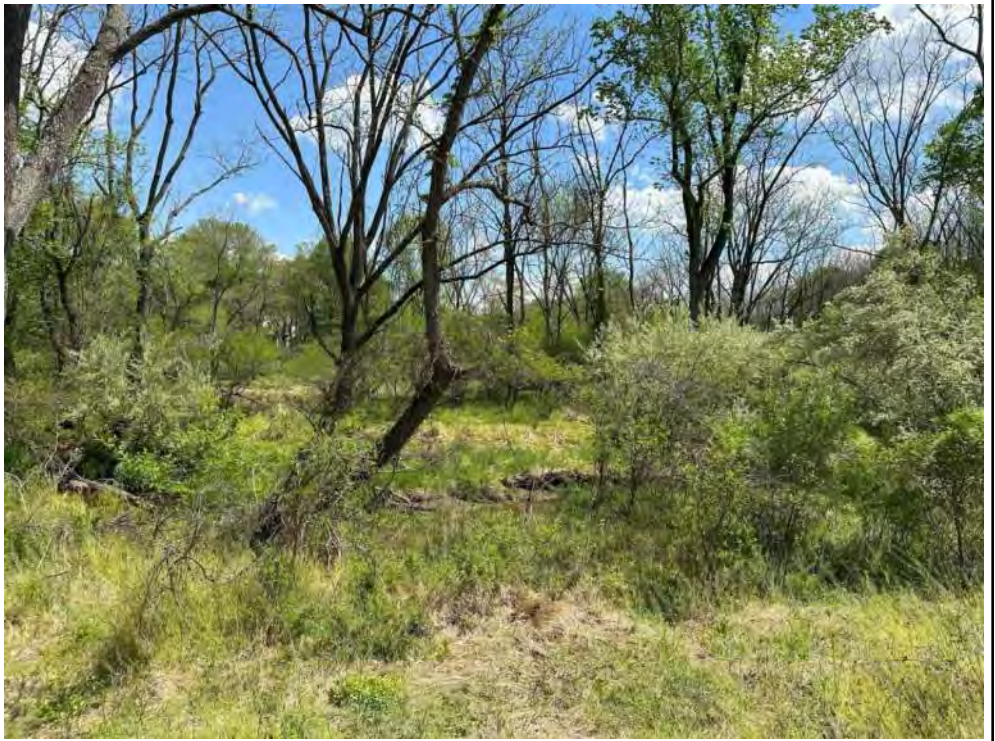
Photo Location: Clay Creek near intersection of Clay Creek and Sullivan Roads			
Direction: North			
Survey Date: 5/8/2024			
Comments: Clay Creek flood plain.

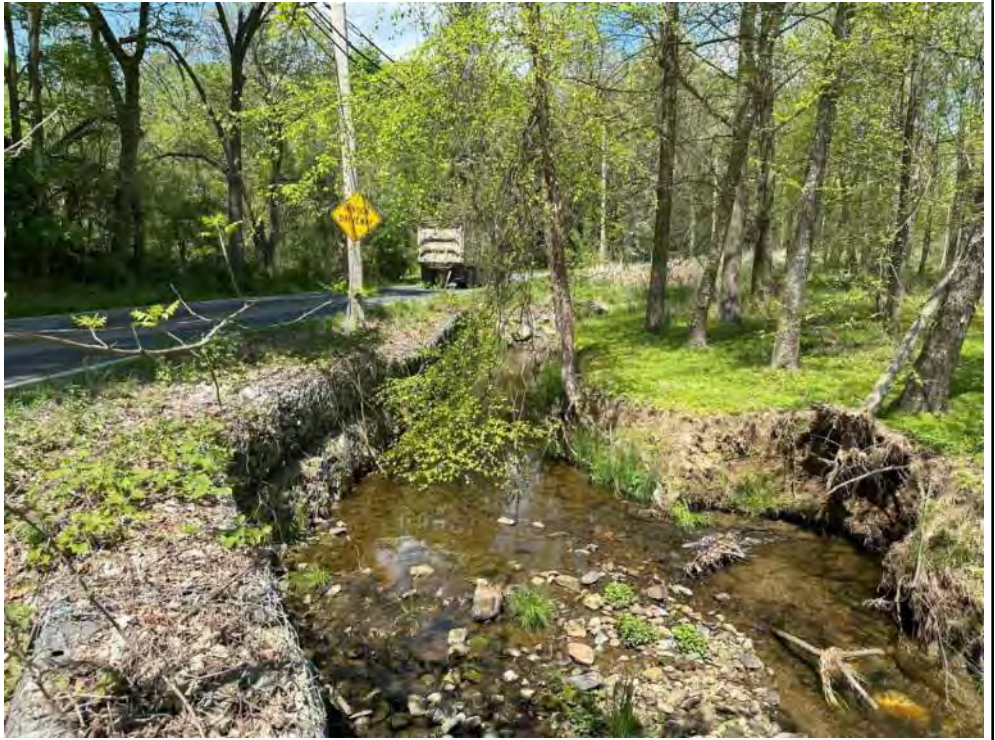
Photo Location: Clay Creek, north of intersection of Clay Creek and Sullivan Roads			
Direction: Northwest			
Survey Date: 5/8/2024			
Comments: Clay Creek impinging along east side of Clay Creek Road.			
Photograph ID: 12

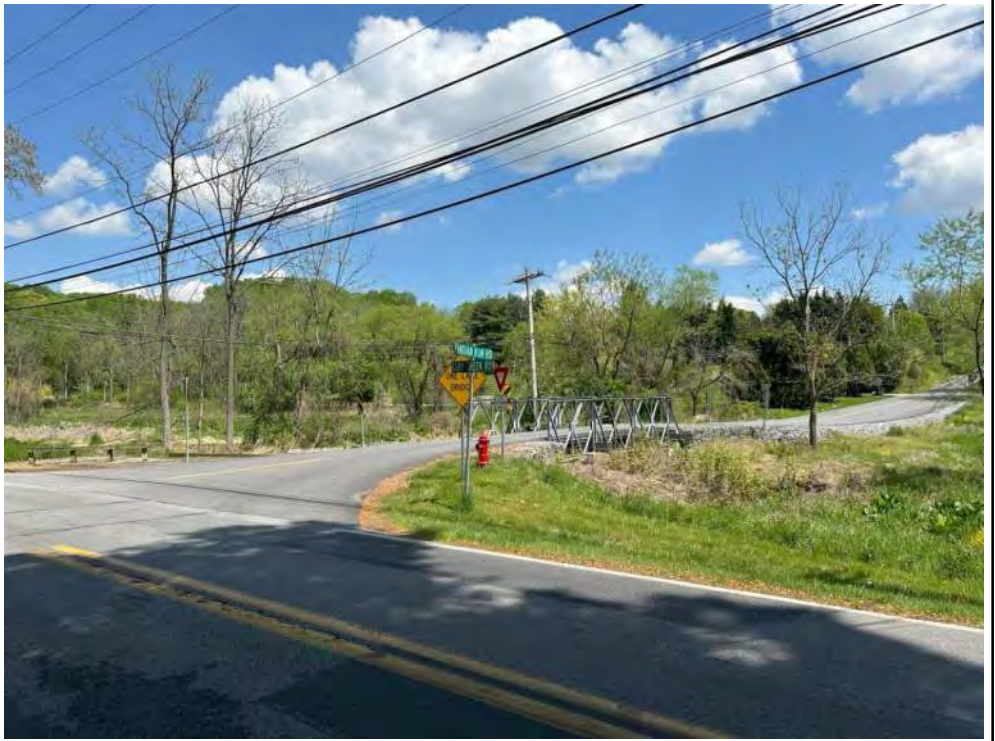
Photo Location: Intersection of Clay Creek and Indian Run Roads			
Direction: Northeast			
Survey Date: 5/8/2024			
Comments: Bridge over Clay Creek.

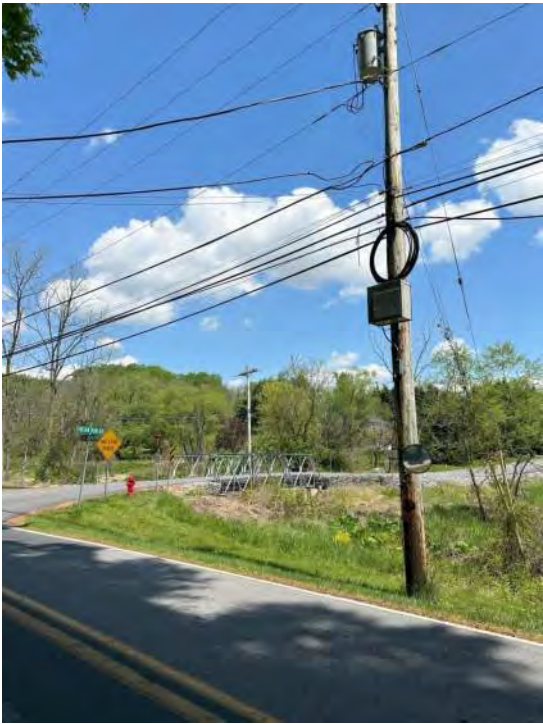
Photo Location: Intersection of Clay Creek and Indian Run Roads			
Direction: Northeast			
Survey Date: 5/8/2024			
Comments: Pole mounted transformer			
Photograph ID: 14

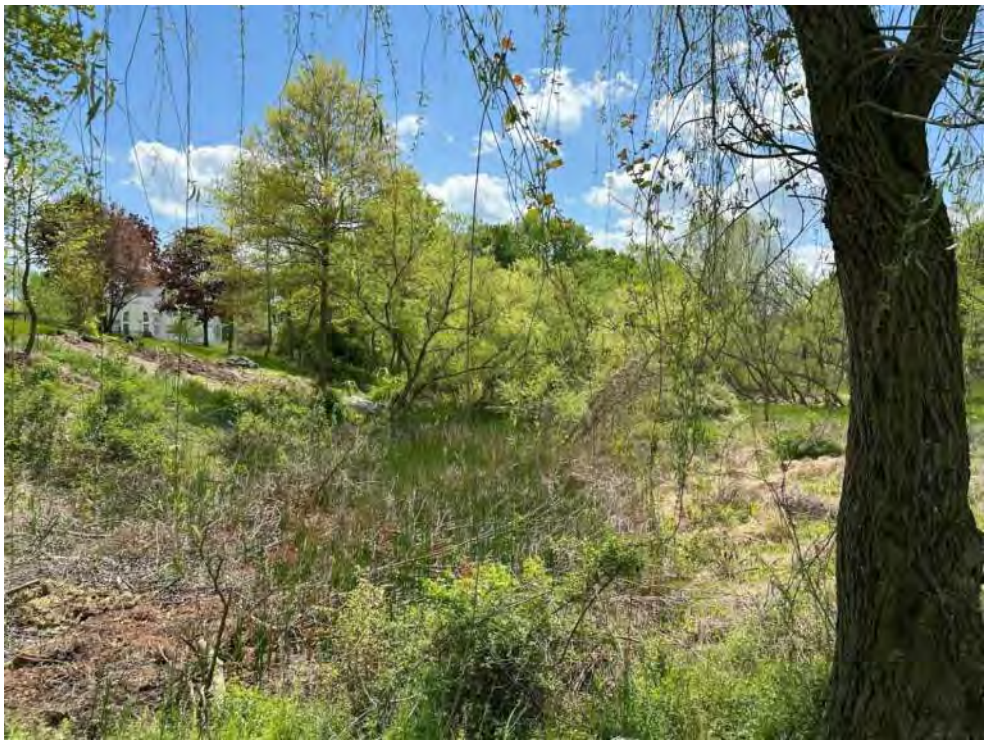
Photo Location: Clay Creek south of Indian Run Road			
Direction: Southeast			
Survey Date: 5/8/2024			
Comments: Clay Creek with residence in background.

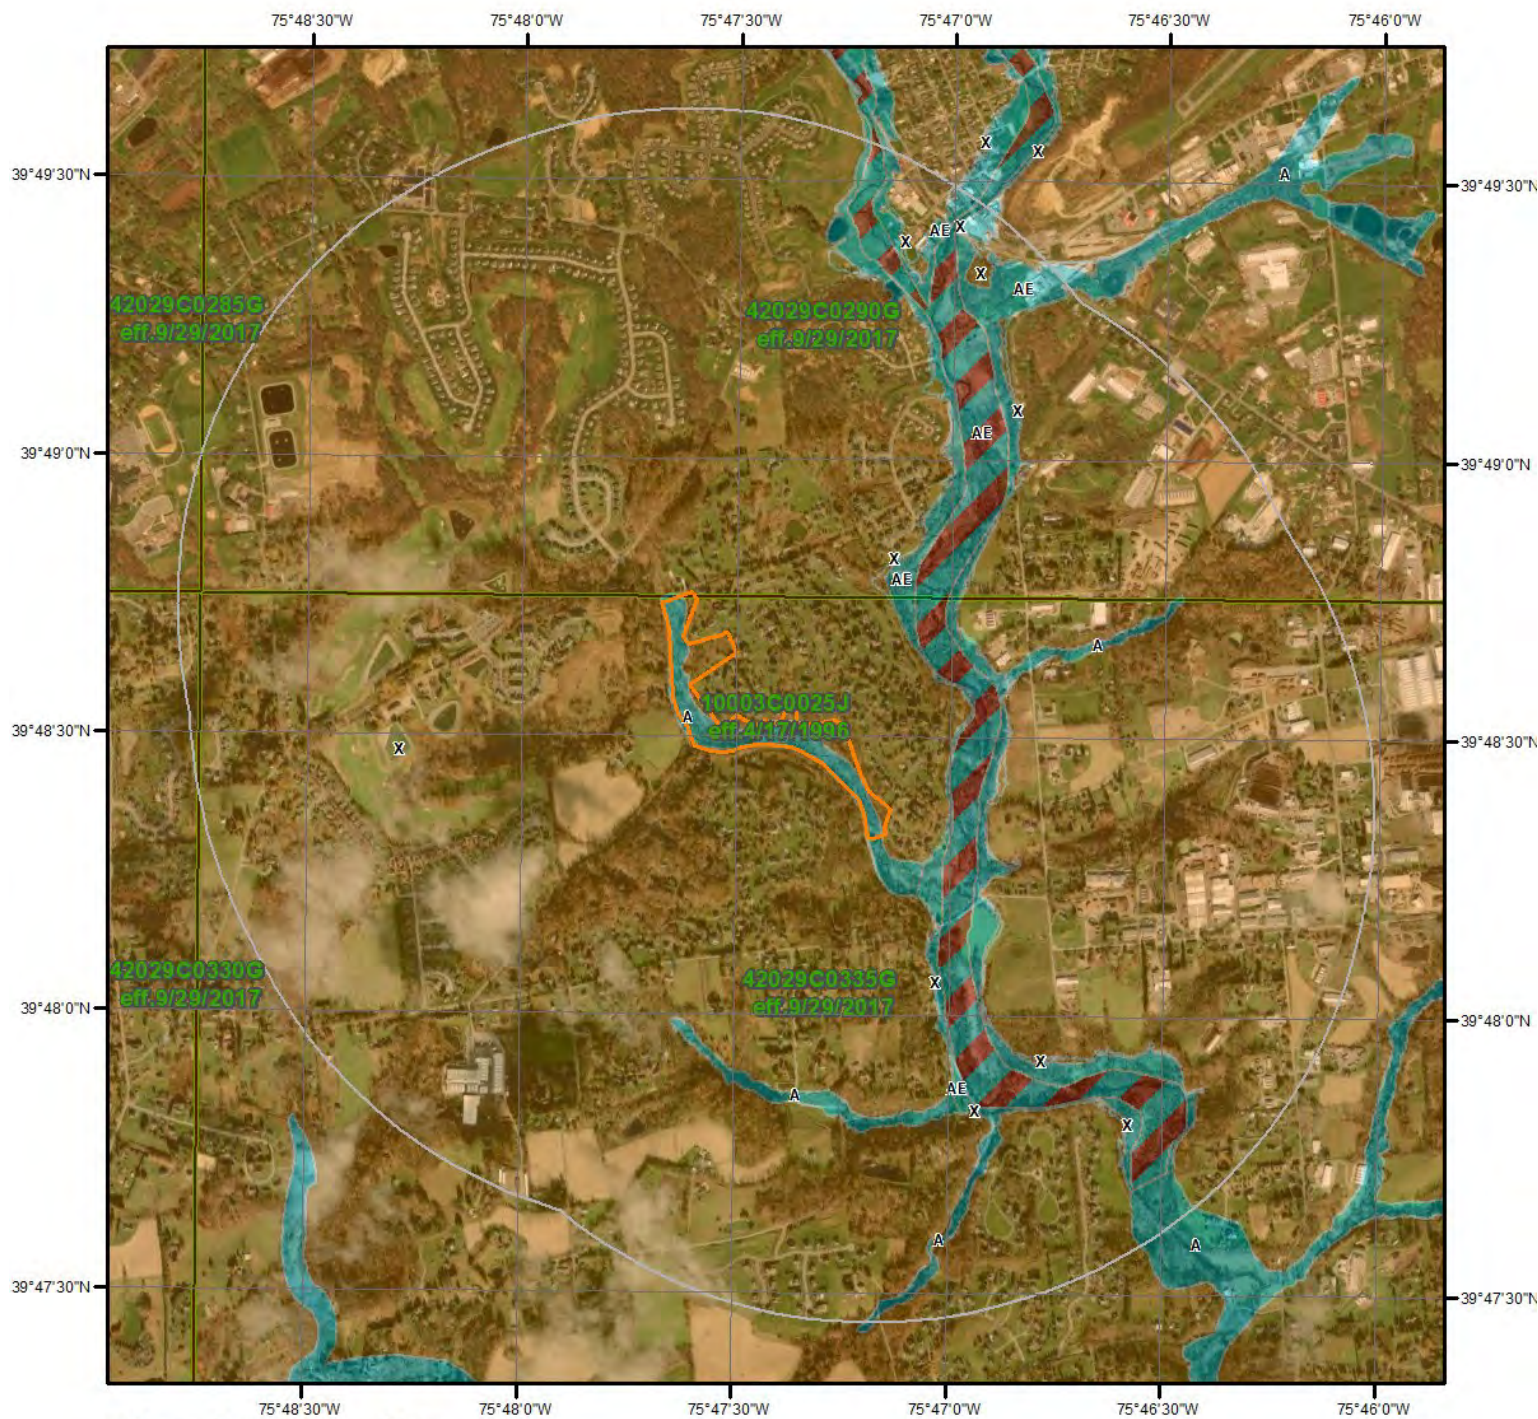
Flood Hazard Zones

This map shows FEMA flood hazard zones based on FEMA's National Flood Hazard Layer. FIRM Panels are overlaid. An absent FIRM panel represents no data available.

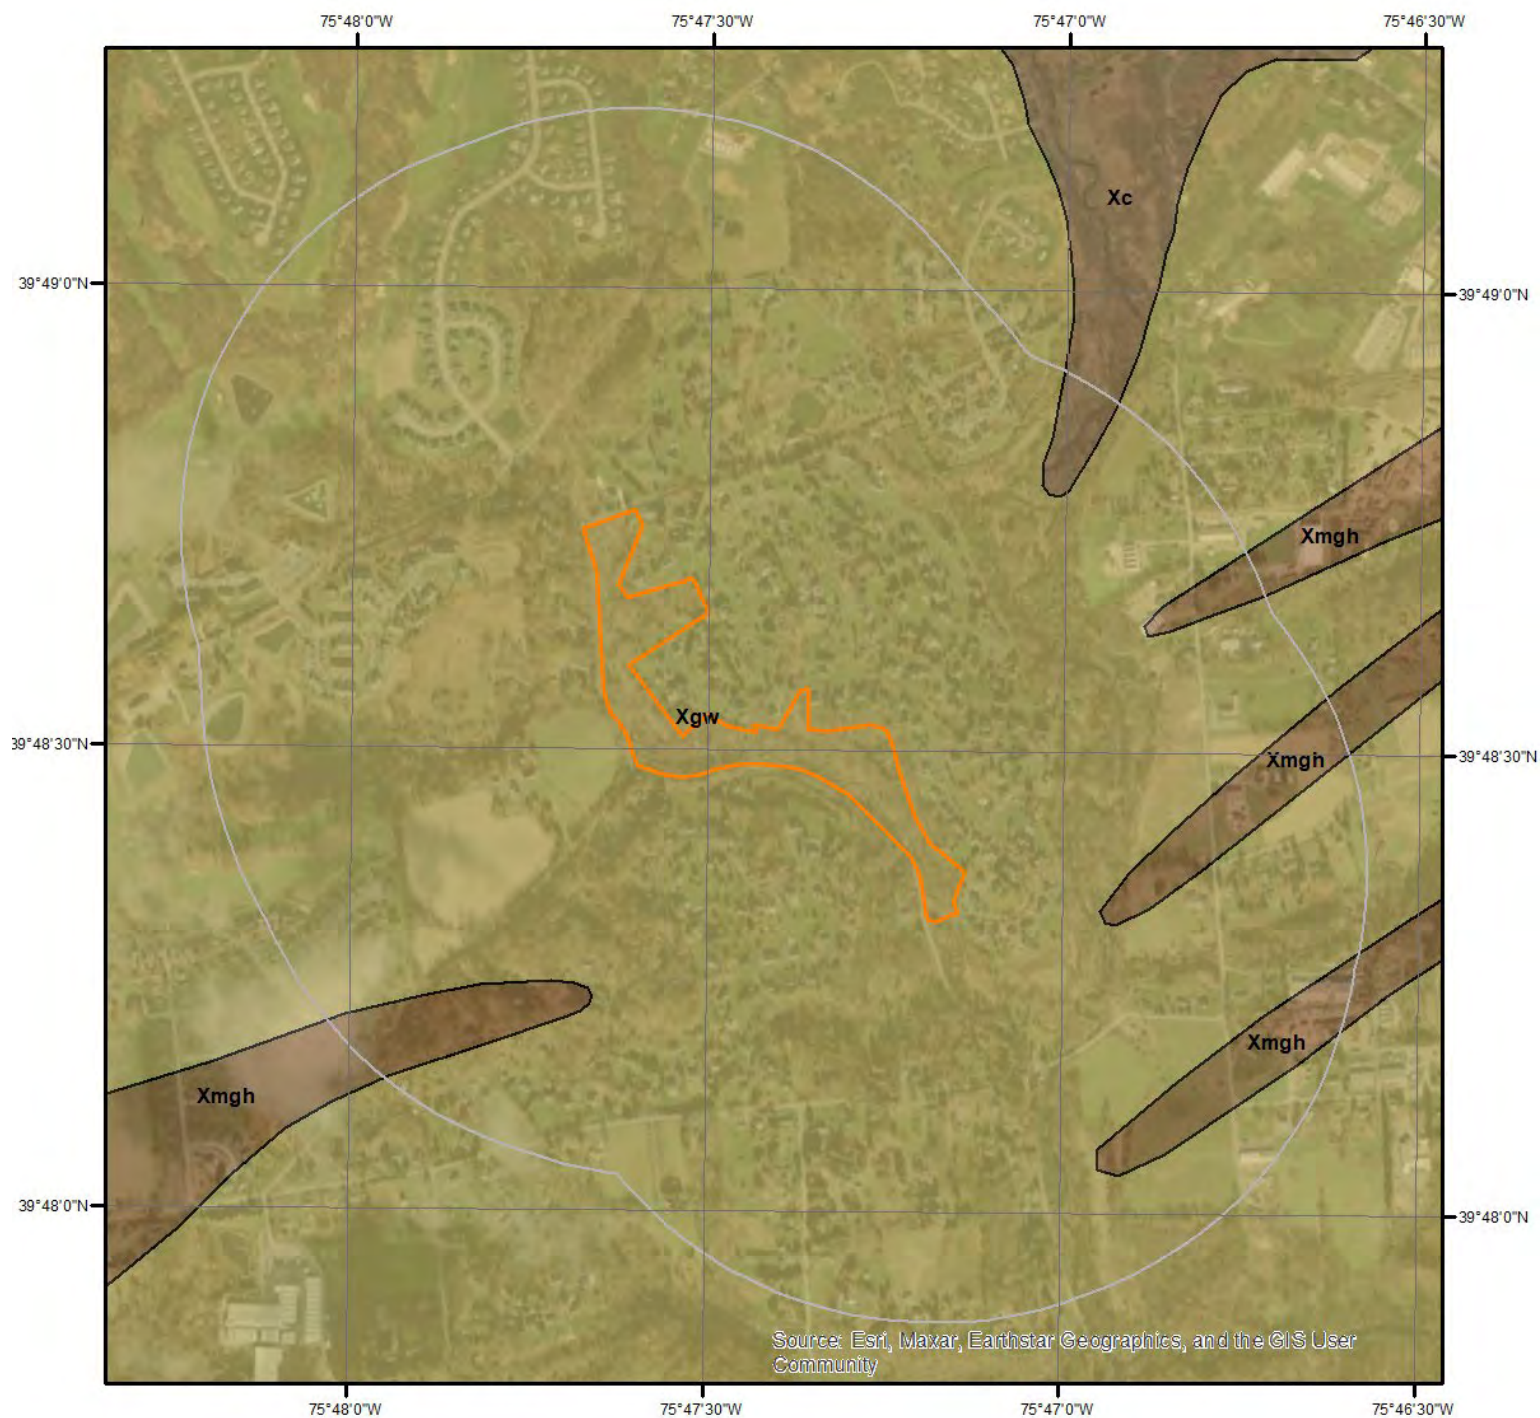
Geologic Units

This maps shows geologic units in the area. Please refer to the report for detailed descriptions.

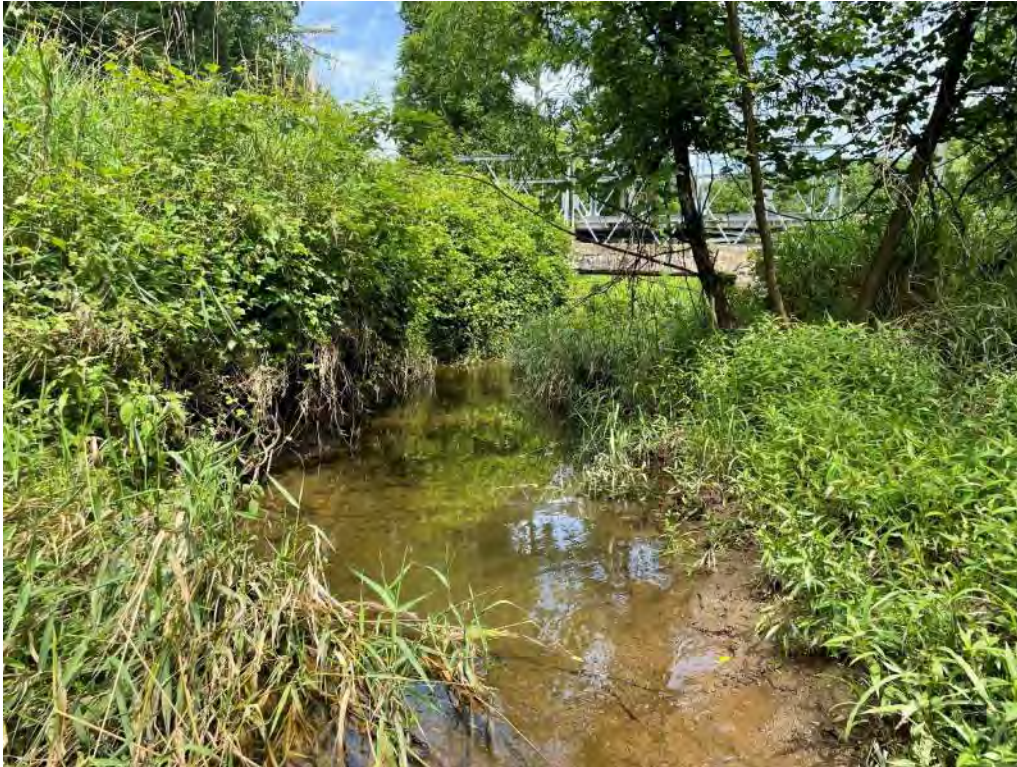
Photo 1. View upstream, to the northwest, of the bridge at Indian Run Road, the upstream limit of the Clay Creek Mitigation Bank.

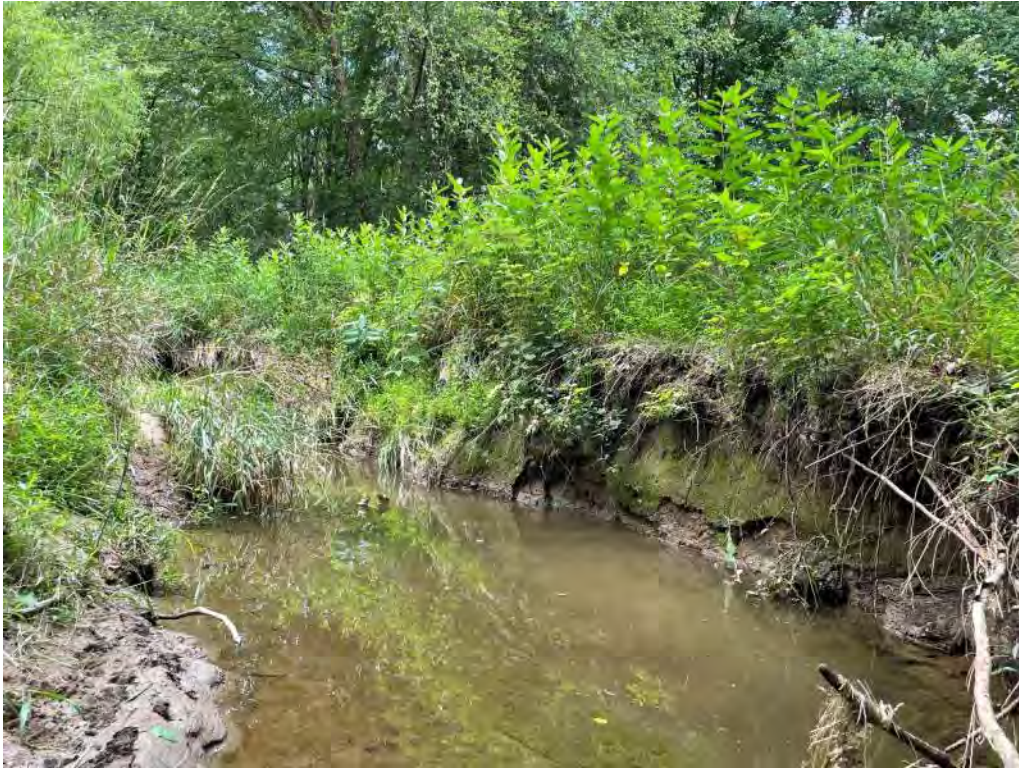
Photo 3. View upstream, to the northwest, on Tributary to Clay Creek.

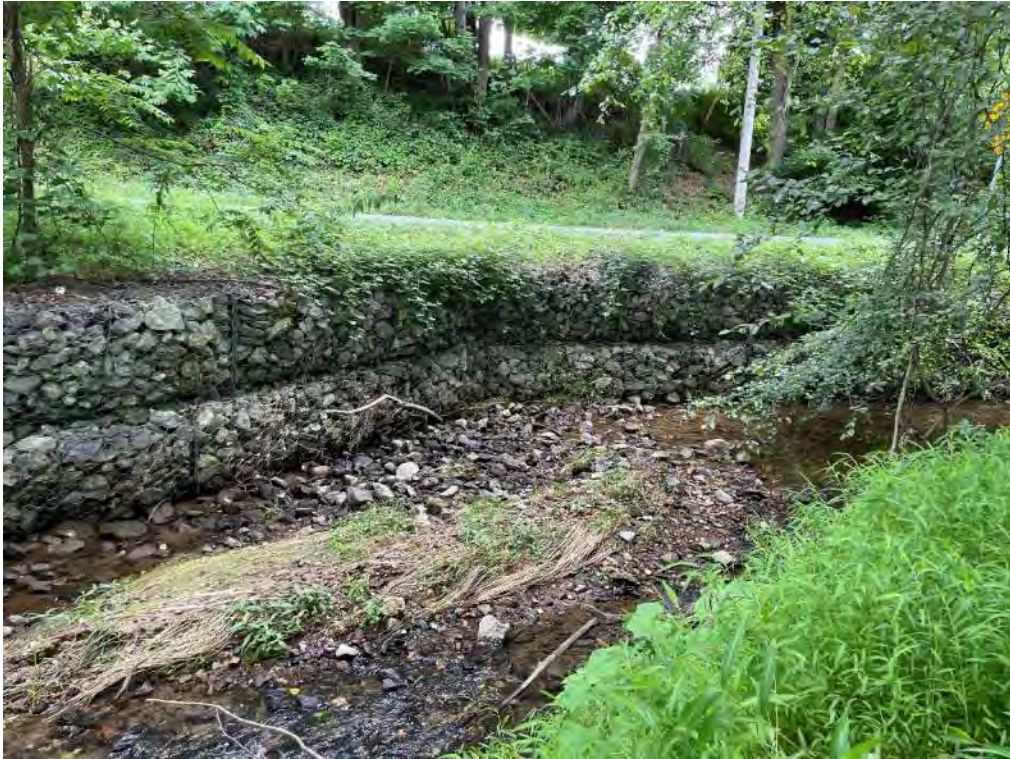
Photo 5. View upstream, to the northwest, on tributary to Clay Creek adjacent to Clay Creek Road

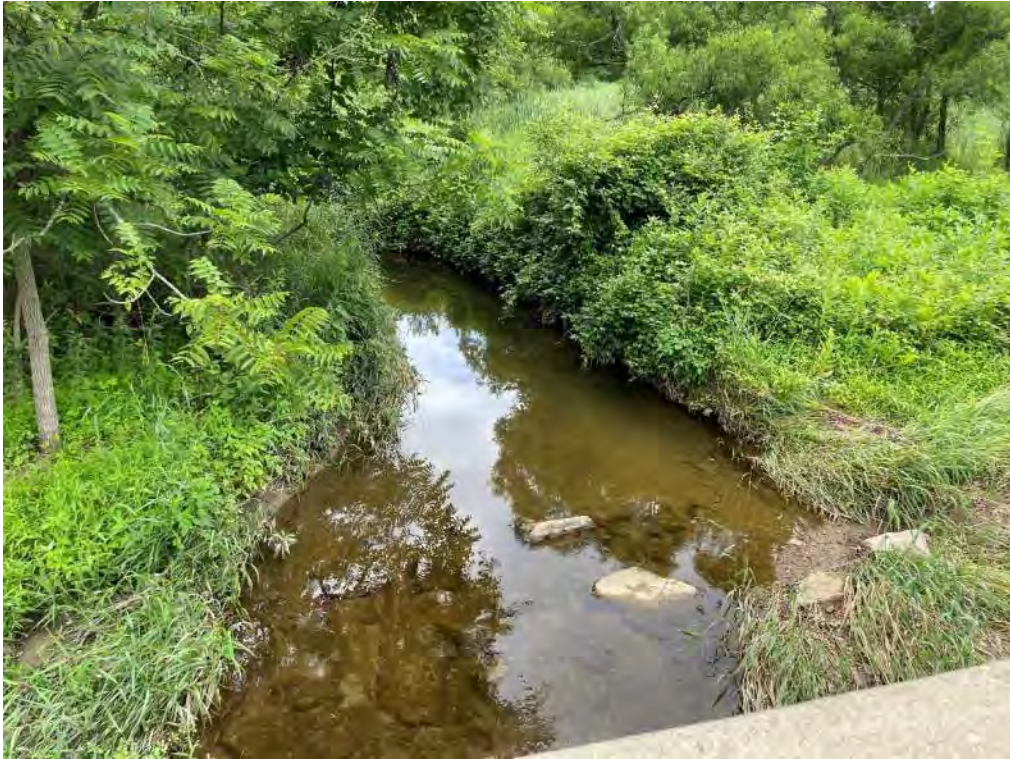
Photo 7. View upstream, to the west, from the bridge at Friendship Lane within the Clay Creek Bank Site.

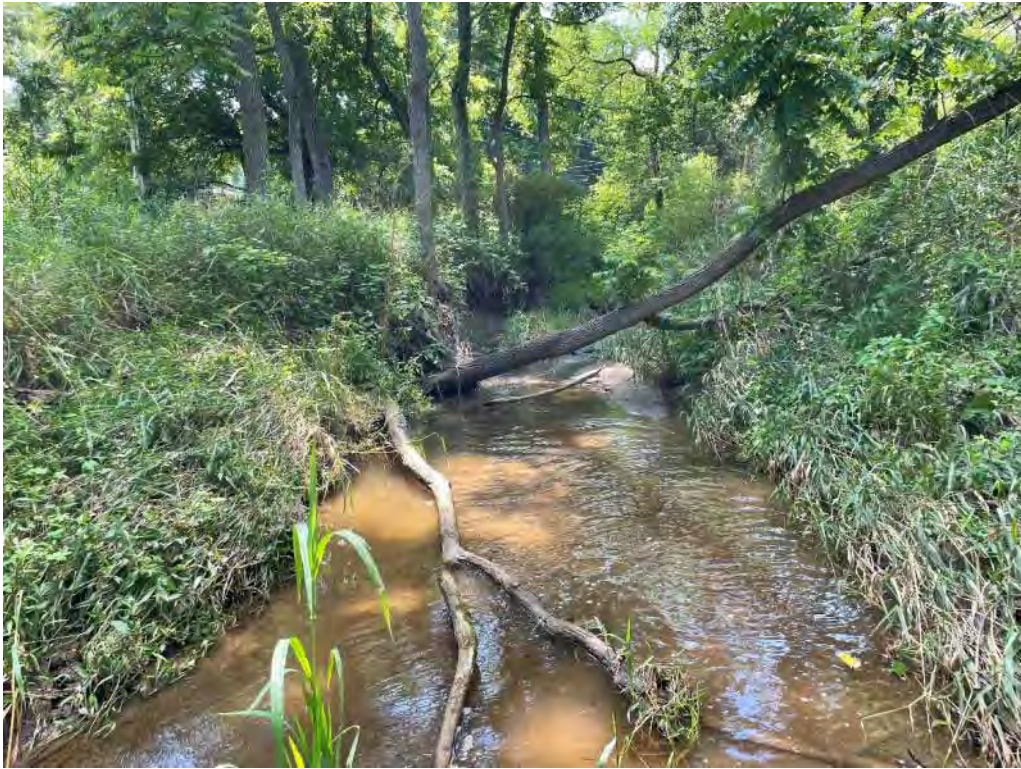
Photo 8. View upstream, to the southwest, within the Clay Creek Bank Site.

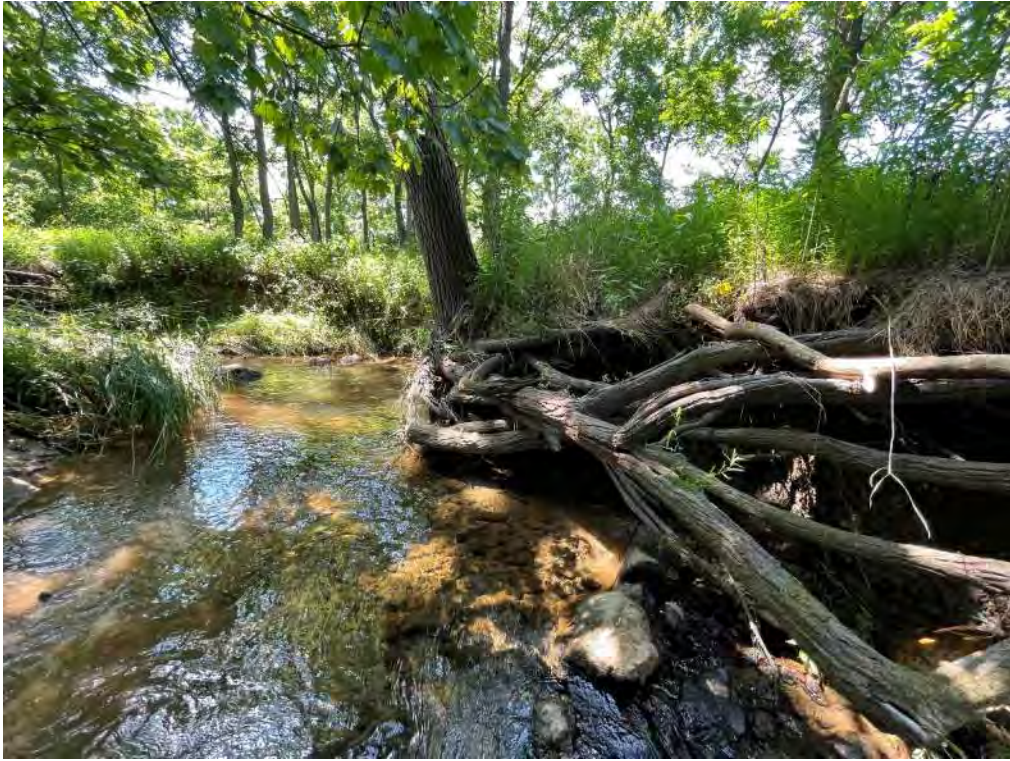
Photo 9. View upstream, to the northwest, from the Tributary to Clay Creek.

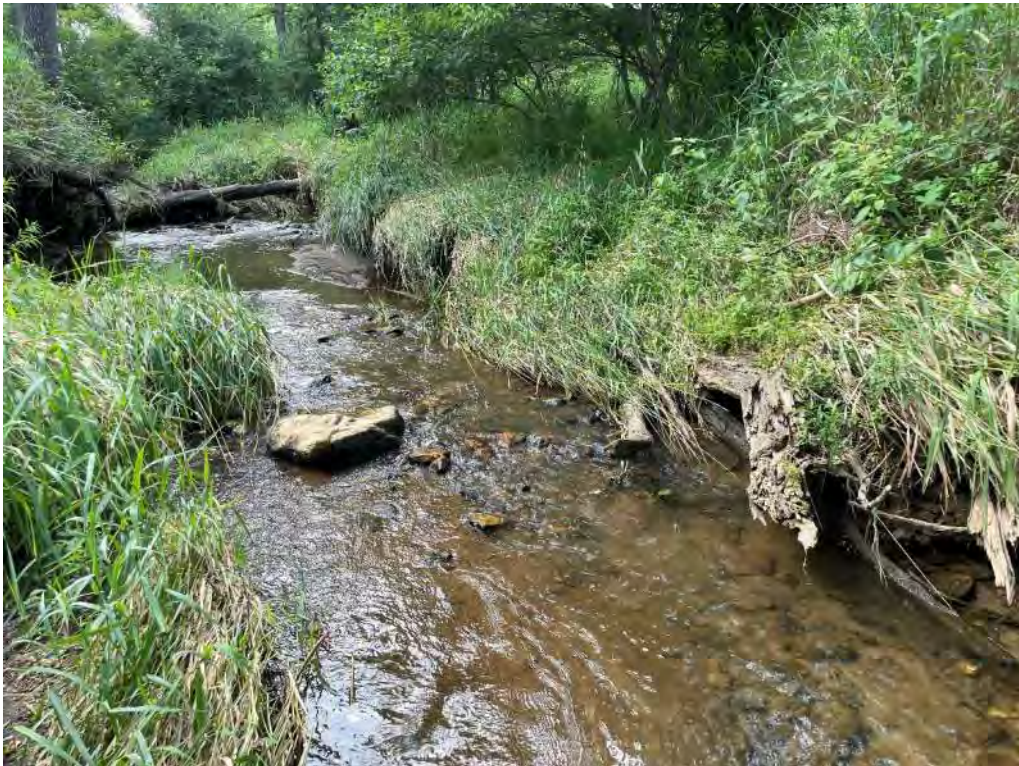
Photo 10. View to the northwest, upstream, from the Tributary to Clay Creek.

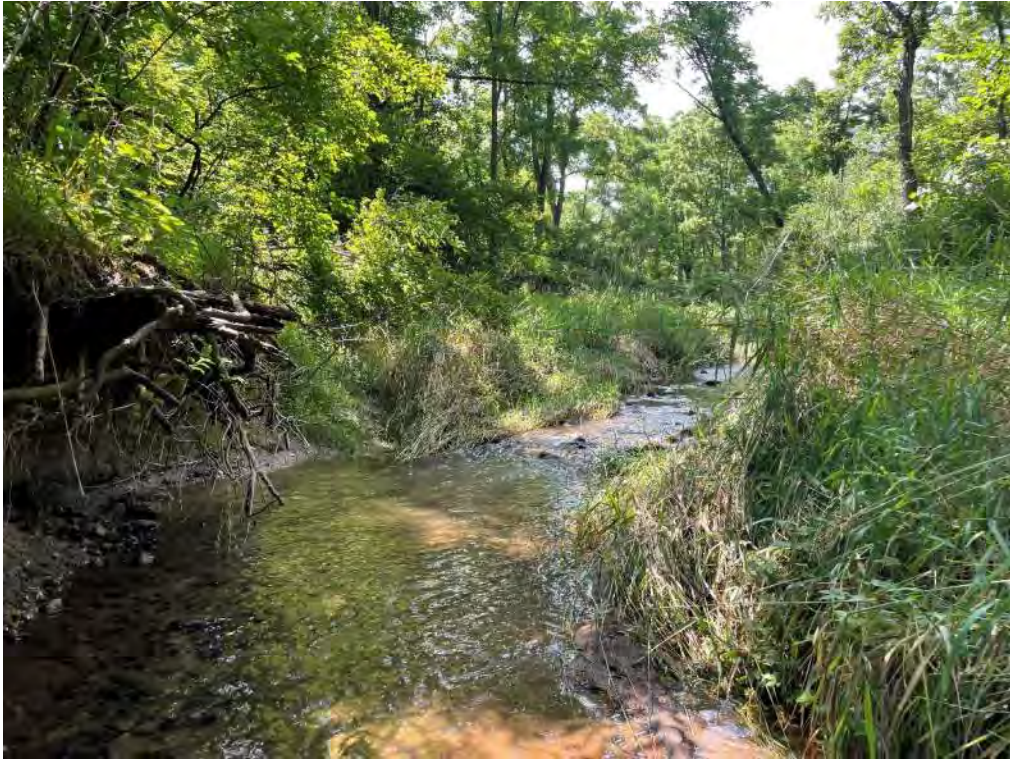
Photo 11. View to the northwest, upstream, from the Tributary to Clay Creek.

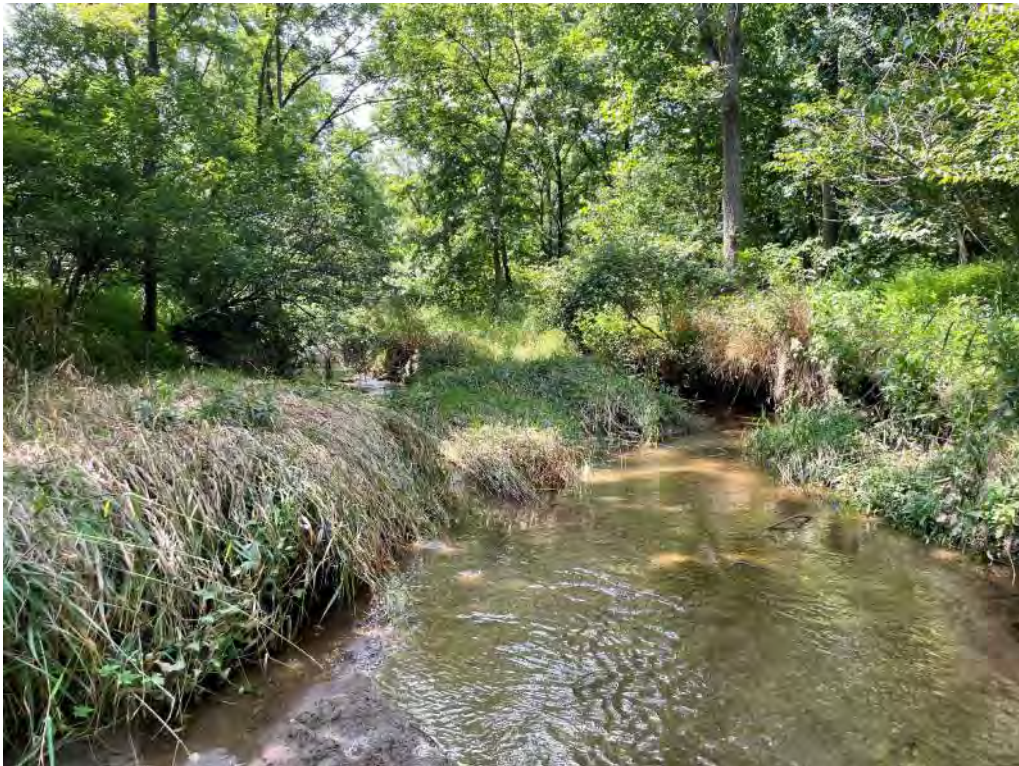
Photo 12. View upstream, to the northwest, within the Clay Creek Mitigation Bank.

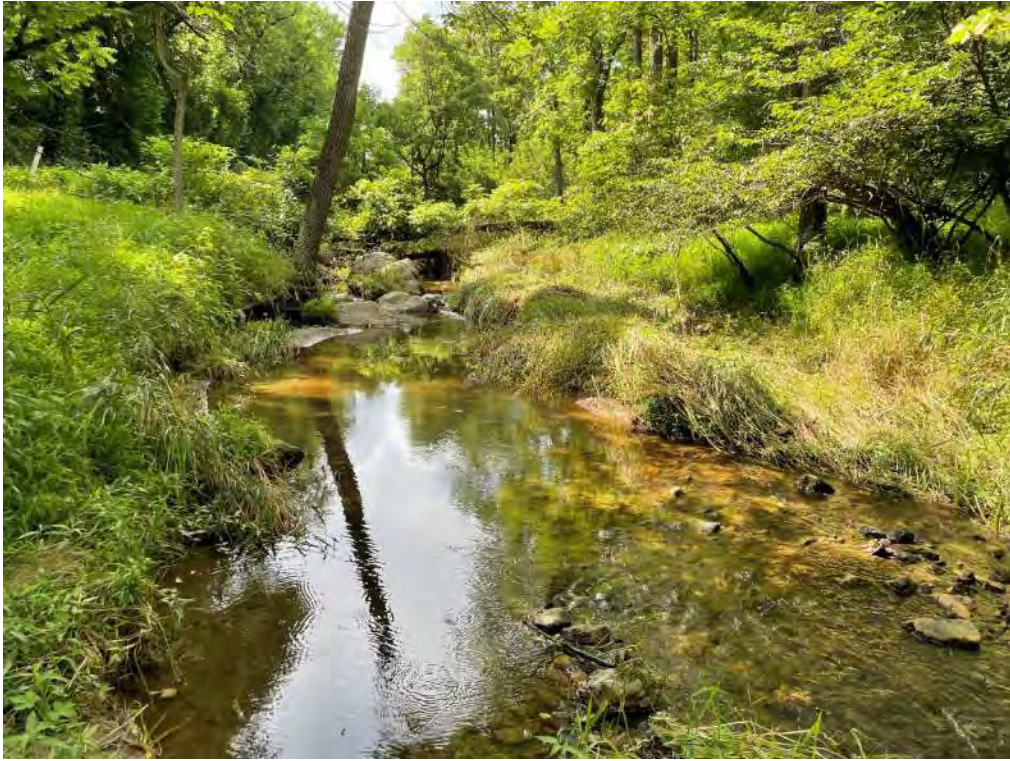
Photo 13. View upstream, to the northwest, from tributary to Clay Creek.

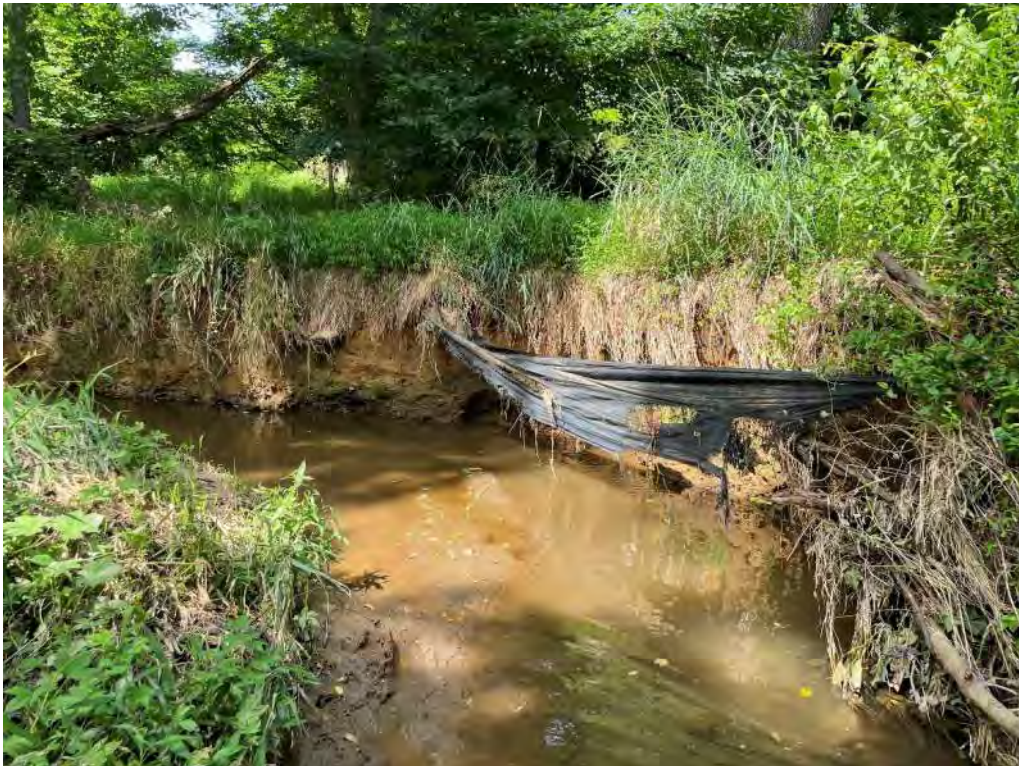
Photo 14. View upstream, to the northwest, from unnamed tributary to Clay Creek, just upstream of the bridge at Angelica Drive.
