Site Visit Report

Date: Tuesday, Nov. 6, 2001

Project: Bushkill Creek Stream Restoration Project

Purpose of Visit: Observe Geophysical Investigation

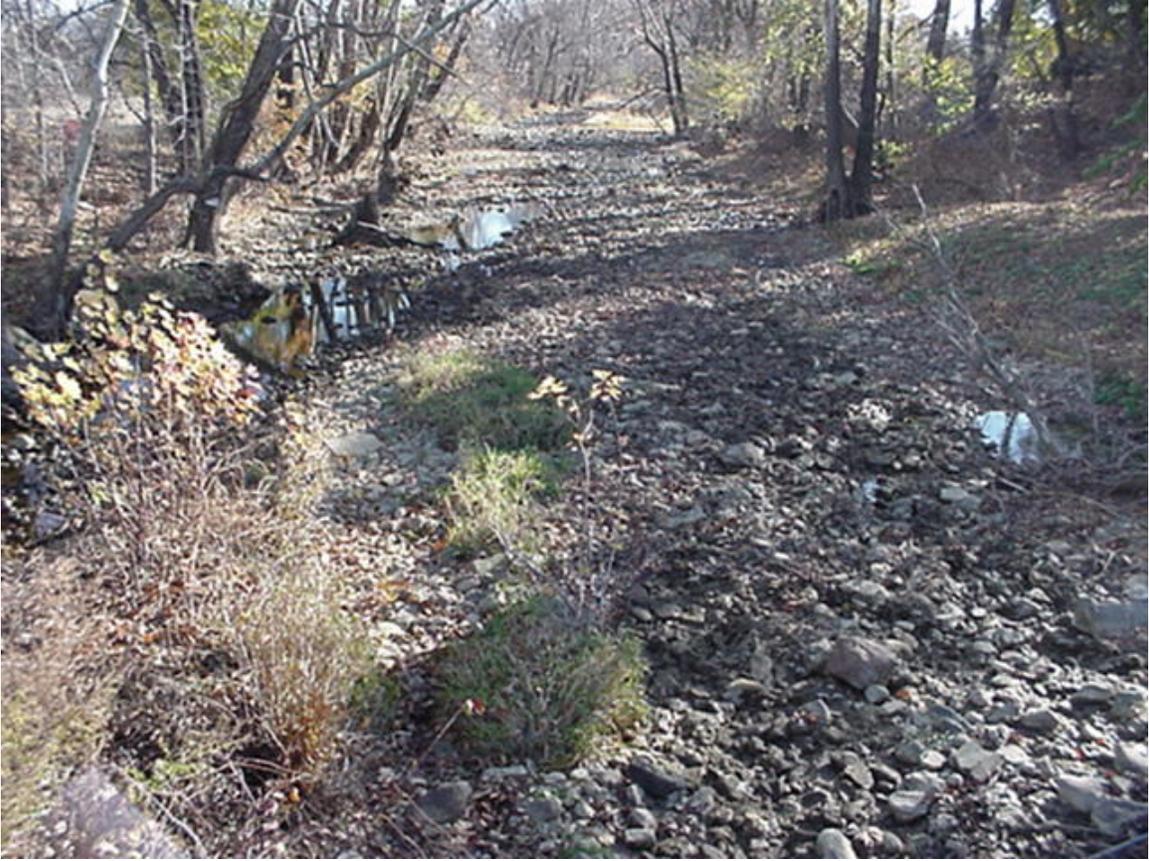
View northwest of the exposed foundation of the north abutment of the bridge. The spread footing is located just above the shadow of the photographer's head.
