Site 10: Thomas Mill Dam

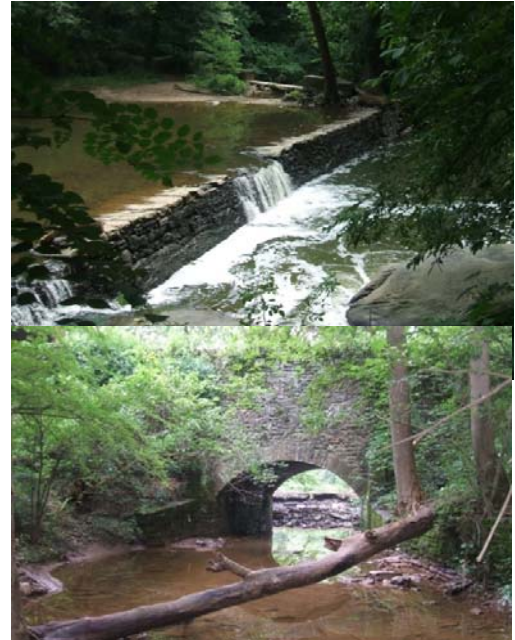
The Thomas Mill Dam is located approximately 5.6 miles above the confluence of Wissahickon Creek with the Schuylkill River, and on the creek’s mainstem, just above Thomas Mill covered bridge.

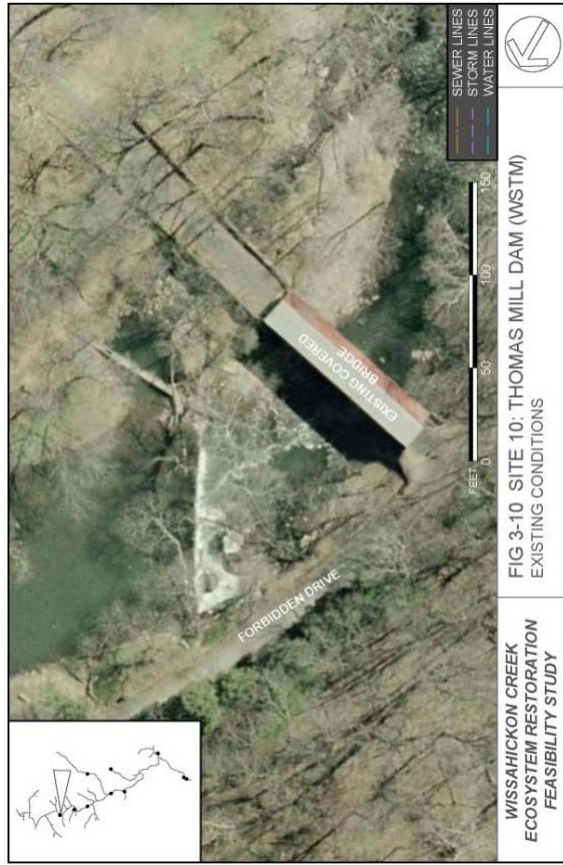
Alternative	Overview
1: No action	Under without project conditions, the Thomas Mill Dam will remain a barrier to fish passage, preventing species from migrating further upstream and poor habitat conditions will persist in the backwater behind the dam. This structure will likely need extensive renovation or replacement within 50 years.

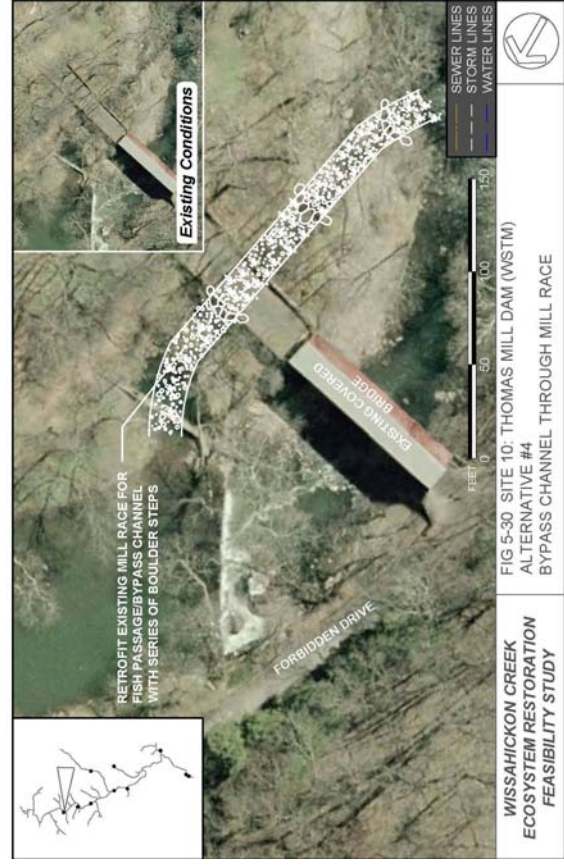
4: Bypass channel through mill race	Alternative #4 would provide fish passage through the historical mill race and control structure along the eastern side of the dam, thereby preserving most of the structure. Upstream aquatic habitat would not be improved. Like Alternative #3, this alternative would allow for fish passage and sensitivity to historic/cultural resources, but poor habitat conditions would likely persist in those areas still inundated by backwater conditions.
