Site 9: Cathedral Run

Site Information

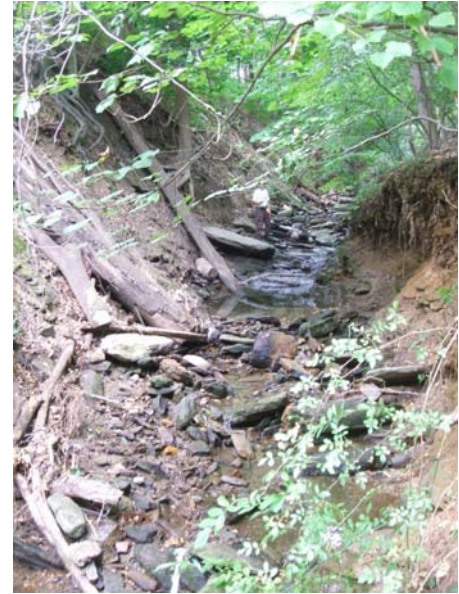
A tributary of Wissahickon Creek, Cathedral Run is located approximately 4.9 miles above the confluence of Wissahickon Creek with the Schuylkill River, and to the southwest of the creek's mainstem.

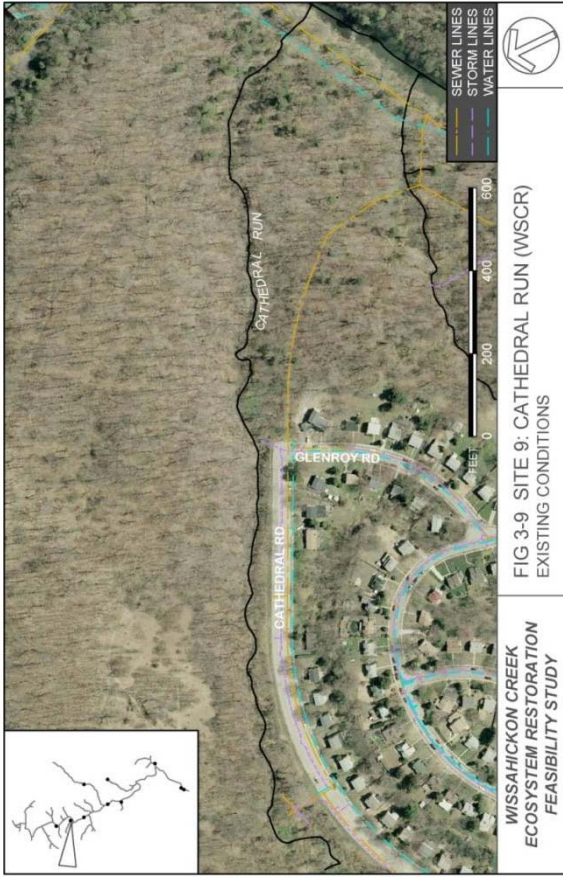
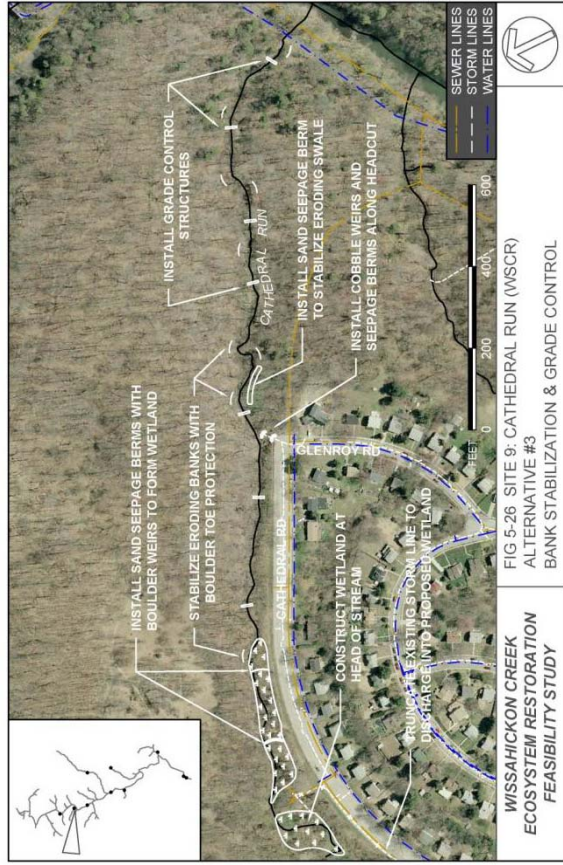
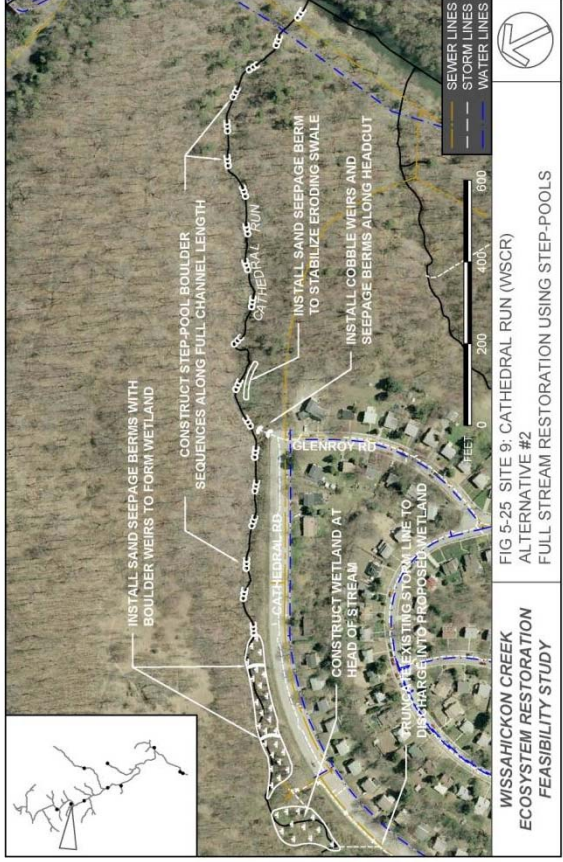
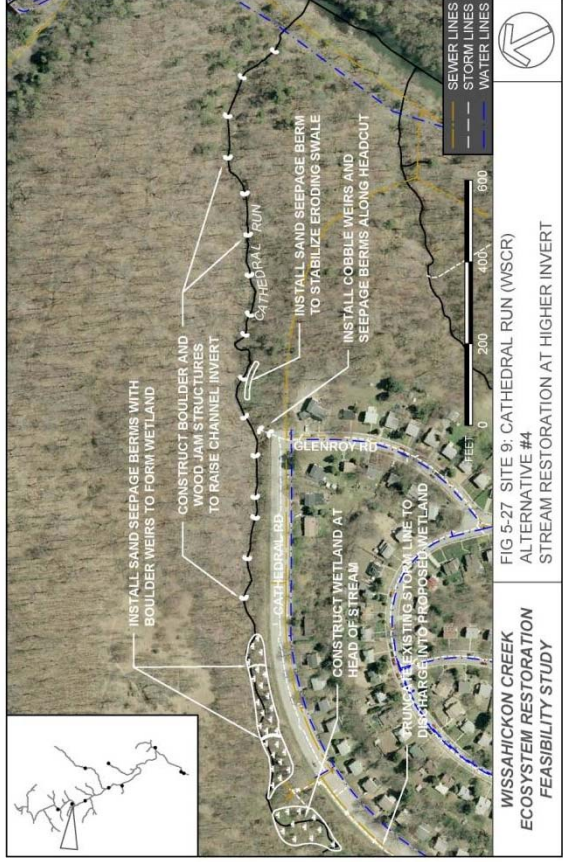
Alternative	Overview
1: No action	Severe erosion, excessive sediment delivery to Wissahickon Creek, and poor aquatic habitat will persist under without project conditions. The high and variable discharges that contribute to channel instability will continue to deliver pollutants to Cathedral Run during storm events.

3: Bank stabilization & grade control	Alternative #3 includes stabilization of sections of the channel that are experiencing the most severe bank erosion. As in Alternative #2, this alternative would also create wetlands in the upper project reach and stabilize the gullies at the end of Cathedral Road.

4: Stream restoration at higher invert	Alternative #4 includes raising the baseflow water surface by installing structures composed of boulders and large woody debris. As in Alternatives #2 and #3, this alternative would also create wetlands in the upper project reach and stabilize the gullies at the end of Cathedral Road.
