**Cape May Seawall
City of Cape May
Cape May County, New Jersey**

**Coastal Storm Risk Management
Continuing Authorities Program Section 103**

**Draft Integrated Feasibility Report &
Environmental Assessment**

**U.S. ARMY CORPS OF
ENGINEERS
PHILADELPHIA DISTRICT**

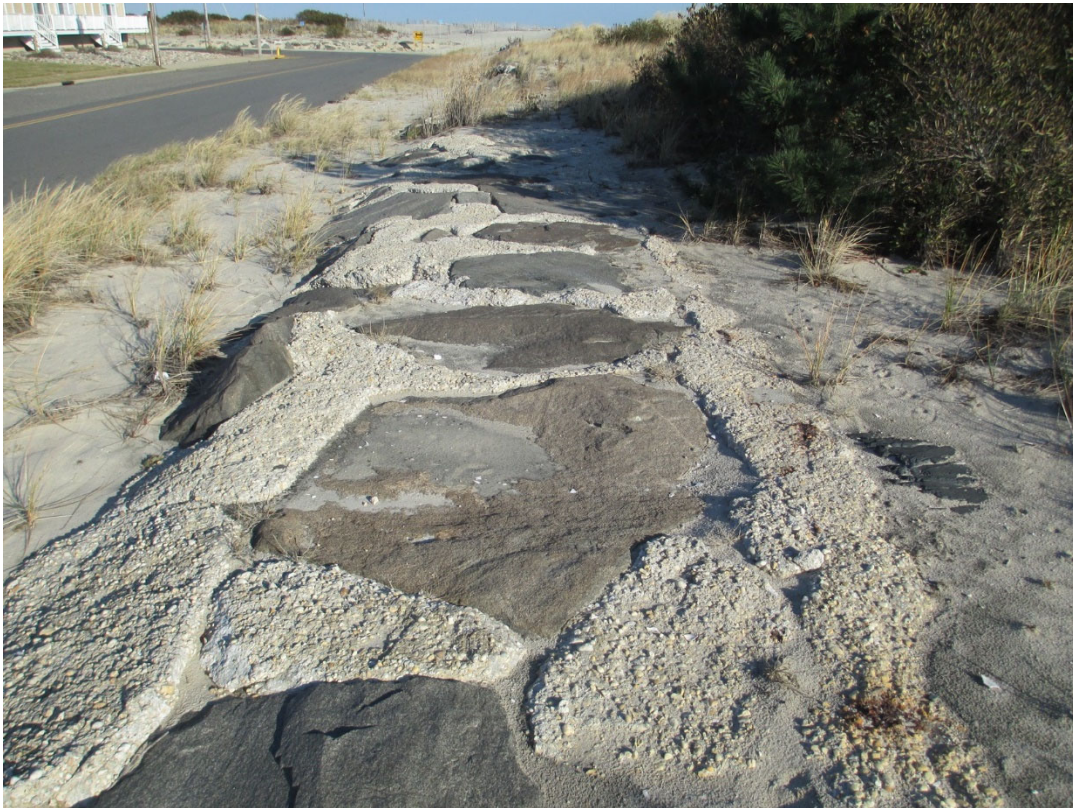
Figure 7: Typical seawall construction from Philadelphia Ave to Wilmington Ave.

A timber bulkhead provided coastal storm risk management along the ocean front of Cape May through the 1960s. The seawall was constructed following the destruction of the bulkhead and boardwalk by the Ash Wednesday Storm in March of 1962. The seawall is constructed of large rocks (approximately 4 to 5 feet in diameter) with concrete grouted within the voids (Figure 7). It extends from 2nd Avenue on the west side of the City to Wilmington Avenue on the east side. From 2nd Avenue to Madison Avenue, the top of the seawall is covered by an asphalt promenade that is used for recreation (Figure 8). This length of the seawall also has a concrete retaining wall on the street side. From Philadelphia Avenue to Wilmington Avenue, the seawall does not have an asphalt promenade and has a two-foot timber bulkhead on the street side. (Figures 9 and 10).

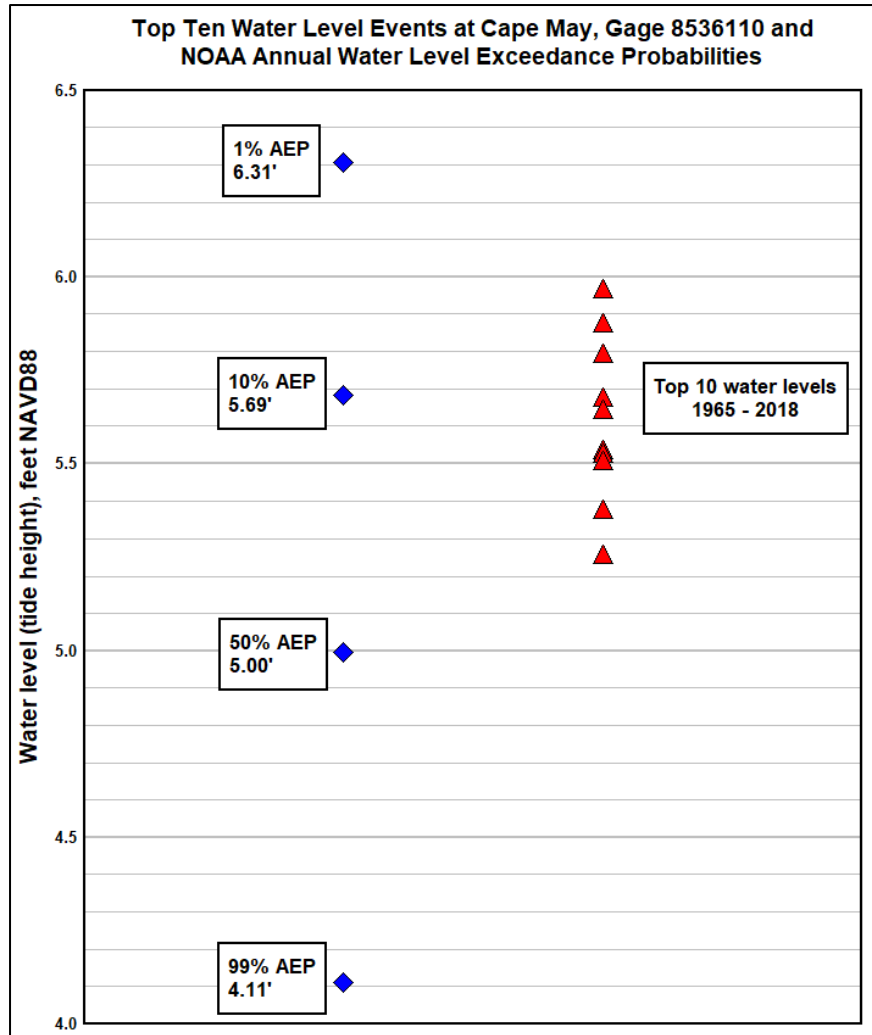
Figure 13: Comparison plot of top ten water levels and AEPs.

Figure 13 displays the top ten highest water levels (in red) compared to the 1%, 10%, 50%, and 99% annual exceedance probability (AEP) water levels (in blue) for the Cape May tide gage. It can be seen that the top three events fall between the 1% and 10% AEP elevations, and the remainder between the 10% and 50% AEPs.

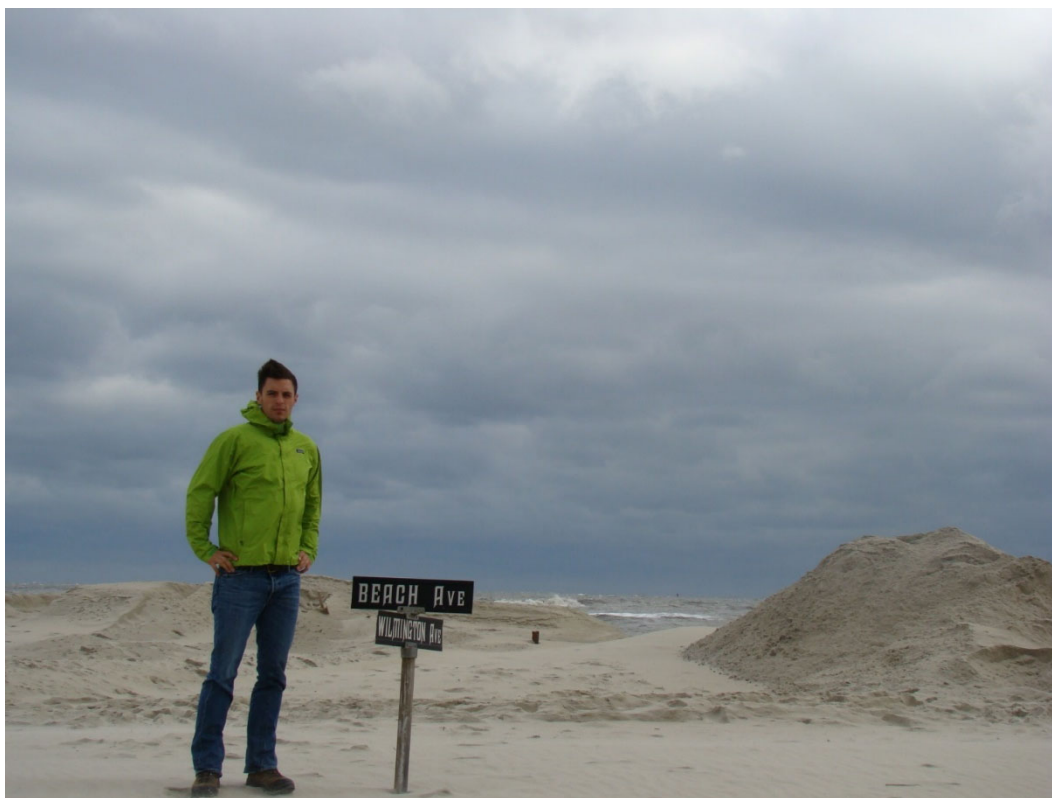
Figure 15: Intersection of Beach and Wilmington Avenues following Hurricane Sandy.

The highest water surface elevations recorded during Hurricane Sandy equated to approximately a 5% flood in the vicinity of Cape May. During the storm, the ocean overtopped the seawall in a number of locations, but primarily at the corner of Beach and Wilmington Avenues on the east end of the City. Local residents witnessed the ocean “pouring over the seawall like a waterfall” in this location during both high and low tides. Wave and tidal action from Sandy brought approximately 8,000 cubic yards of sand over the seawall at the intersection and onto Beach Avenue and adjacent residential properties. Sand deposition in some areas was approximately 8 feet high (Figure 15). The City’s cleanup costs for the sand deposition were approximately \$30,000.

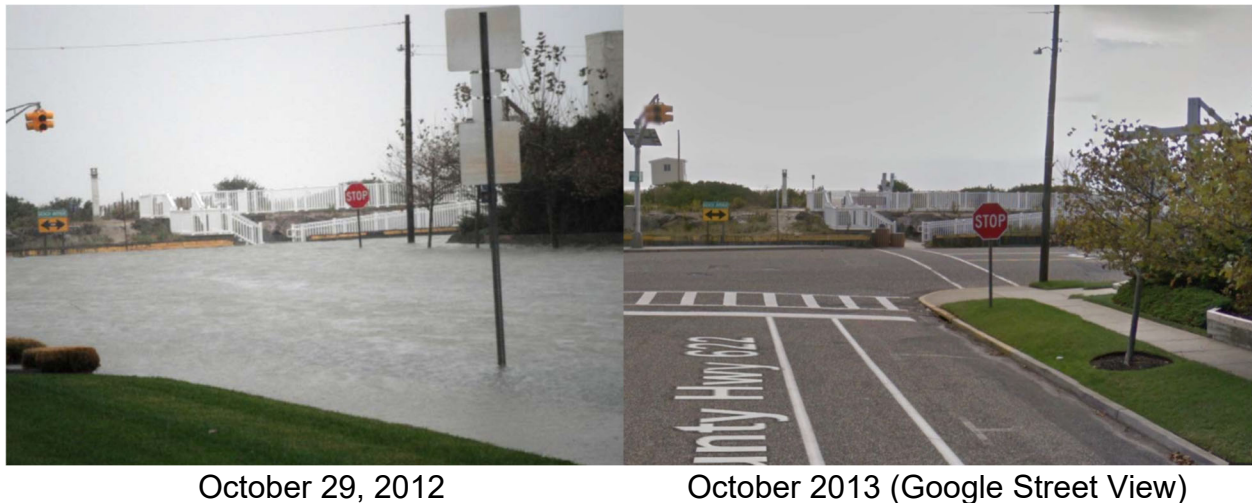
Figure 16: Intersection of Beach and Pittsburgh Avenues during Hurricane Sandy (left).

When the ocean overtops the seawall during an event like Hurricane Sandy, Beach Avenue floods (Figure 16) and acts as a drainage channel that funnels the ocean water west into Frog Hollow, the lowest-lying part of the City. Local residents reported at least 3 feet of water in the streets of Frog Hollow during Hurricane Sandy. Local officials also reported that the pump stations in Frog Hollow were operating for approximately 48 hours straight throughout the storm. Rainfall amounts during Hurricane Sandy were relatively low for a large coastal storm (about 10 inches between 28 and 31 October 2012) and should have been adequately managed by the pump stations to keep the area free of

flooding. However, the presence of 3 feet of water would indicate that the storm water system was overwhelmed by the additional input of the ocean water. And if the pumping stations had failed to function during Hurricane Sandy, the flooding would have been much more significant.

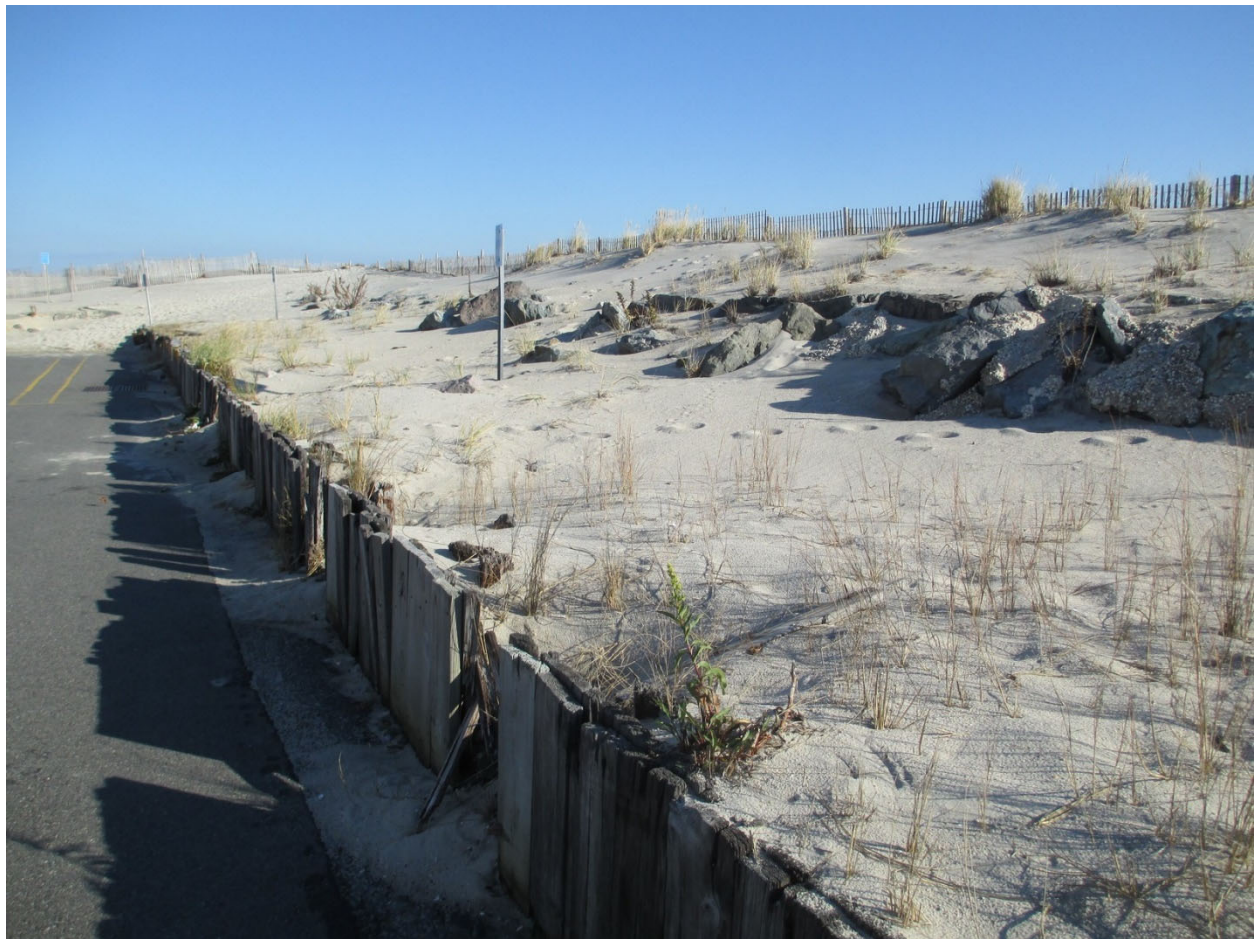
Figure 17: View from Beach Avenue looking east toward Wilmington Avenue.

The ocean is not visible from Beach Avenue on the east side of the City, from approximately Philadelphia to Wilmington Avenues. The top of the stone seawall is approximately 4 to 5 feet higher than the ground along Beach Avenue. Sand which has accreted and vegetation which has established also adds approximately 3 to 4 feet of elevation to the top of the seawall, which blocks pedestrian views of the ocean. Pedestrians must access the beach via one the public access ramps which crossover the seawall to view the ocean. According to 2018 USACE topographic surveys, the top of the sand lying on top of the seawall at the corner of Beach and Wilmington Avenues is at an approximate elevation of 14 feet NAVD (Figure 17).

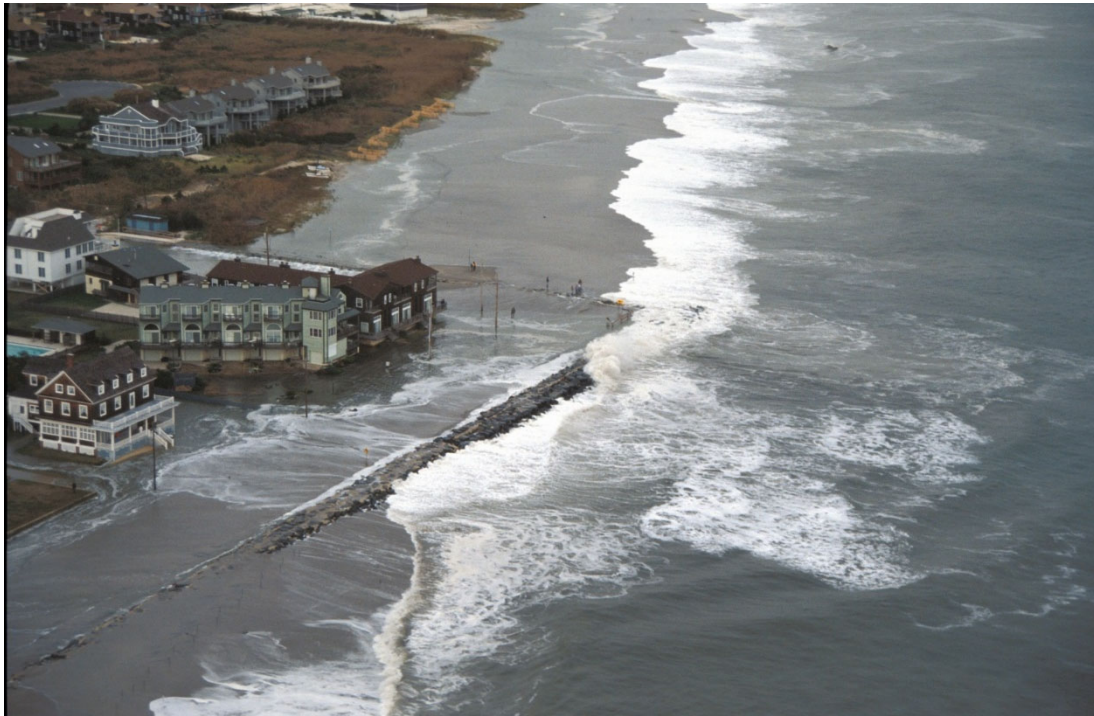
Figure 18: Corner of Beach and Wilmington Avenues, Halloween Storm in 1991.

City officials indicated that four storm events had overtopped the seawall in the last 26 years. These were the Halloween Storm of 1991 (Figure 18), the two nor'easters of 1992, and Hurricane Sandy.

The Federal beach project was constructed by July 1991 and was in place for all of these events. In each storm, overtopping occurred primarily at the corner of Beach and Wilmington Avenues. Other isolated areas of the seawall along the ocean front may have been briefly overtopped during these storms, but the area in the vicinity of Beach and Wilmington Avenues was consistently the problematic location.

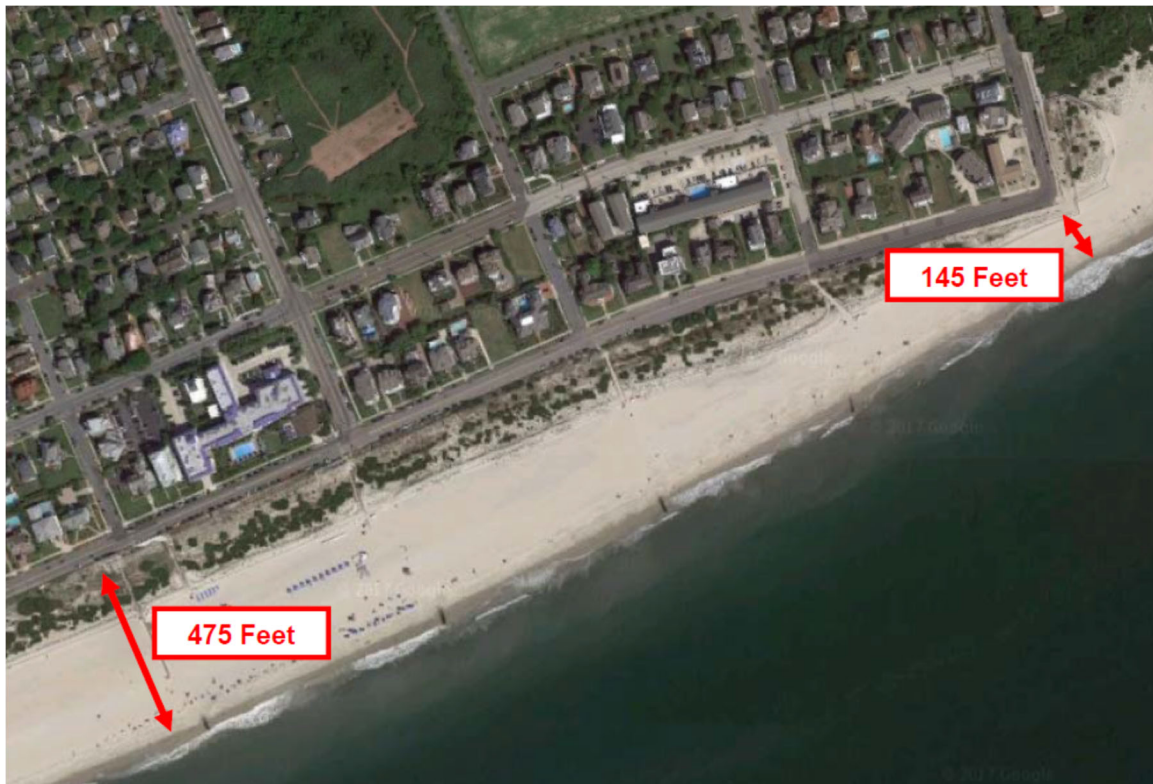
Figure 19: Distance from the seawall to the ocean at Beach and Wilmington Avenue Area.

The PDT has concluded that the underlying condition which makes the area so vulnerable is the distance from the seawall to the ocean (Figure 19). The last two blocks of Beach Avenue angle out toward the ocean, which decreases the distance between the seawall and the ocean by approximately 300 feet compared to the rest of the ocean front in Cape May. During a storm surge event when the ocean surface is elevated, this corner is the first and most susceptible point for wave attack. Frequent encroachment by the ocean is also the reason that a dune has not accreted and become vegetated in front of the seawall as it has along the rest of the ocean front.

In an effort to determine why the area in the vicinity of Beach and Wilmington Avenues was the “weak spot” for flooding along the ocean front, the PDT examined recent survey profiles of the Federal beach project in conjunction with the seawall elevation survey data that was collected for this study. The PDT also discussed the Beach and Wilmington Avenues area with the USACE project manager for the Federal beach project. The project manager indicated that the area is considered an erosion “hot spot” where it is difficult to maintain sand which is placed during periodic beach renourishment cycles. Even when an additional lobe of sand has been added as a buffer at Beach and Wilmington Avenues area, the tidal and wave forces of the ocean quickly bring the area into a linear equilibrium with the beaches to the east and west.

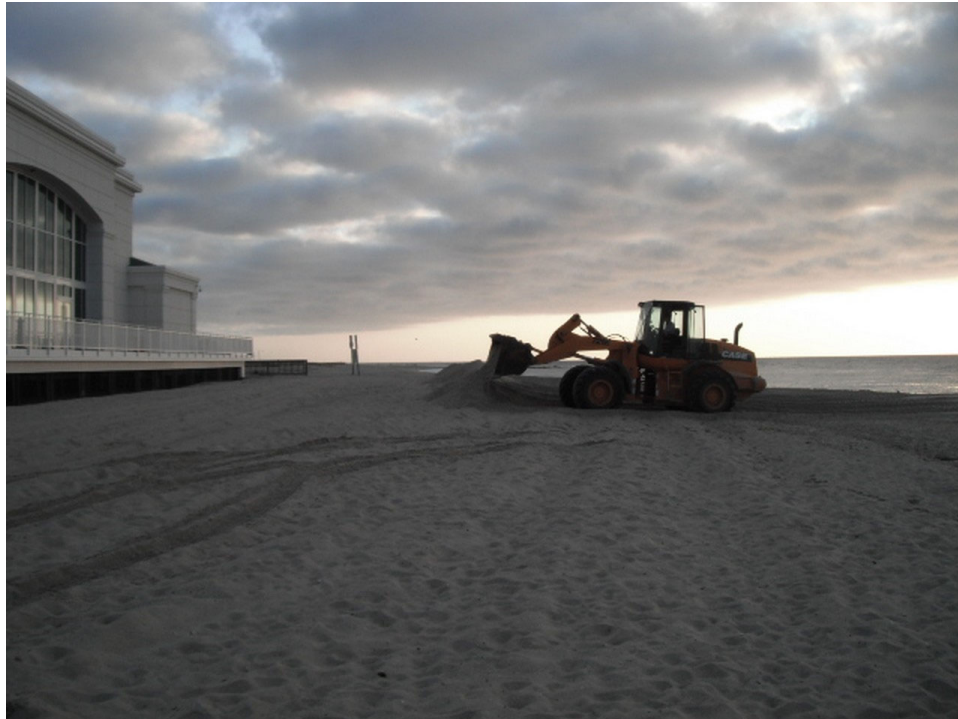
Figure 20: Temporary flood fighting efforts by the City prior to Hurricane Sandy.

Within the 50-year Federal project horizon, there is potential that local and/or regional interests will implement CSRМ measures within the study area in the absence of a USACE project. In preparation for Hurricane Sandy and the nor'easter in January of 2016, the City requested permission from the State to temporarily modify the beach in an attempt to mitigate storm damage. Prior to Hurricane Sandy, small, temporary dunes were constructed with beach sand in front of Convention Hall (Figure 20). Similar efforts were performed at the corner of Beach and Wilmington Avenues prior to the 2016 nor'easter. The temporary dunes eroded throughout the course of the storm and the ocean eventually overtopped the seawall, although not to the same degree as during Hurricane Sandy. If the temporary dunes had not been present, overtopping by the 2016 storm would likely have been more significant. Local flood-fighting efforts such as these are not reliable measures given the inherent uncertainties of staff and equipment availability, timing of the storm, evacuation status, etc. They are not intended to be a long term CSRМ solution for Cape May.

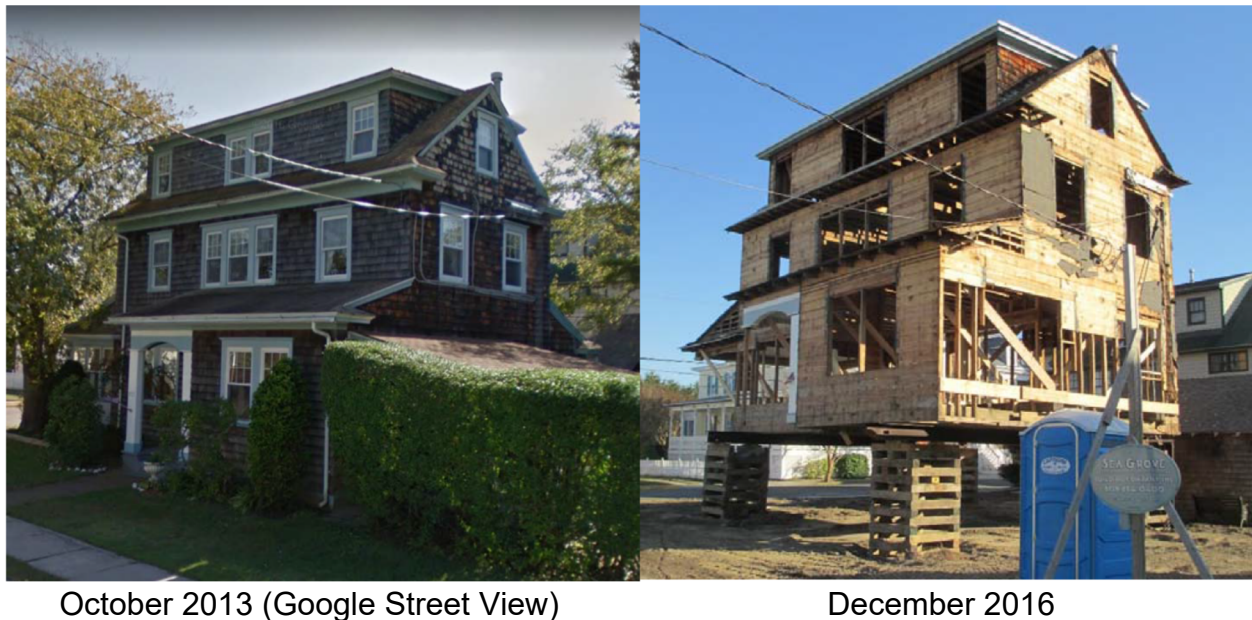
Figure 21: Recently elevated structure at the corner of Kearney Avenue and Jefferson Street in Frog Hollow.

Throughout the previous decades, some residents in the study area have elevated their homes in response to frequent coastal storm damage (Figure 21). The availability of post-Hurricane Sandy grant funding has also prompted renewed interest in this opportunity. However, the first floor elevations of many structures in the study area remain, and are likely to remain, near existing grade. The large hotels along Beach Avenue have extensive first floors which are near existing grade. Elevation of these types of structures is typically costly, complicated, and achieved through demolition and rebuilding.

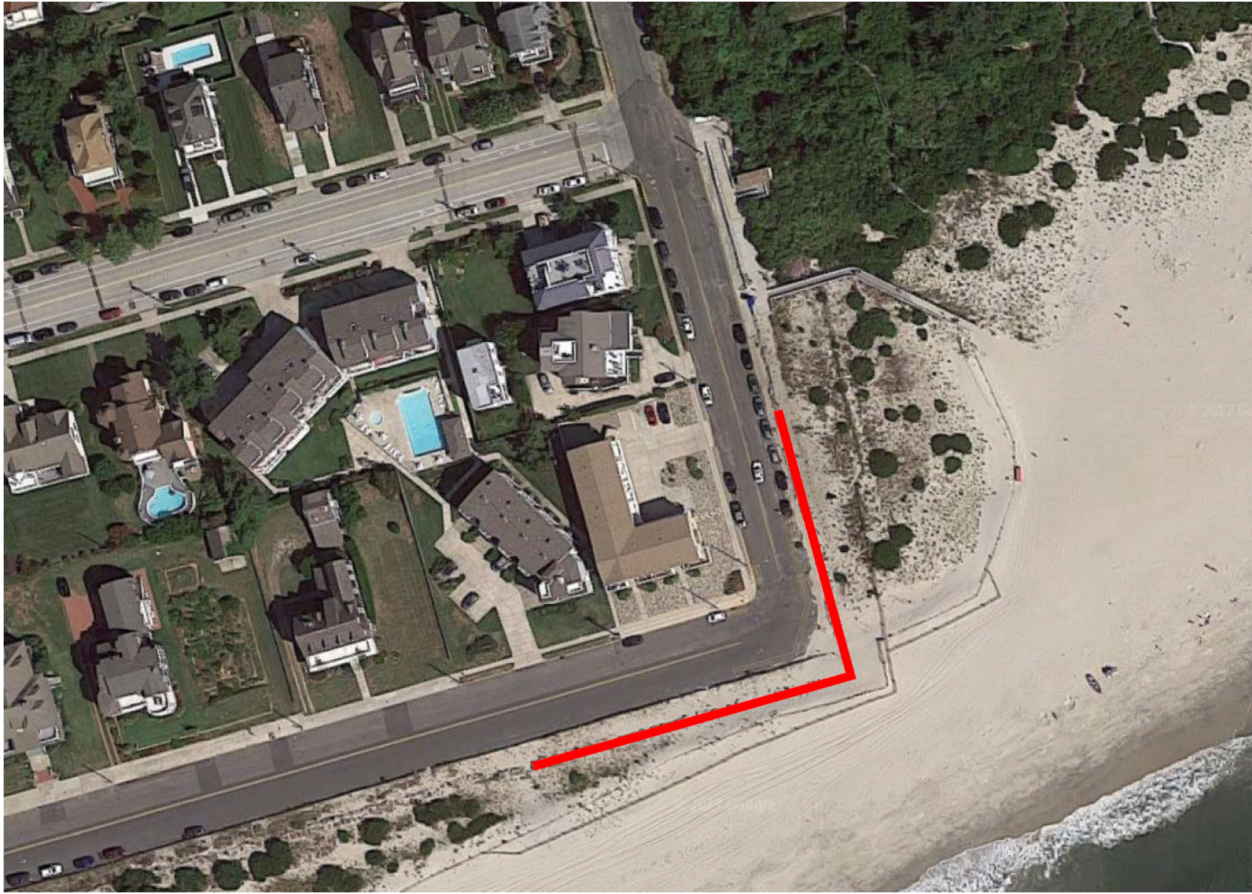
Figure 22: Extent of the 350-foot section where an elevated barrier is proposed.

For the initial screening of structural alternatives, the conceptual barriers were all designed to an elevation of 13 ft (NAVD88) for comparison purposes. This height was selected based on the ocean water surface elevation that occurred during Hurricane Sandy and resulted in overtopping. A conceptual barrier with an elevation of 13 ft (NAVD88) would have likely prevented any significant overtopping during Sandy.

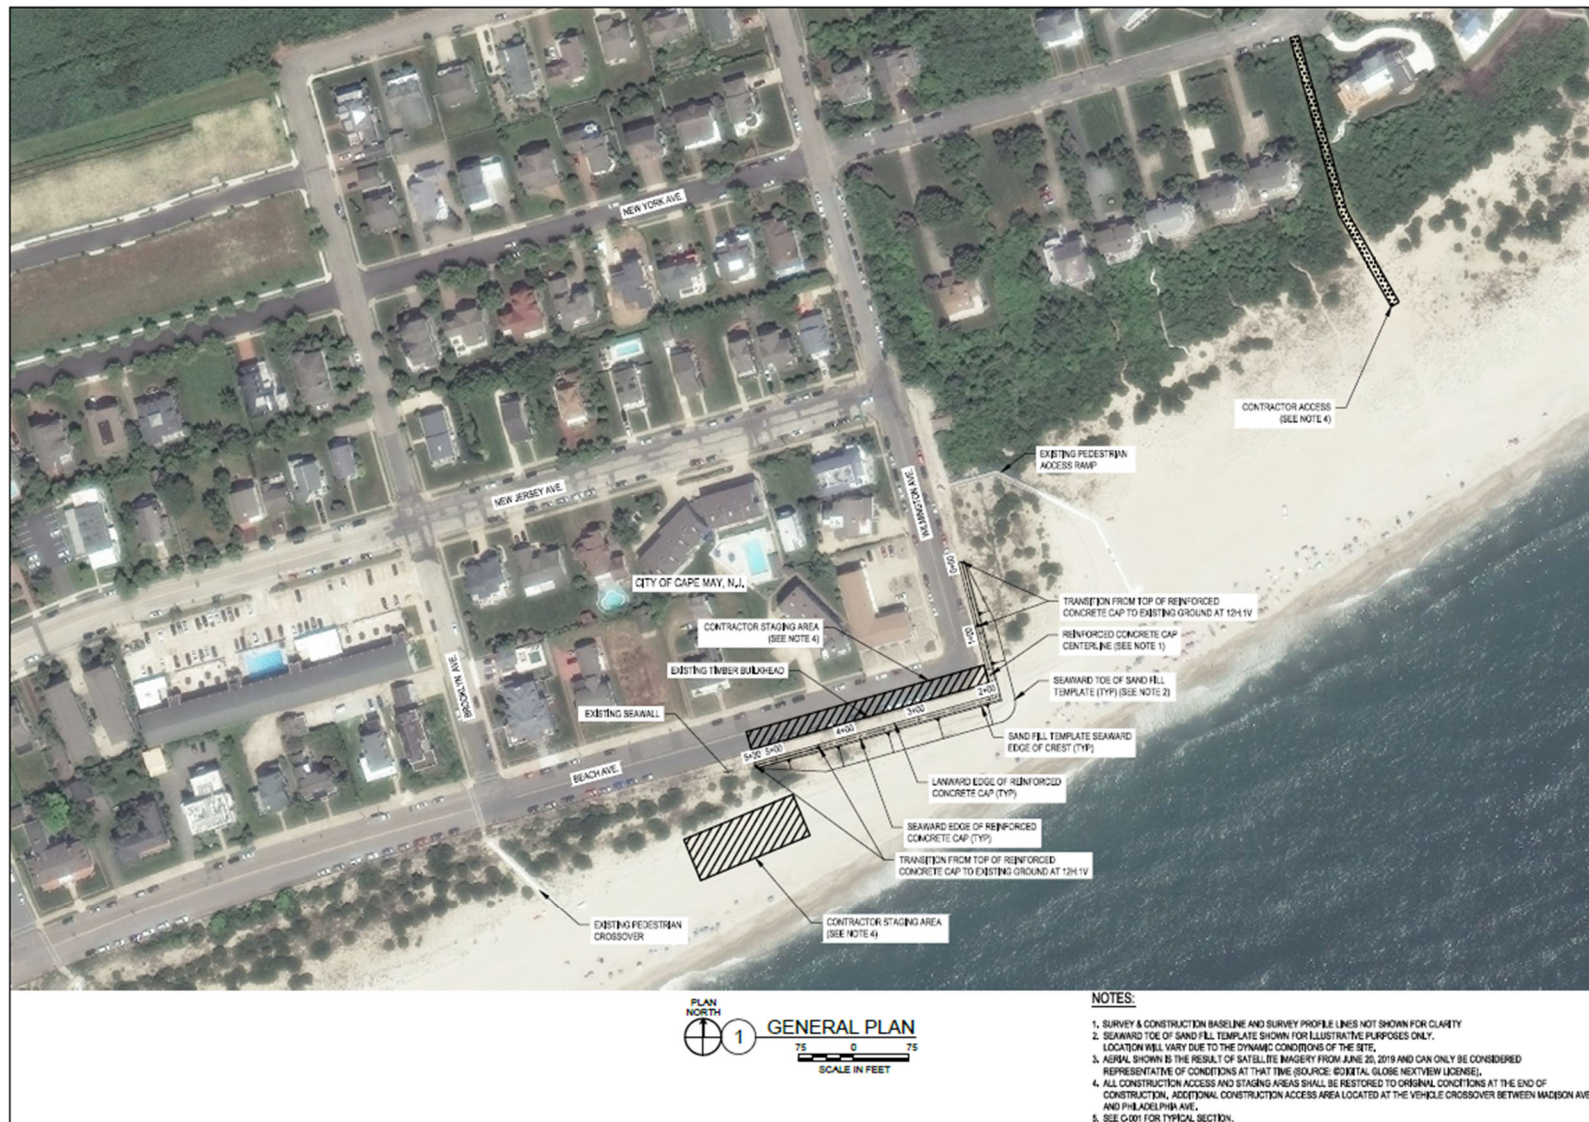
Figure 23: Site Plan

The tentatively selected plan (TSP) is Alternative 4 which consists of raising the elevation of the existing stone seawall along its current alignment by placing a reinforced concrete cap on top of the existing stone seawall to elevation +17 feet (NAVD88) for 350 feet. At this elevation, the existing stone seawall would be raised approximately 7.5 feet from its existing elevation. The extent of where the existing seawall will be raised is shown in Figure 23.

Staging areas and contractor access points needed for project construction are indicated on Figure 23. Due to the work being on top of the existing stone seawall, this alternative would not require modification of the decommissioned storm water pipe.

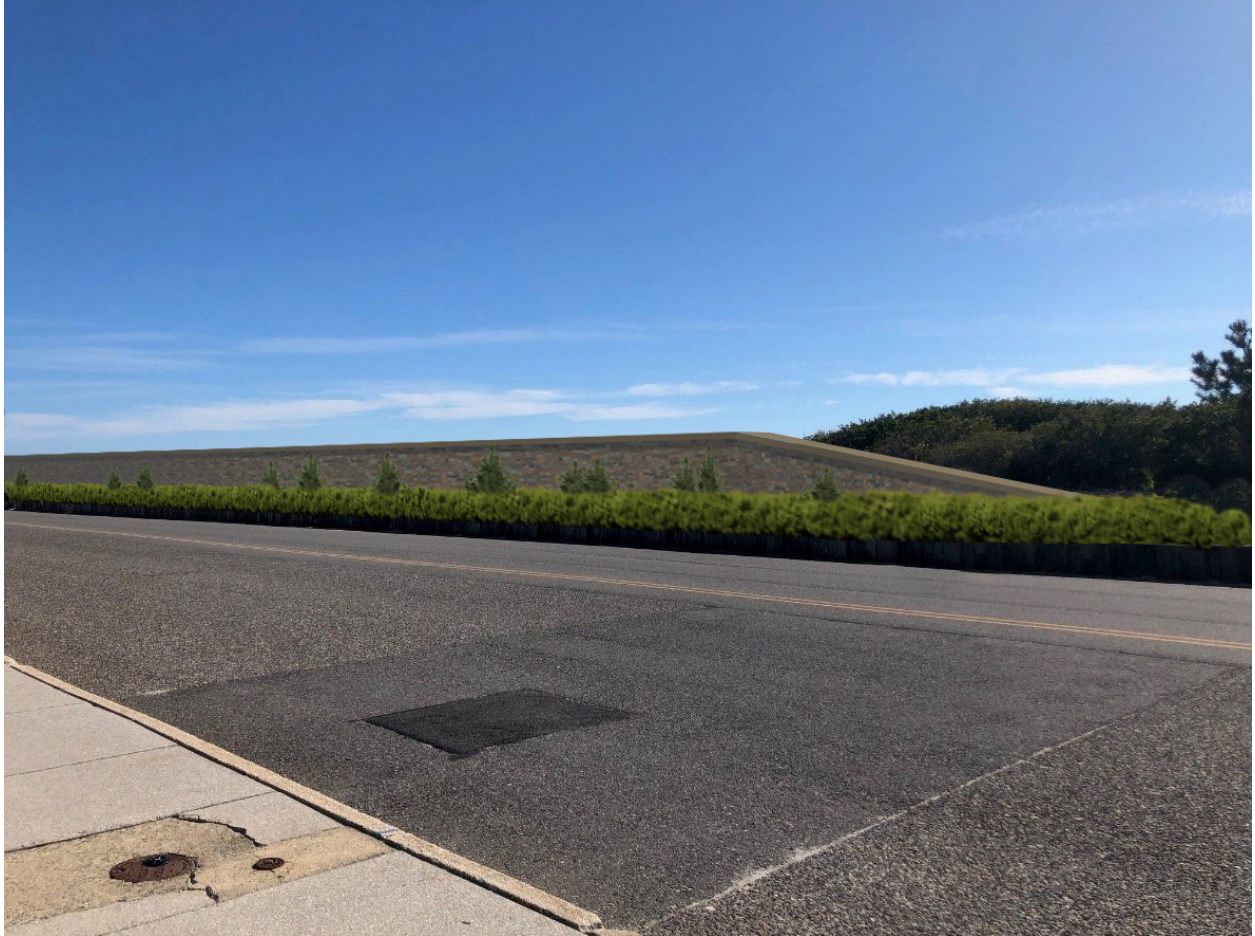
Figure 25: Visual rendering from the Land

Visual renderings of the constructed seawall associated with this project are demonstrated in Figures 25 and 26.
